Analysis of the State of Building Conservation through Study of Damage and Its Evolution with the State of Conservation Assessment BIM Model (SCABIM)

The selected case is situated at Calle Bertsolari Txirrita, 38, in San Sebastián, Spain. It is a tall residential building with 90 homes built in 1972 and consists of a ground floor and 15 upper floors with a rectangular floor plan, from which four bodies stand out, forming a double T. It also has a basement which occupies the same area as the block. The ground floor is mostly open, forming a perimeter porch, in the centre of which is the entrance doorway providing access to three options: the stairway to the basement, the stairway to the residences and the two lifts. The building is shown in Figure 3.

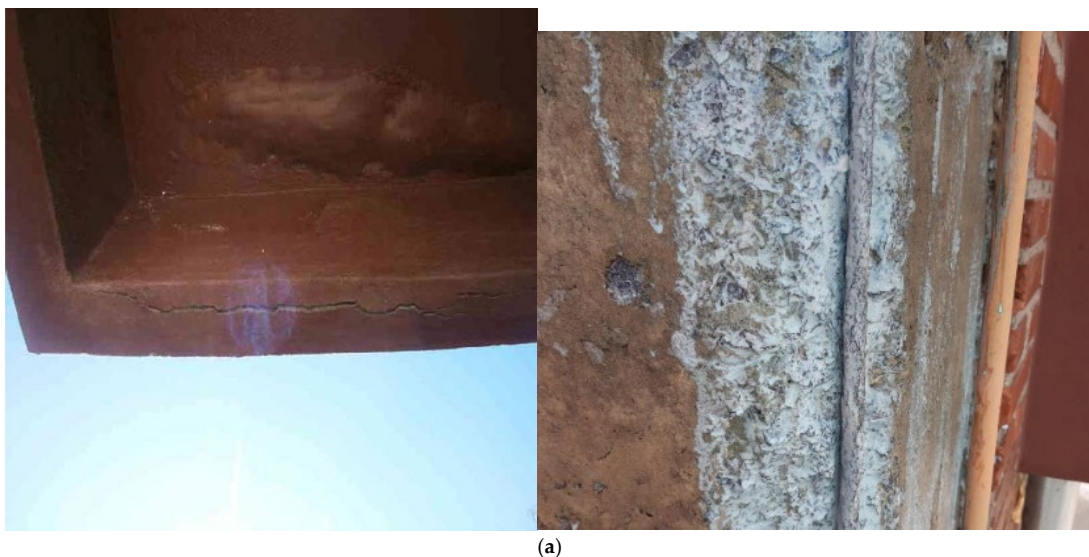
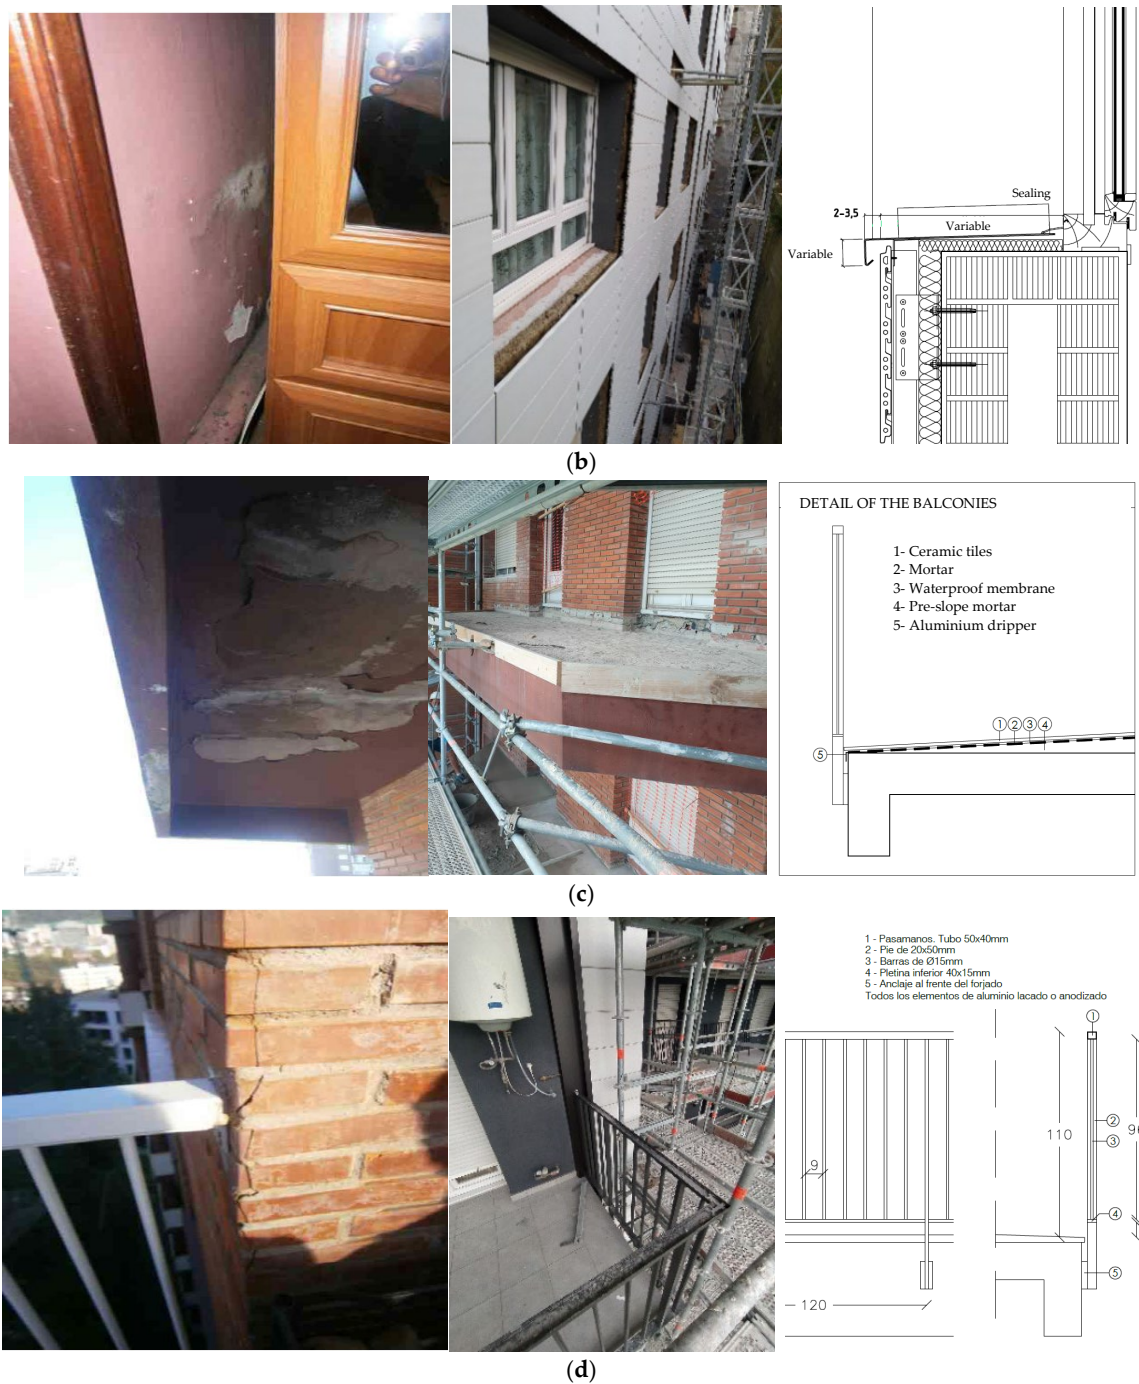
Figure 11. Information generated is unconnected. (a) Photo in the report: carbonatation of reinforced concrete and photo taken while monitoring work to repair the carbonatation; (b) photo in the report of condensation moisture stains, photo in the documentation on monitoring the work on energy improvement of the envelope and detail of the intervention set out in the rehabilitation plan; (c) photo in the report of areas of dampness from leaks and efflorescence due to poor waterproofing of overhanging balcony slabs, photo in the documentation on monitoring the intervention work on those slabs and detail in the rehabilitation plan; (d) photo in the report of railing anchor detachment, photo in the documentation on the monitoring of work to replace the railings and detail in the rehabilitation plan.

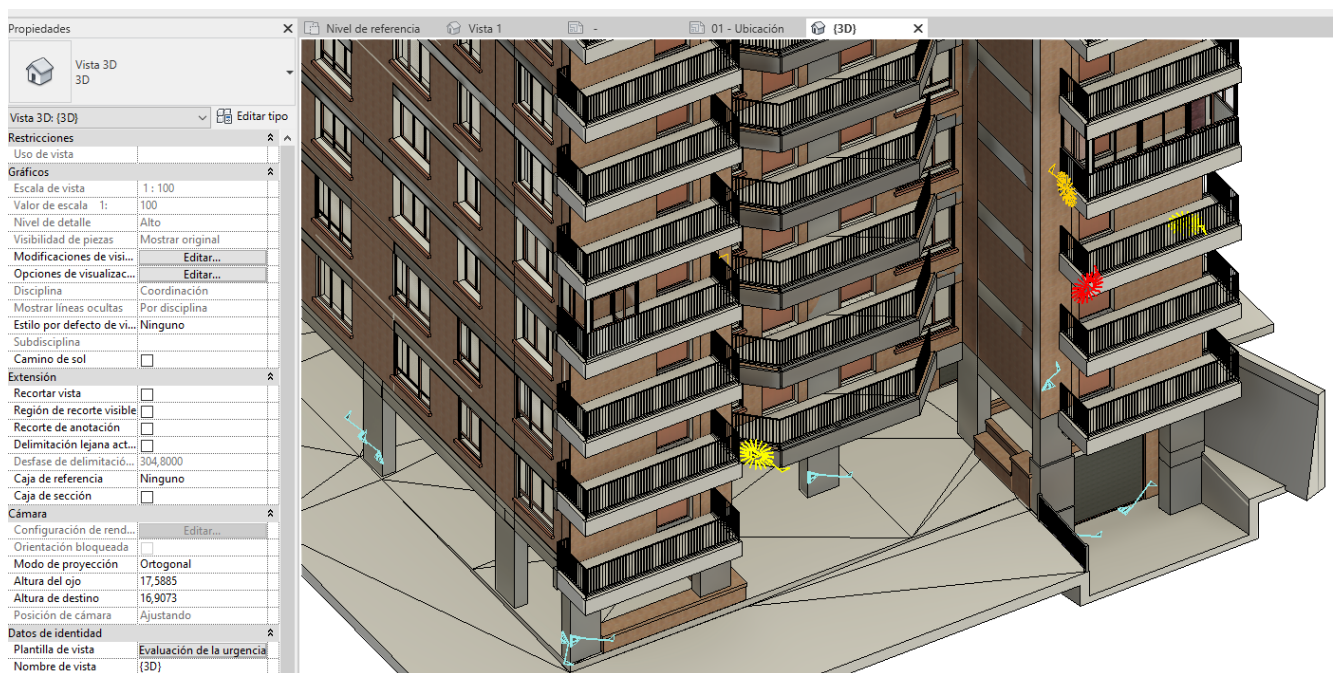
Figure 13. Three-dimensional model of the building's state of conservation. Instances of damage are located, showing the intervention urgency and the need for safety measures according to the colours established for each case: red = immediate intervention; orange = very urgent intervention; yellow = urgent intervention; blue = intervention needed in the medium term; green = maintenance. The activated crowns indicate the need for safety measures.
