Methodology for assessing the vulnerability of built cultural heritage

Laura Damas Mollá ^{a,*}, Maialen Sagarna ^b, Ane Zabaleta ^a, Arantza Aranburu ^a, Iñaki Antigüedad ^a, Jesus A. Uriarte ^a

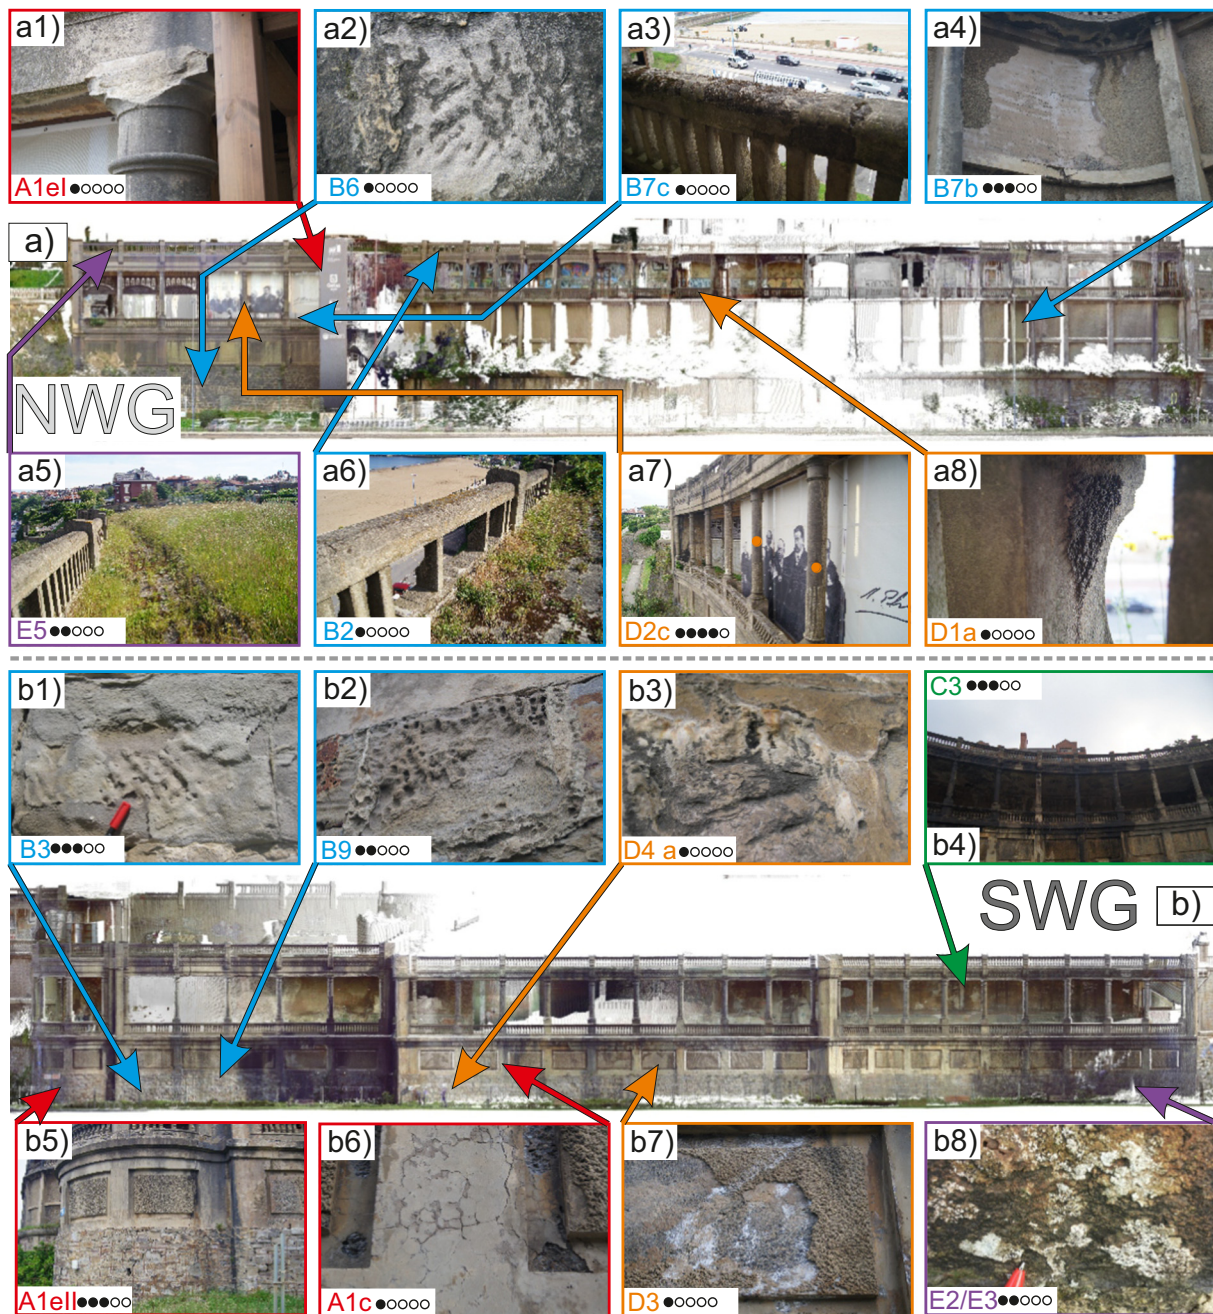
Fig. 5. Main alterations in the façades of the Punta Begoña Galleries located on the point cloud of: a) NWG (Northwest Gallery); a1) A1eI: fracture without loss of stability, breakage, of the upper part of the column; a2) B6: peeling of masonry sandstones; a3) B7c: contour flaking of plastering mortar of balustrade crosspieces; a4) B7b: spalling of decorative plaster mortar of concrete quadrants of intermediate section; a5) E5: plants on roofing; a6) B2: hiatus in balustrade crosspieces; a7) D2c: soot on façade, columns (orange circles); a8) D1a: black crusts on sides of balustrade crosspieces in the gallery corridor; and b) Southwest Gallery (SWG); b1) B3: blistering in masonry wall sandstones; b2) B9: alveolar weathering in sandstones of masonry wall; b3) D4 a: calcium carbonate encrustations in curtain walls caused by degradation of the mortar used in the masonry; b4) C3: darkening from damp area on the curved façade of the SWG; b5) A1eII: fracture with loss of stability (SWG); b6) A1c: cracking of plastering mortar of the intermediate concrete wall; b7) D3: white efflorescence on reinforced concrete of the intermediate quadrants; b8) E2/E3: bioalteration from lichen and mould. (Degree of effect: ○○○○○: no ASA; ●○○○○: <10 % ASA; ●●○○○: 10 % to 25 % of ASA; ●●●○○: 25 % to 50 % of ASA; ●●●●○: 50 % to 75 % of ASA; ●●●●●: all ASA) (based on Damas Mollá et al., 2018).

Type A (crack) alterations have developed mainly in the SWG (Fig. 5 b5). Consequently, the highest values of F_CVI were also obtained in this area.

Type B alterations, such as detachments, are caused by an interaction between factors intrinsic to the materials and natural factors, especially

weather impacts. In this regard, the texture, composition and compatibility of the different materials of the galleries influences the degree of weathering they suffer. The main alterations of this type recorded are of type B5 (disintegration) in the sandstones of the masonry section (Fig. 5 b1), and of type B7b (spalling) (Fig. 5 a4), in the concrete quadrants, where the covering mortar is spalled. The materials used in the two façades are similar and for this reason, the values obtained for F_MVI in NWG and SWG are also similar. The F_NVI is also similar in the two study areas, mainly due to the climate of the area in which the galleries are located: a mesothermal Atlantic climate, with mild temperatures and very high rainfall (Euskalmet, 2022). However, the index is higher in SWG. This is due to the orientation of the façade itself leading to greater intensity of some weather impact factors, aerosols, pollutants (Madariaga et al., 2019) and exposure to sunlight.

For type C alterations (Chromatic), the CI of SWG is higher than that of NWG. In the galleries, this type of alteration is caused by breakage and lack of maintenance. In the case of NWG, clogged and/or broken guttering systems were recorded throughout the façade. In addition, due to its orientation, this façade receives fewer hours of direct sunlight, so damp areas remain damp over time. In SWG, the Type C3 alteration (darkening due to damp areas) (Fig. 5 b4), is largely concentrated in the curved portion of the façade. The main factors involved are the morphology of this part of the façade, the hours of sunlight (F_NVI) and, above all, the condition of maintenance of the roof (F_CVI).

The DIs of both façades are in the medium range and are similar for the two façades; type D alterations are mainly deposits of exogenous materials, primarily soot (Fig. 5 a7), accumulated as a result of the proximity of road traffic. In some specific areas, there is also some shrinkage due to degradation of the rendering mortar of the masonry wall (Fig. 5 b3) or the concrete of the structure itself. These types of alterations are therefore related to the three main types of factors analysed, especially the last two (F_MVI and F_NVI). The same is true of EI; the range obtained is somewhat higher in NWG because of the vegetation on the roof (Fig. 5 a5). This type of

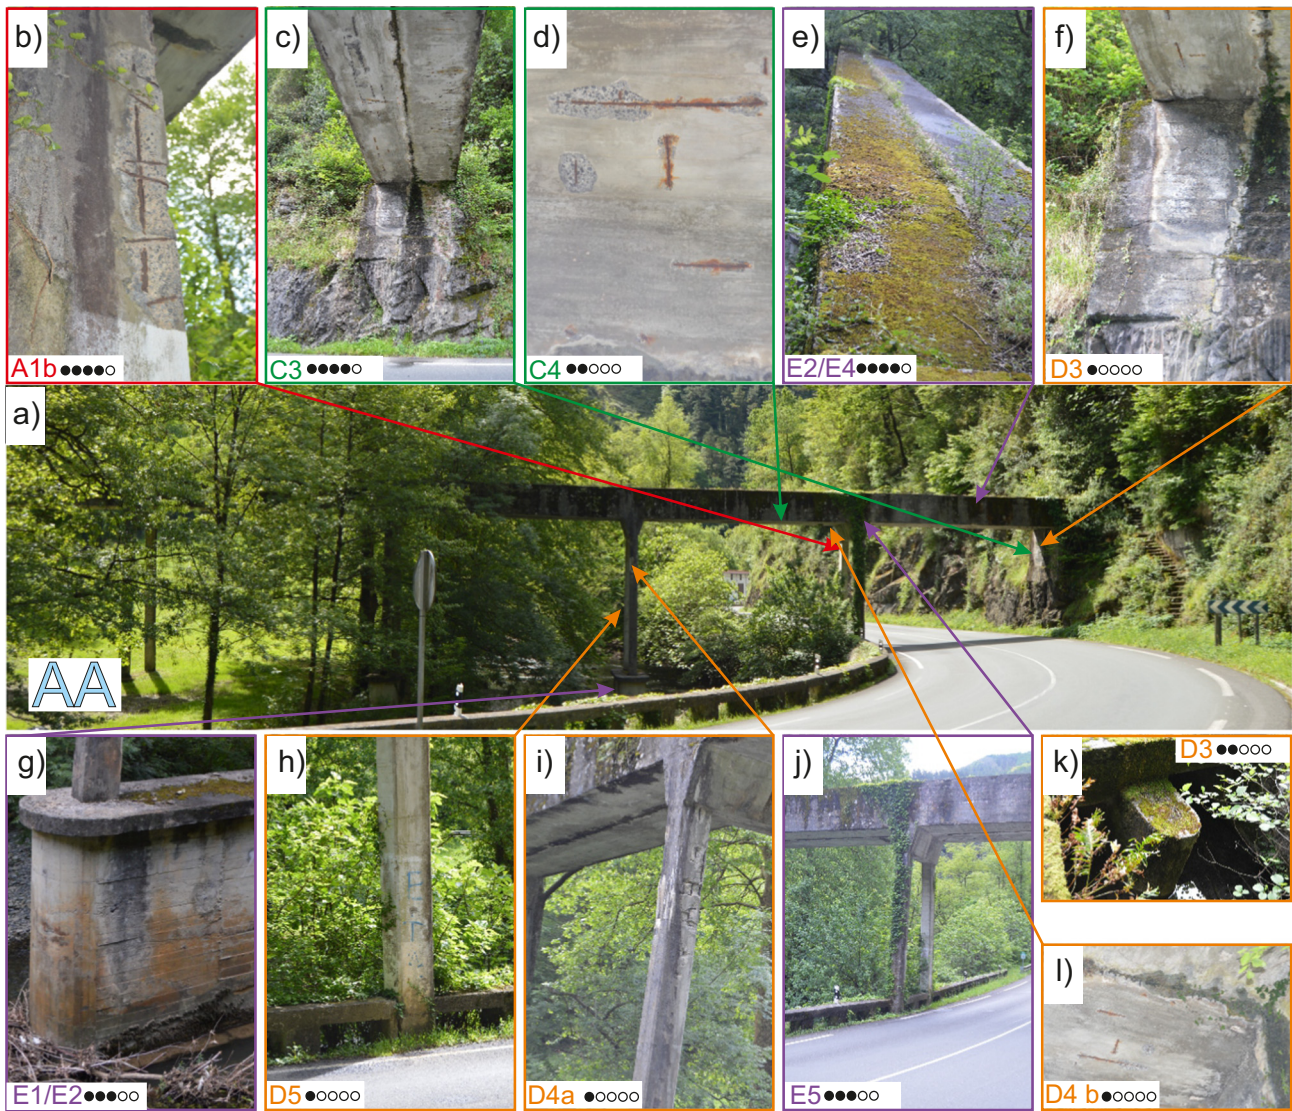
Fig. 6. Main alterations in the Araxes Paper Mill Aqueduct (APMA): a) Side view of the aqueduct; b) A1b: splitting; c) C3: darkening from damp zone in the support with the rock; d) C4: Staining of concrete due to degradation of metal reinforcement at the base of the case; e) E2 and E4: lichen and moss on the case; f) D3: efflorescence in the area of support with the rock; g) E1 and E2: algae and lichen at the base of the palisades above the river; h) D5: graffiti on pillar; i) D4a: encrustation in curtain on palisade; j) E5: creeper-type plant on palisade; k) D2b: debris inside case; l) D4b: macaroni-type encrustations in the bottom joint of the case (Degree of effect: ○○○○○: no ASA; ●○○○○: <10 % ASA; ●●○○○: 10 % to 25 % of ASA; ●●●○○: 25 % to 50 % of ASA; ●●●●○: 50 % to 75 % of ASA; ●●●●●: all ASA) (based on Damas Mollá et al., 2018).

The highest value is for AI alteration index (type A, cracks). These alterations are of splitting type (A1b), caused by degradation of the concrete reinforcement and loss of its covering (Fig. 6b). An analysis of the FVI results indicates that this corrosion is not only due to construction factors or the construction material itself, since both the F_{CVI} and the F_{MVI} stand within the moderate range. This alteration has been generated by a conjunction of both, which is also intensified by the natural conditions to which the structure is subjected (F_{NVI} moderate).

Bioalterations (type E alterations) are the second highest type of index and stand in the medium range. This type of alteration is caused by the rural environment in which it is located (F_{NVI}) and lack of maintenance of the structure (F_{CVI}). All kinds of bioalteration, algae and lichens have been recorded, mainly at the base of the pillars (Fig. 6g) and moss, mould and plants at the top of the case (Fig. 6e).

Alterations of type C (Chromatic Changes) are not very significant in this construction. In general, they may be related to others of greater incidence such as the orange staining (C3) related to degradation of the reinforcements (Fig. 6d). In some areas there is also darkening due to constant damp (C3) (Fig. 6f). This is to be expected, given that the construction under study is an aqueduct and is mainly the result of lack of maintenance.

The type D alterations (deposits) are basically deposits of exogenous materials, mainly of soot type, on the surface, as a result of the heavy road traffic under this structure. This type of alteration shows the relationship between natural and environmental factors and vulnerability. In this case the F_{NVI} is the highest. Numerous calcium carbonate encrustations have also formed, (Fig. 6f, i); the factors intrinsic to the materials and construction factors are mainly responsible for their formation, since they are recorded in the area of the joins between slabs, but the humid environment typical of the surrounding Atlantic climate also plays a role. Proper maintenance of the structure would contribute to reducing many of these alteration indexes. Regarding the value obtained for F_{CVI} , the generally good state of the structure is noteworthy, bearing in mind its age and the lack of regulatory standards on concrete construction at the beginning of the century. The low F_{MVI} result is also notable, but this is due to the use of a single construction material and the simplicity of the structure itself, with straight lines, in contrast to the Punta Begoña Galleries.
