# Repair of Beam End Joints Using Steel Rods and Wood Prosthesis in Heritage Buildings: Implantation in the Structure of the Zabala Palace in Ordizia (Basque Country, Spain)

**Abstract:** This paper presents the methodology developed in the repair of three oak beam ends in a protected heritage building: the Zabala Palace in Ordizia (Basque Country, Spain). It describes the structural assessment, design, calculation and execution process, as well as the experimental tests carried out in the laboratory to verify and validate the structural capacity of the repair method. The intervention consisted of cutting and removing the beam ends degraded by fungi and replacing them with wooden prostheses. These elements were connected to the beams by means of threaded steel rods and epoxy resin. Calculations based on standards and the literature were verified by laboratory tests where aspects such as the fluidity, filling and pull-out resistance of four commercial epoxy resins were tested. Once the epoxy resin was selected, three samples of the reinforcement design were also flexure tested. The results of the different tests show capacities much higher than those resulting from the application

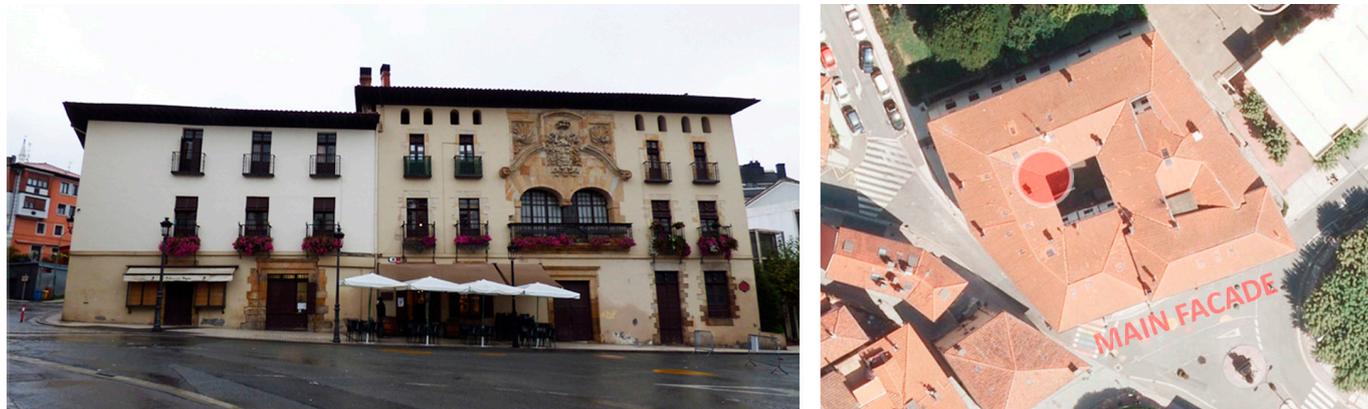
**Figure 1.** Image of the main facade. Aerial photo of the building, showing the corner of the courtyard with damage.

As well as other historical heritage buildings in the Basque Country [28–30], the Zabala Palace has a structure composed of masonry perimeter load-bearing walls and an interior structure of wooden posts, beams and joists. In the central part, the palace has a Renaissance courtyard, where a row of sandstone Doric columns support the wooden beams and the loads of the upper floors. Before the intervention, pathologies of biological origin were visible throughout the courtyard. The most serious damage was in the support of the northwest corner of the courtyard (Figure 1, right), in which three beam ends were badly decayed.

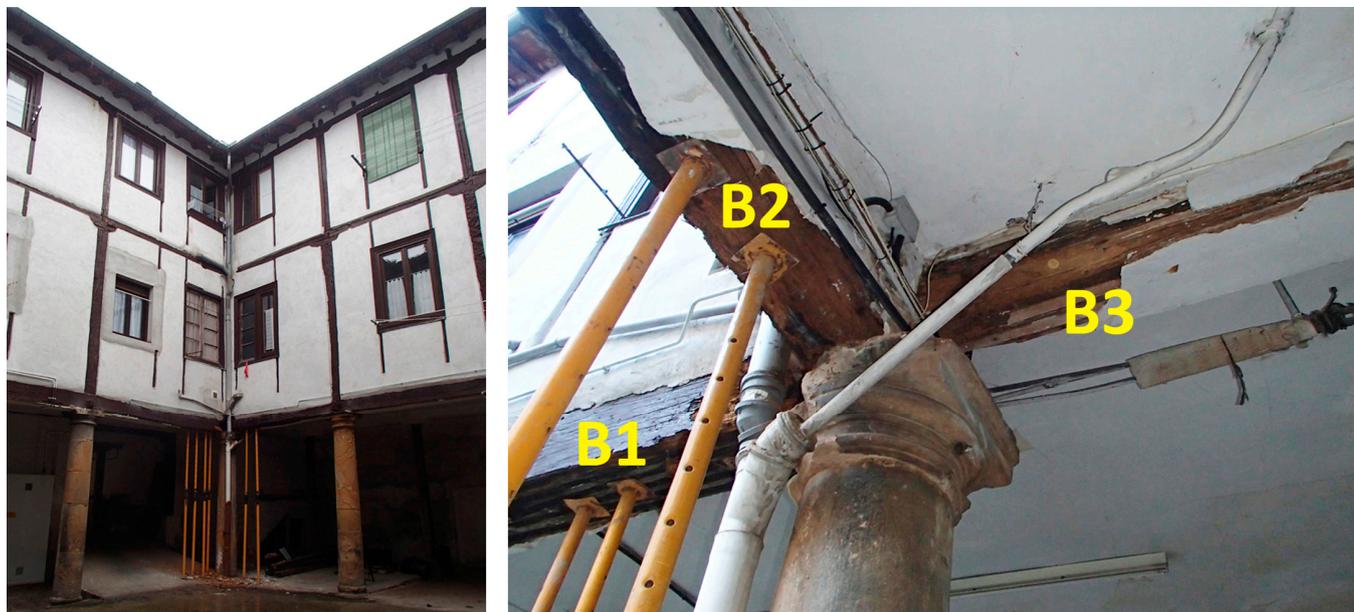
This article deals with the intervention carried out in these three wooden beams located in an outdoor environment. The structural joint of this corner is complex, since three beams converge at the same point with little support surface. In addition, this point is exposed to external humidity and rain, and a downspout runs through it as well. Two of the members are facade beams (Figure 2, B1 and B2) and the third beam (Figure 2, B3) allows

**Figure 2.** General view of the corner. Detail of the support of the three beams on the stone column.

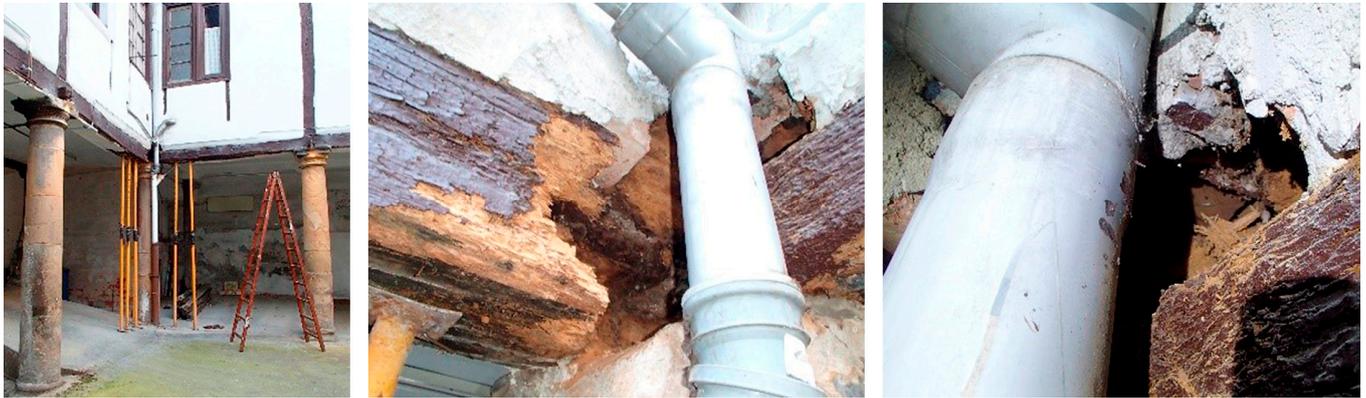
Regarding the study of the historical documentation on the building, no information was found on relevant transformations or previous repair works in the intervened area. The only important previous work, which is not documented, is the installation of the downspout. During the visual inspection, it was observed that the corner was already shored up by the property and that the three beam ends showed severe degradation caused by wood decay fungi (Figure 3). It was determined that the cause of this damage was leaks from the downspout and the water trap formed at the joint of the beams resting on the stone column. The on-site inspection also served to verify that the species of the three beams was oak wood.

**Figure 3.** Beam ends damaged by fungi and the downspout.

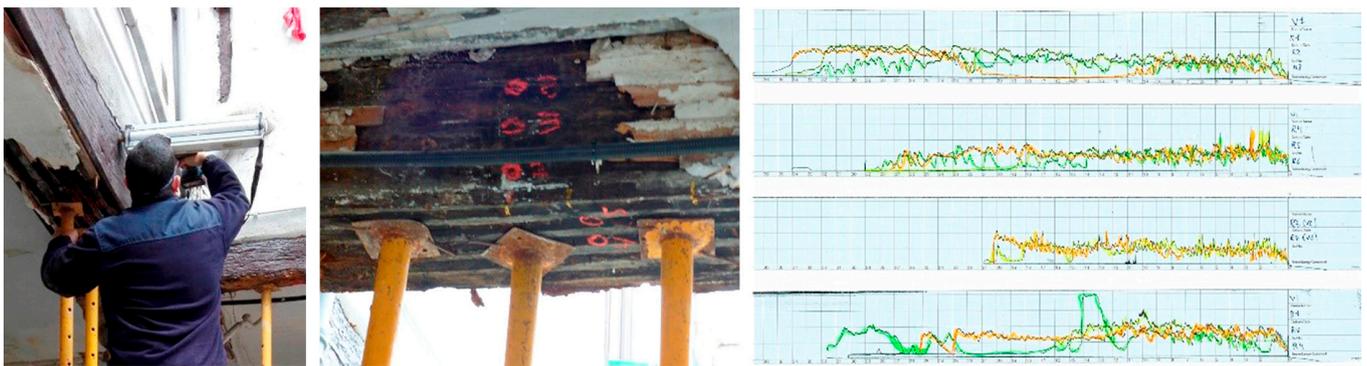
In the instrumental diagnosis (Figure 4), the moisture meter and micro-drilling were used to determine the area and extent of degradation hidden by fungi in the three beams. To be able to measure with the necessary accuracy, some of the damaged finishes had to be removed at some points by manual means, avoiding vibrations or levers and causing the least possible damage to the healthy parts. In the three members, a gradual improve-

ment in the condition of the wood was observed as the beams extended away from the corner. The micro-drill tests determined that the non-recoverable extent of degradation in beams 2 and 3 was slightly less than 500 mm in length from the beam end. Beam 1 showed a greater degradation, which was around 700–750 mm in length from the beam end. Thus, this study served to determine the length of the beam to be sectioned, removed and replaced by a wooden prosthesis of the same species.

**Figure 4.** On-site inspection, marking of tests on the beams and several graphs obtained using the micro-drilling technique, in which the areas damaged by fungi appear with lower values.

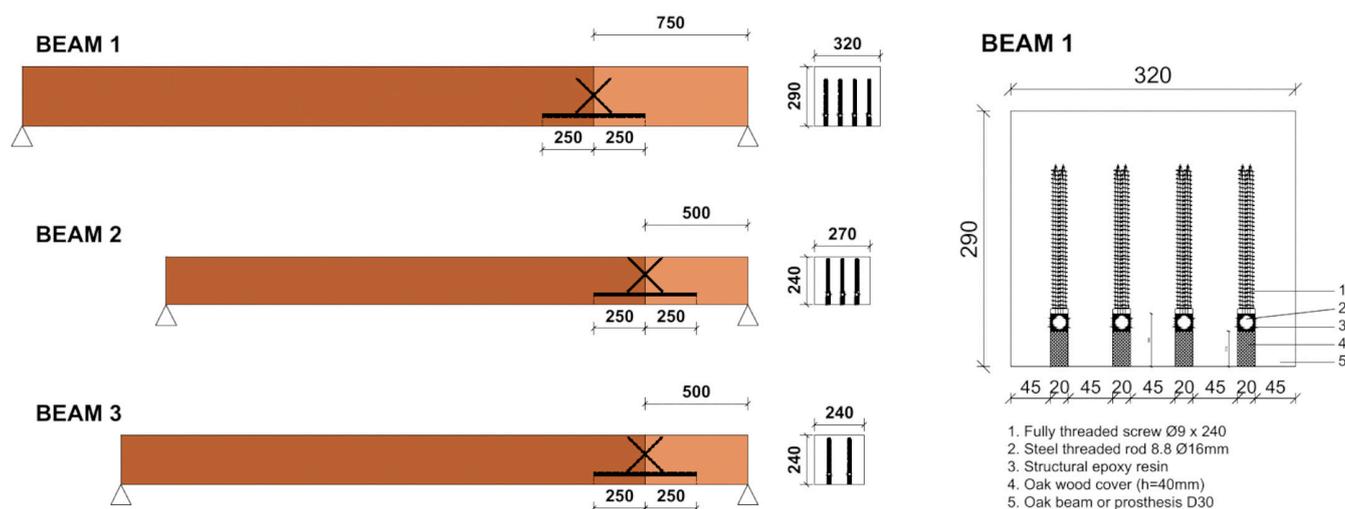
**Figure 5.** Design of the prostheses of beams B1, B2 and B3. Detail of beam B1.

At this stage, the optimal approach for restoring the original appearance and structural capacity of the degraded elements with minimal intervention was to manufacture and install wood prostheses. The technique aimed to reduce both the overall intervention and the impact on the original wooden elements. After consulting with the contractor and the carpenter regarding their technical and operational capabilities, fully vertical cut (instead of an angle cut) timber prostheses were designed. This solution minimized the loss of material in the original element and facilitated the execution process for the builder.

The connection was designed to ensure the structural continuity of the prostheses and the original beams consisted of steel threaded rods bonded with epoxy resin for the bottom-edge tensile stress, and fully threaded screws inserted at 45-degree angle for transmission of the shear stress. The relative position of the reinforcement and number of rods were adjusted on every beam according to its degradation length, load and geometry (Figure 5). The rods were concealed within grooves, which were subsequently covered with oak wood covers to maintain the esthetic integrity of the structure with a fully compatible material and to protect the steel elements from fire.

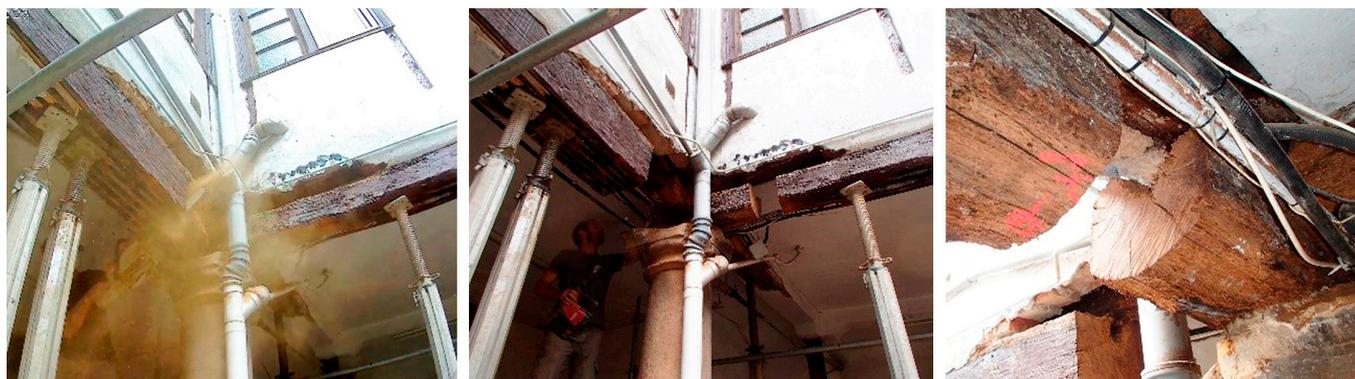
**Figure 13.** Shoring and cutting of beam ends.

Once the experimental tests were completed, the designed solution was executed using the selected resin. The structural reinforcement was carried out without any incidents or unforeseen issues. The first step was to adequately shore up the structure. In this case, four high-strength props were used: two for the front beam and one for each of the remaining beams. After shoring the beams, their ends were cut according to the recommendations derived from the micro-drilling analysis (Figure 13). Two of the three beams still showed shallow degradation on the upper side of the cutting plane, which was consistent with the results of the micro-drilling study and was considered acceptable.

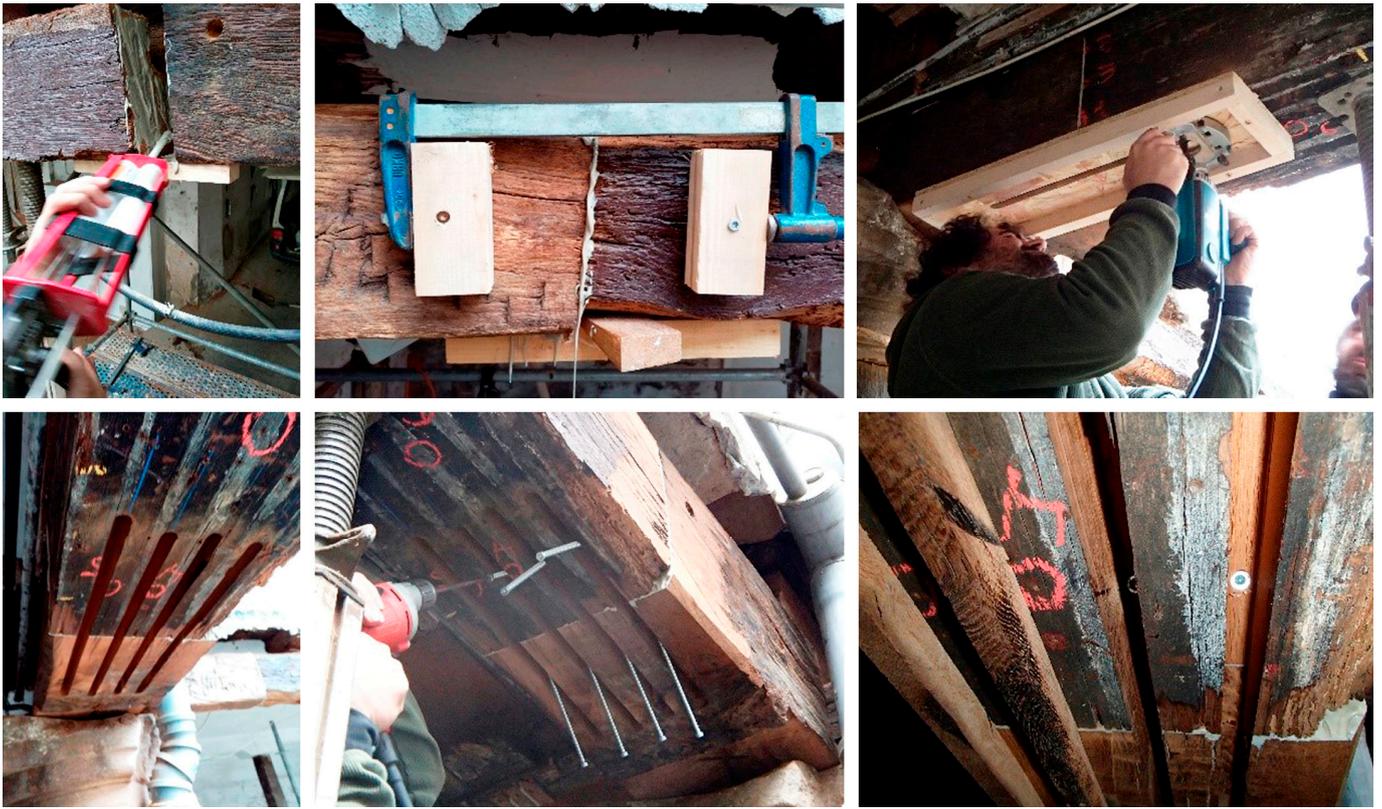
Figure 14. Placement of the wooden prosthesis. Grooving and insertion of fully threaded screws.

Once the beam ends were cut and removed, the new prostheses, made of the same species of oak wood (*quercus robur*) to ensure compatibility, were presented and glued to the beams (Figure 14). The purpose of gluing the heads is to ensure the correct seating of the two pieces. As mentioned above, it was decided to make a vertical cut instead of an inclined cut to minimize the loss of original material and to facilitate the execution process. Once the pieces were bonded and secured, both parts were grooved, and the fully threaded screws were inserted to support the shear stress. Given that it was in an outdoor environment, moisture content control of the intervened elements was necessary (the moisture content of the prostheses and beams should be almost the same).

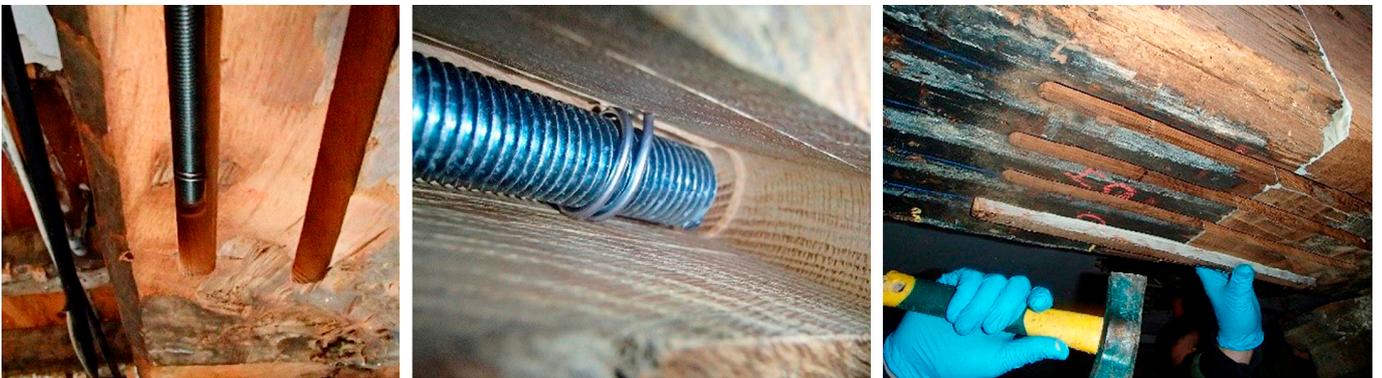
Figure 15. Insertion of rods and placement of glued wooden covers.

After inserting the screws, the threaded rods were placed with the wire spacer, which also served to hold the rods in place before the resin was injected (Figure 15). The epoxy resin used was in cartridge format. Subsequently, the oak cover was installed, and the resin was injected through the entry hole until resin began to come out of the exit hole (Figure 16). Thus, the injection was stopped, and wooden dowels were placed over the two holes. Finally, the mixture was allowed to cure according to the specifications of the manufacturer, leaving the element available to apply the necessary finish treatments.

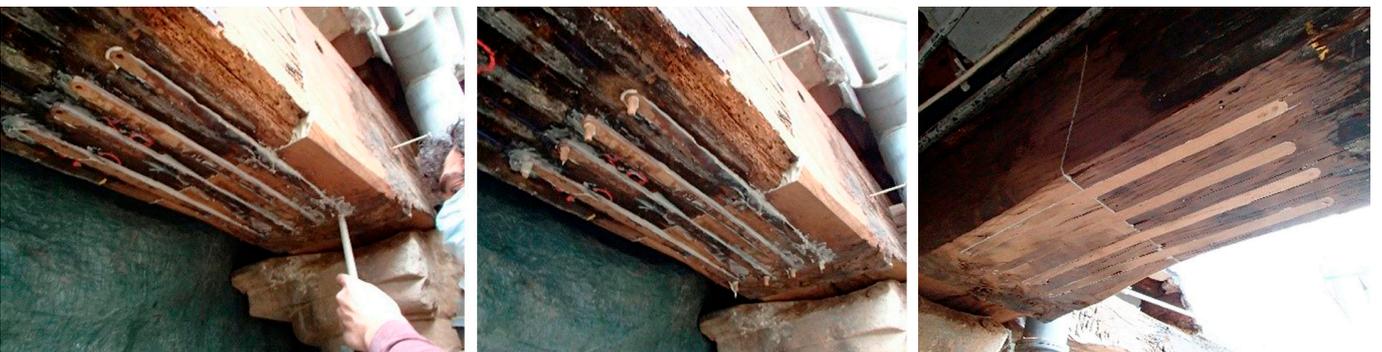
Figure 16. Injection of resins, placement of dowels and final result without finish treatment.
