DEVELOPMENT OF IN SITU NON DESTRUCTIVE ANALYTICAL METHODOLOGIES FOR THE CONSERVATION DIAGNOSIS OF URBAN BUILT HERITAGE

Department of Analytical Chemistry

Report to compete for the International PhD degree

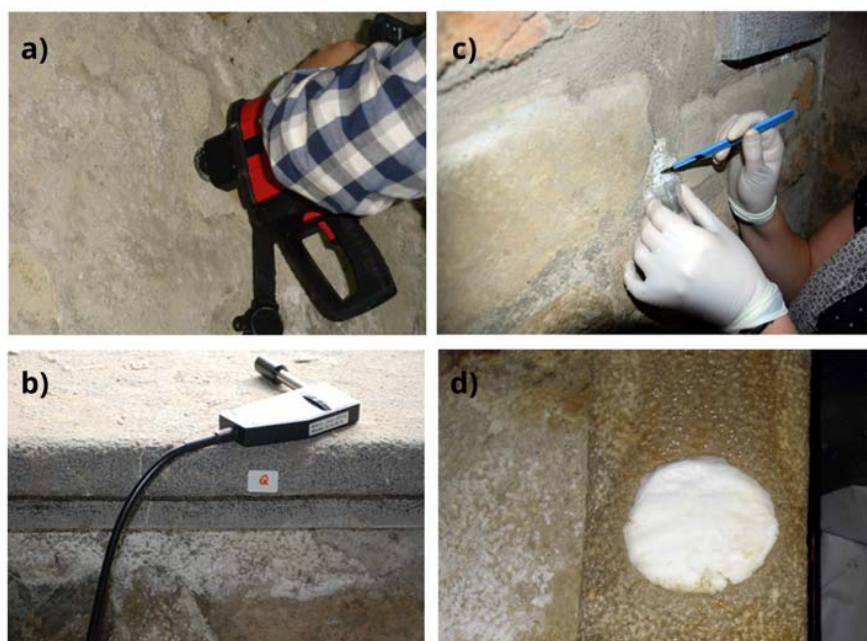
Figure 3.1. Images of the sampling procedure. a-b) Examples of in situ spectroscopic studies, assisted by Raman and DRIFT, taken place previously to the sample collection. c) Collection of an efflorescence sample .d) Extraction of soluble salt content through a cellulose poultice.

The sampling campaign was always performed in accordance to the visual inspection and in situ spectroscopic study taken place previously (Fig. 3.1 a, b), following the Italian guidelines (Normal 3/80)¹. In this manner, samples were collected, just in sufficient amount for laboratory analysis (Fig. 3.1 c), using a chisel and trying to damage the building as little as possible. Besides, the environmental conditions were taking into account through a hygrometric thermometer (TFH 610, Ebro Electronic, Geschäftsbereich, Germany).

Based on the suggestion by Arnold and Zehnder², which asserts that the salt content is seldom homogeneous throughout a wall, several samples were extracted to obtain indications of the salt content. In this way, cellulose pulp of approximately 12 cm² and 5 mm thick, soaked in de-ionized water with a pulp-to-water weight ratio of about 1/8, were applied to the sampling points for 2 hours³ (Fig. 3.1 d). The poultices were then removed and saved to the treatment phase.

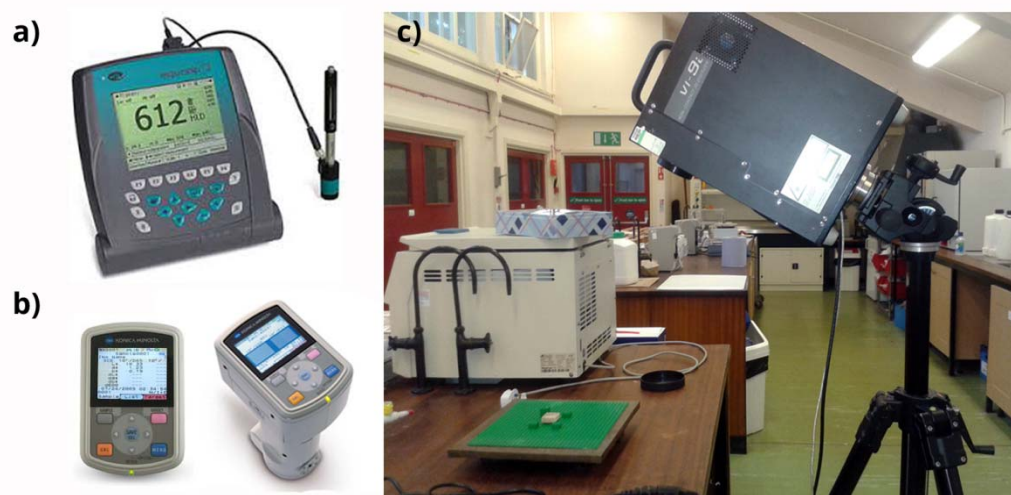
Figure 3.3. Images of portable analytical equipments used to measure physic parameters. a) Rock surface hardness rebound device, Proceq Equotip 3. b) CM-700d Spectrophotometer of Konica Minolta Sensing. c) HD-laser scanner, Konica Minolta (VI-91 3D Digitizer).

When it was required, a rock surface hardness rebound device (Proceq Equotip 3, D-type, Schwerzenbach, Switzerland) was used to assess the variability in rock surface hardness (Fig. 3.3 a) The equipment operates on similar principles to the Schmidt Hammer, but has a much lower impact making it ideal for use on soft surfaces, as it produces no damage²⁵.

In some studies, a spectrophotometer (CM-700d, Konica Minolta Sensing, USA) was used to take colour measures of stone surface following the guidelines of the International Commission on Illumination (CIELAB 2000). The handheld instrument has a color LCD screen, in which spectral colour graphs are displayed at the same time that in situ measurement (Fig. 3.3 b).

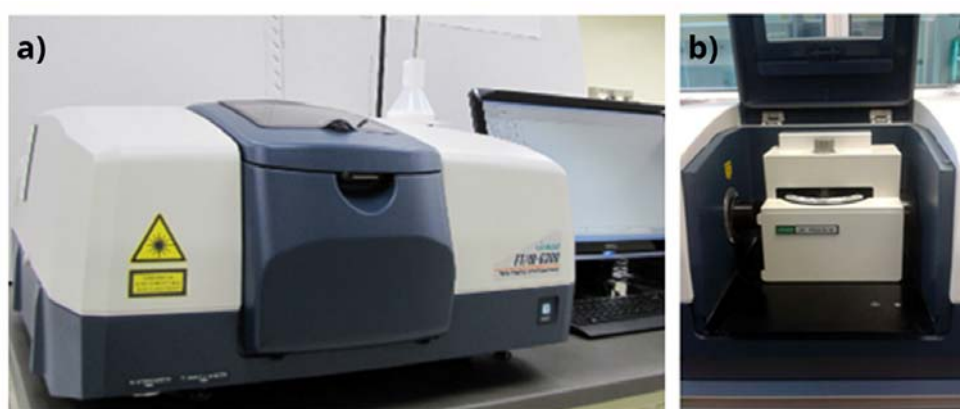
Figure 3.7. Images of DRIFT laboratory equipment. a) FTIR spectrophotometer, 6300 Jasco. b) Difuse reflection module, DR PR0410M Jasco.

(Jasco DR PR0410M, MD, USA) (Fig. 3.7), having the Michaelson interferometer a maximum resolution of 0.07 cm^{-1} .

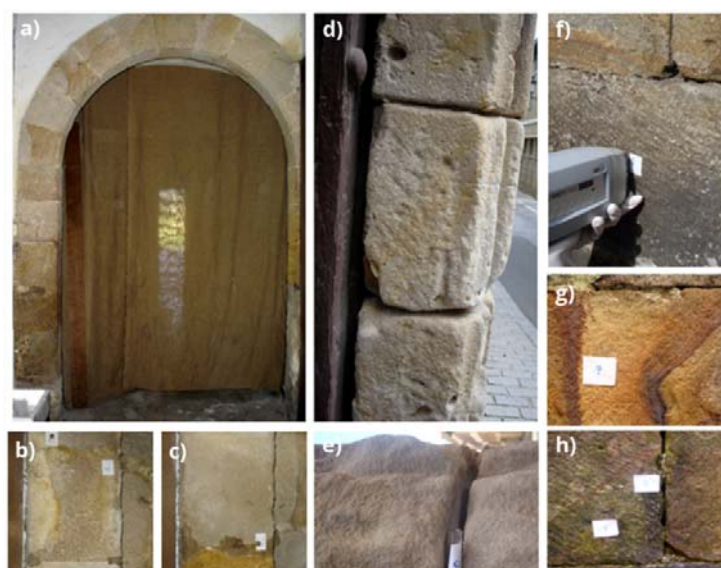
Figure 5.3. Selected photographs of the affections observed in the Palace. a) general view of the central wall arch. b-c) details of efflorescences found in the arch. d-e) material loss observed in the ashlar of the main entrance. f) example of in situ analysis of blackened areas. g) areas with change of coloration. h) biodeterioration and efflorescences found close to the drainpipe.

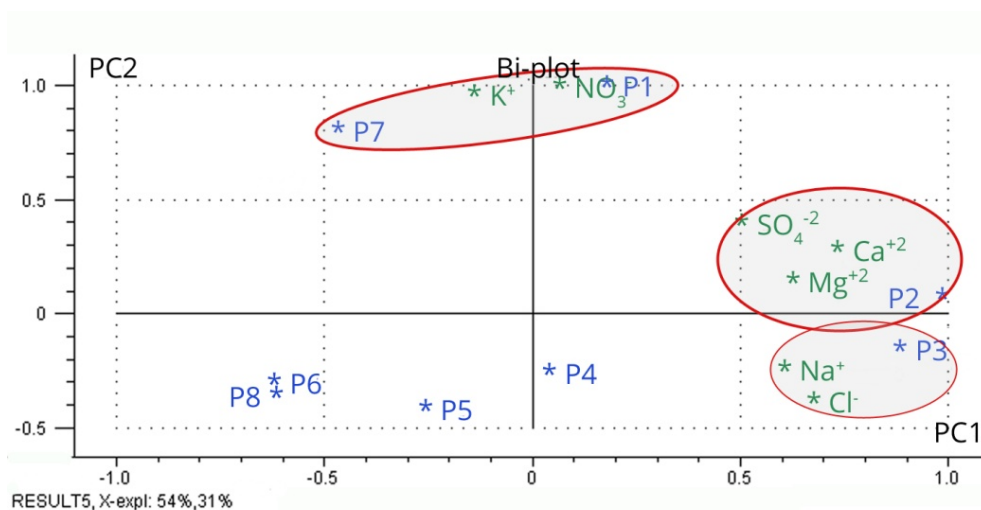
Figure 5.16. Representation of PCAs carried out by Unscrambler. The image shows the soluble content results obtained by ion chromatography. The groups formed according to the PC1 vs PC2 are highlighted: nitrates, sulphates and chlorides.

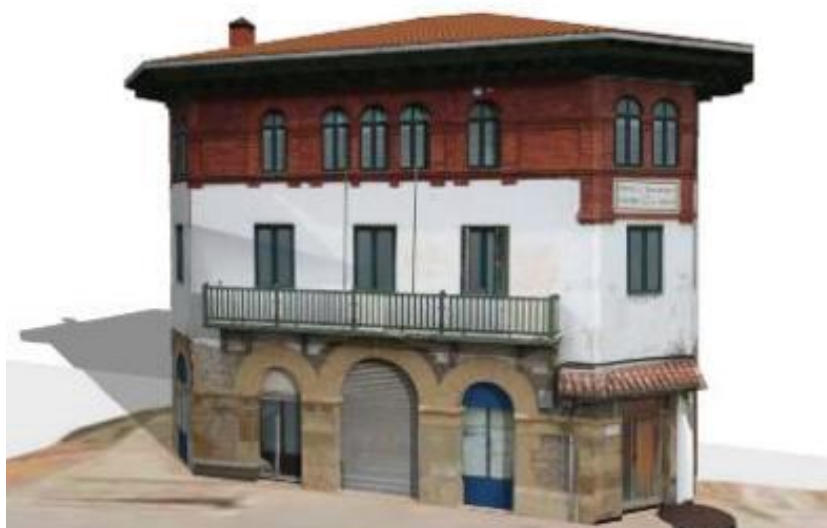
Figure 6.3. Photo-replacement of Blogspot 3D Gipuzkoa, in which the main facade of the building and aesthetic composition is observed.

In addition, from 1995, it is also included in the Special Plan for the Rehabilitation of the old quarter and port of the city. Therefore, nowadays, the possible interventions that can be performed on the building must be only aimed to rehabilitation, avoiding any modification of its current aesthetic (Fig. 6.3).

The ground floor is used as garage and is composed by masonry sandstone ashlar on a bed of limestone. The interior wall, adjacent to the hill, is coated by white plaster, in the same manner as the first and second floor (Fig. 6.3).

In the interior wall of the ground floor (Fig. 6.3), gypsum (identified by its main Raman band at 1008 cm^{-1}), mirabilite (main Raman band at 989 cm^{-1} and the weakest bands at 458 and 446 cm^{-1} aside from 1130 , 1120 , 1108 , 628 and 616 cm^{-1}), thenardite (Na_2SO_4 , identified by the strongest peak at 993 cm^{-1} and the weakest pair of peaks at 466 and 451 cm^{-1} aside from the signals at 1149 , 1128 , 644 , 632 and 621 cm^{-1}) (Fig. 6.11), nitrocalcite (identified by its Raman at 1050 and 719 cm^{-1}), niter (detected by its main peak at 1050 and its secondary at 1359 , 1344 and 715 cm^{-1}) and nitratine (identified by its Raman bands at 1067 and 724 cm^{-1}) were identified as the main compounds of the efflorescences. These results were in situ corroborated thanks to the DRIFT identification of several mixtures of sulphates and nitrates.

According to the analysis of the samples collected in the **interior wall of the ground floor** (Fig. 6.3), gypsum, mirabilite, nitrocalcite and nitratine were identified as the main compounds of the salt crust layer. Furthermore, this time, the full spectra of glauberite (Raman bands at 1140 , 1106 , 1002 , 644 and 471 cm^{-1}) was found.

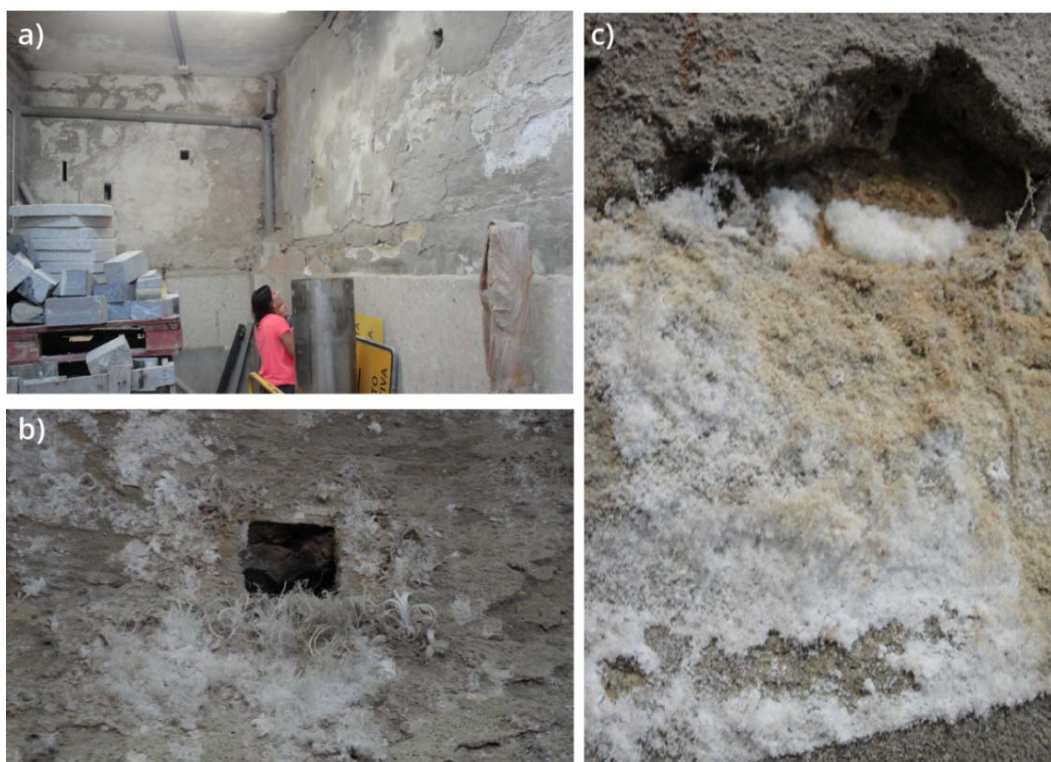
Figure 6.7. Selected photographs of the affection observed in the masonry wall of the groundfloor. a) Salt efflorescence and detachment of the plaster of the wall. b) Accentuated precipitation of salts around putlog holes. c) Enlargement of one of the most affected areas in which the efflorescences, the layer of Portland cement plaster and the original sandstone masonry can be observed.

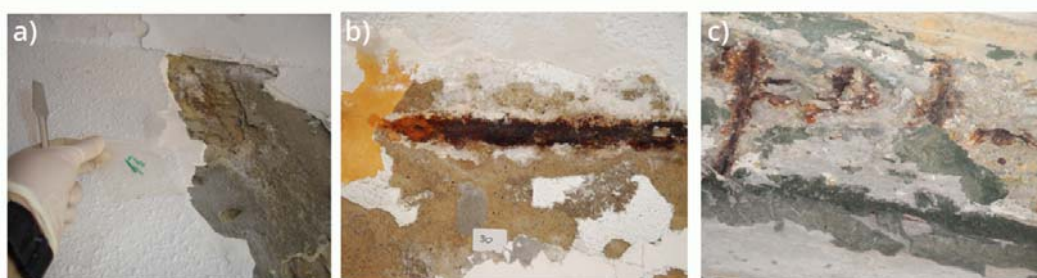
Figure 6.8. Selected photographs of the affection observed in the stairs area. a) Salt efflorescences and detachment of the plaster of the wall. b-c) Wet structures covered by efflorescences.

Finally, in the areas of stairs that give access to the upper floors, whose walls are adjacent to the garage of the ground floor, several detachment of gypsum plaster layer were observed, leaving uncovered some structures and numerous subefflorescences (Fig. 6.7).

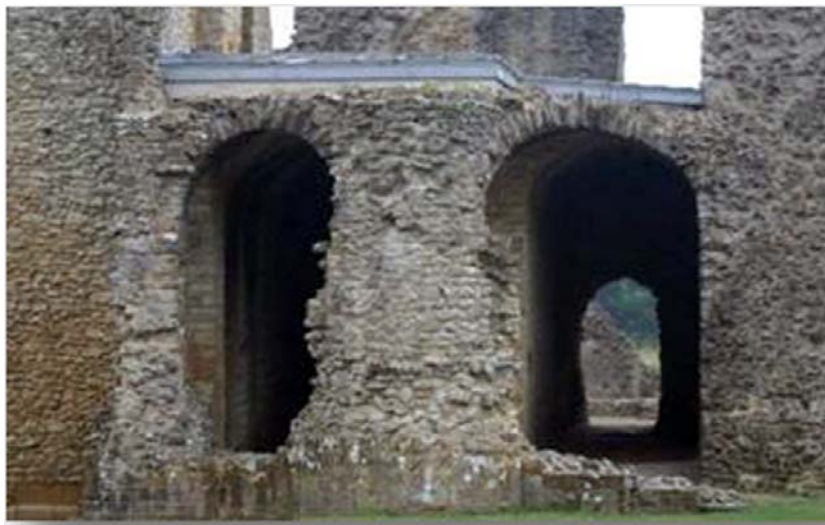
Figure 7.2. Images of a ruin historical monument of England, in which the Hard capping method was applied.

The Hard capping (Fig.7.2) was widely implemented during much of the 20th century since it was considered as the best practice for inhibiting the ingress of moisture to ruinous masonry, while at the same time it imitates the original fabric of the wall⁶. The treatment starts removing the natural vegetation growing of the top of the ruin and then, the head of the wall is reset in cement or hydraulic lime mortars to form an impermeable cap, which helps to minimize the water ingress into the wall. The goal of this method is to renew the adhesion of the mortar and for that purpose, the surface joints are raked out and pointed with fresh mortar, either directly into the cavities or over cement that is used for tamping at the back joint. If the mortar presents loss of cohesion in the wall, liquid cement is usually pumped inside to set as a solid mass⁷.

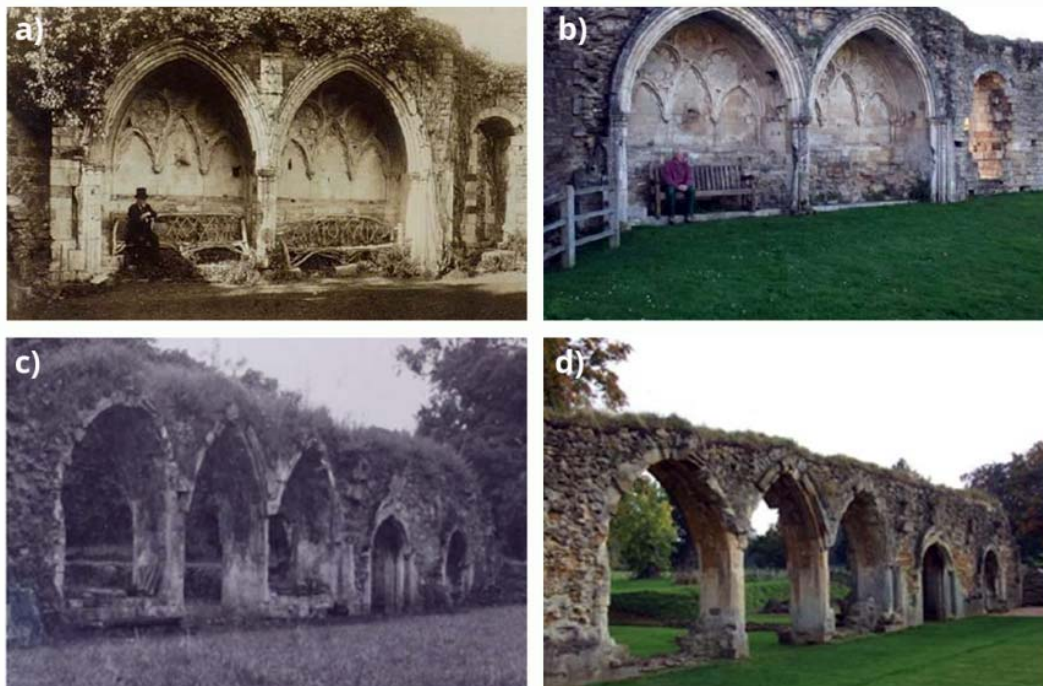
Figure 7.4. Images of ruins historical monuments of England, in which their past and present state can be compared. a-b) Kirkham Priory (19th image vs 2007) where past conservation methods led to removal of the protective vegetation cover. c-d) Hailes abbey (1937 vs 2007), where an alternative green method was applied¹⁰.

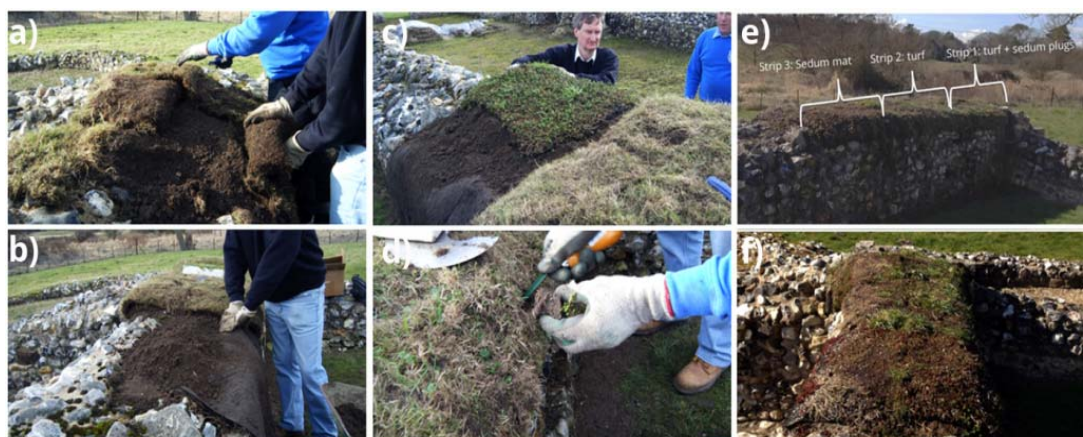
Figure 7.8. Establishment of soft caps. a) Placing the turf layer .b)Securing the sedum mat. c) Management the blocks. d) Adding the sedum plugs. e) The Soft capping test areas finished. f) Top of the test areas (viewed from East).

Lastly, after the soil, a turf layer and the selected vegetation were placed for the study. Taking into account previous investigations, sedum species can facilitate the growth of grasses during dry periods, preventing evaporation from the soil surface. This effect could be particularly useful in the preservation of ruined wall as large fluctuations in moisture and temperature conditions can accelerate weathering processes³⁰. In this way, strip 1 was composed by a mixture of grass and sedum plugs, being *Supurium tricolour* the species native to the UK selected by its suitable characteristics (very common, resistant to winds and high temperatures, low fertility and limited water necessity)³¹. Strip 2 was composed by grass and strip 3 only by the same sedum mat (Table 7.1), in which a fine membrane was applied between the soil and the turf layer in order to avoid the root damage (Fig.7.8).

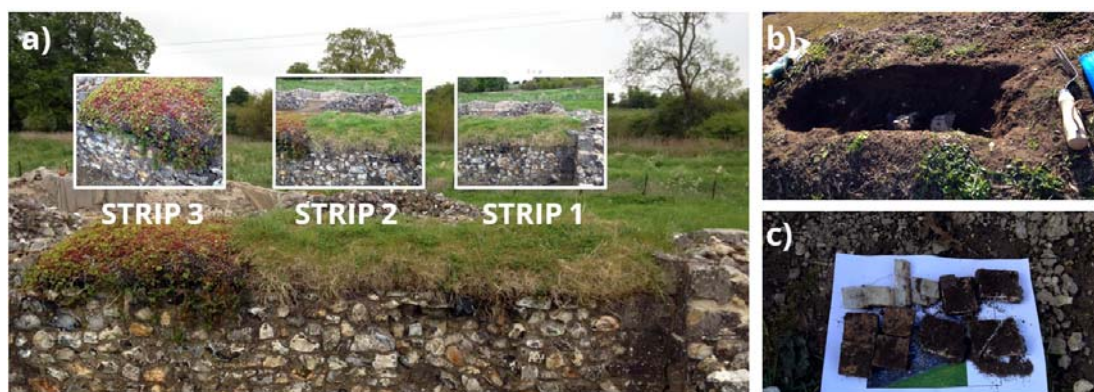
Figure 7.9. a) The wall after one year of soft caps application, where the state of each strip can be observed. b-c) extraction of the samples.

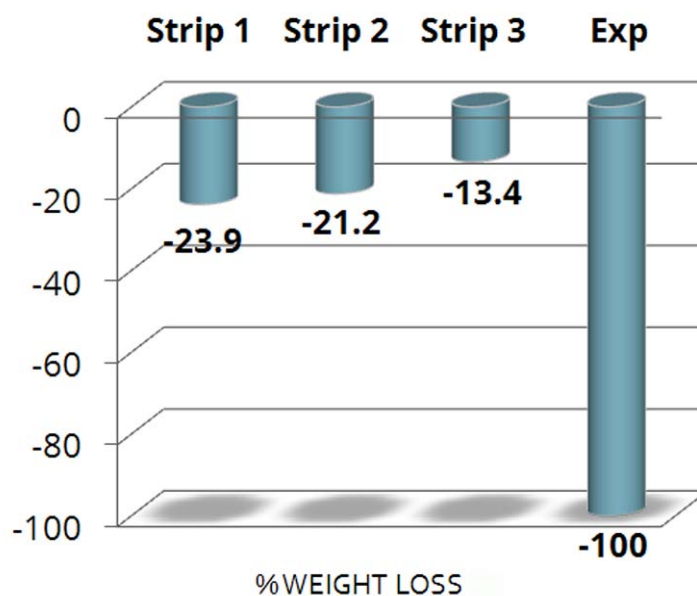
Figure 7.19. Percentage comparison of weight loss average produced in 2 years under each kind of experiment.

According to the calculations, the open air samples were totally dissolved. Soft capping samples were better preserved, being the strip 3 the best option to preserve them (Fig.7.19).

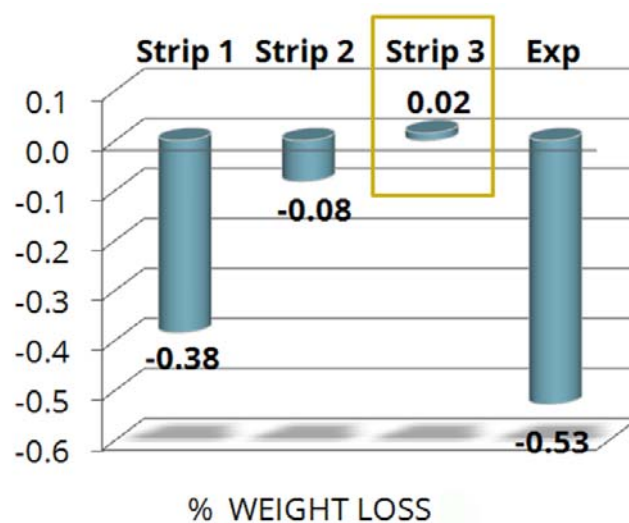
Figure 7.25. Percentage comparison of weight loss average produced under each kind of experiment, in which the values of the open air samples (Exp) correspond to 9 months of exposition and the rest of them to 24 months.

According to the data, the samples exposed to the open air (Exp), in only 9 months without any extrapolation applied, presented the highest loss of material. Nevertheless, soft capping samples were better preserved, seeming the strip 3 (sedum mat) again the best option to protect limestone material (Fig.7.19). The weight gain presented was probably caused by soil particles trapped, although the samples were washed, brushed although not too hard to avoid surface damage.
