Title: Rehabilitation of masonry arches with compatible advanced composite material

Article Type: Special Issue: Masonry Research

Rehabilitation of masonry arches with compatible advanced composite material

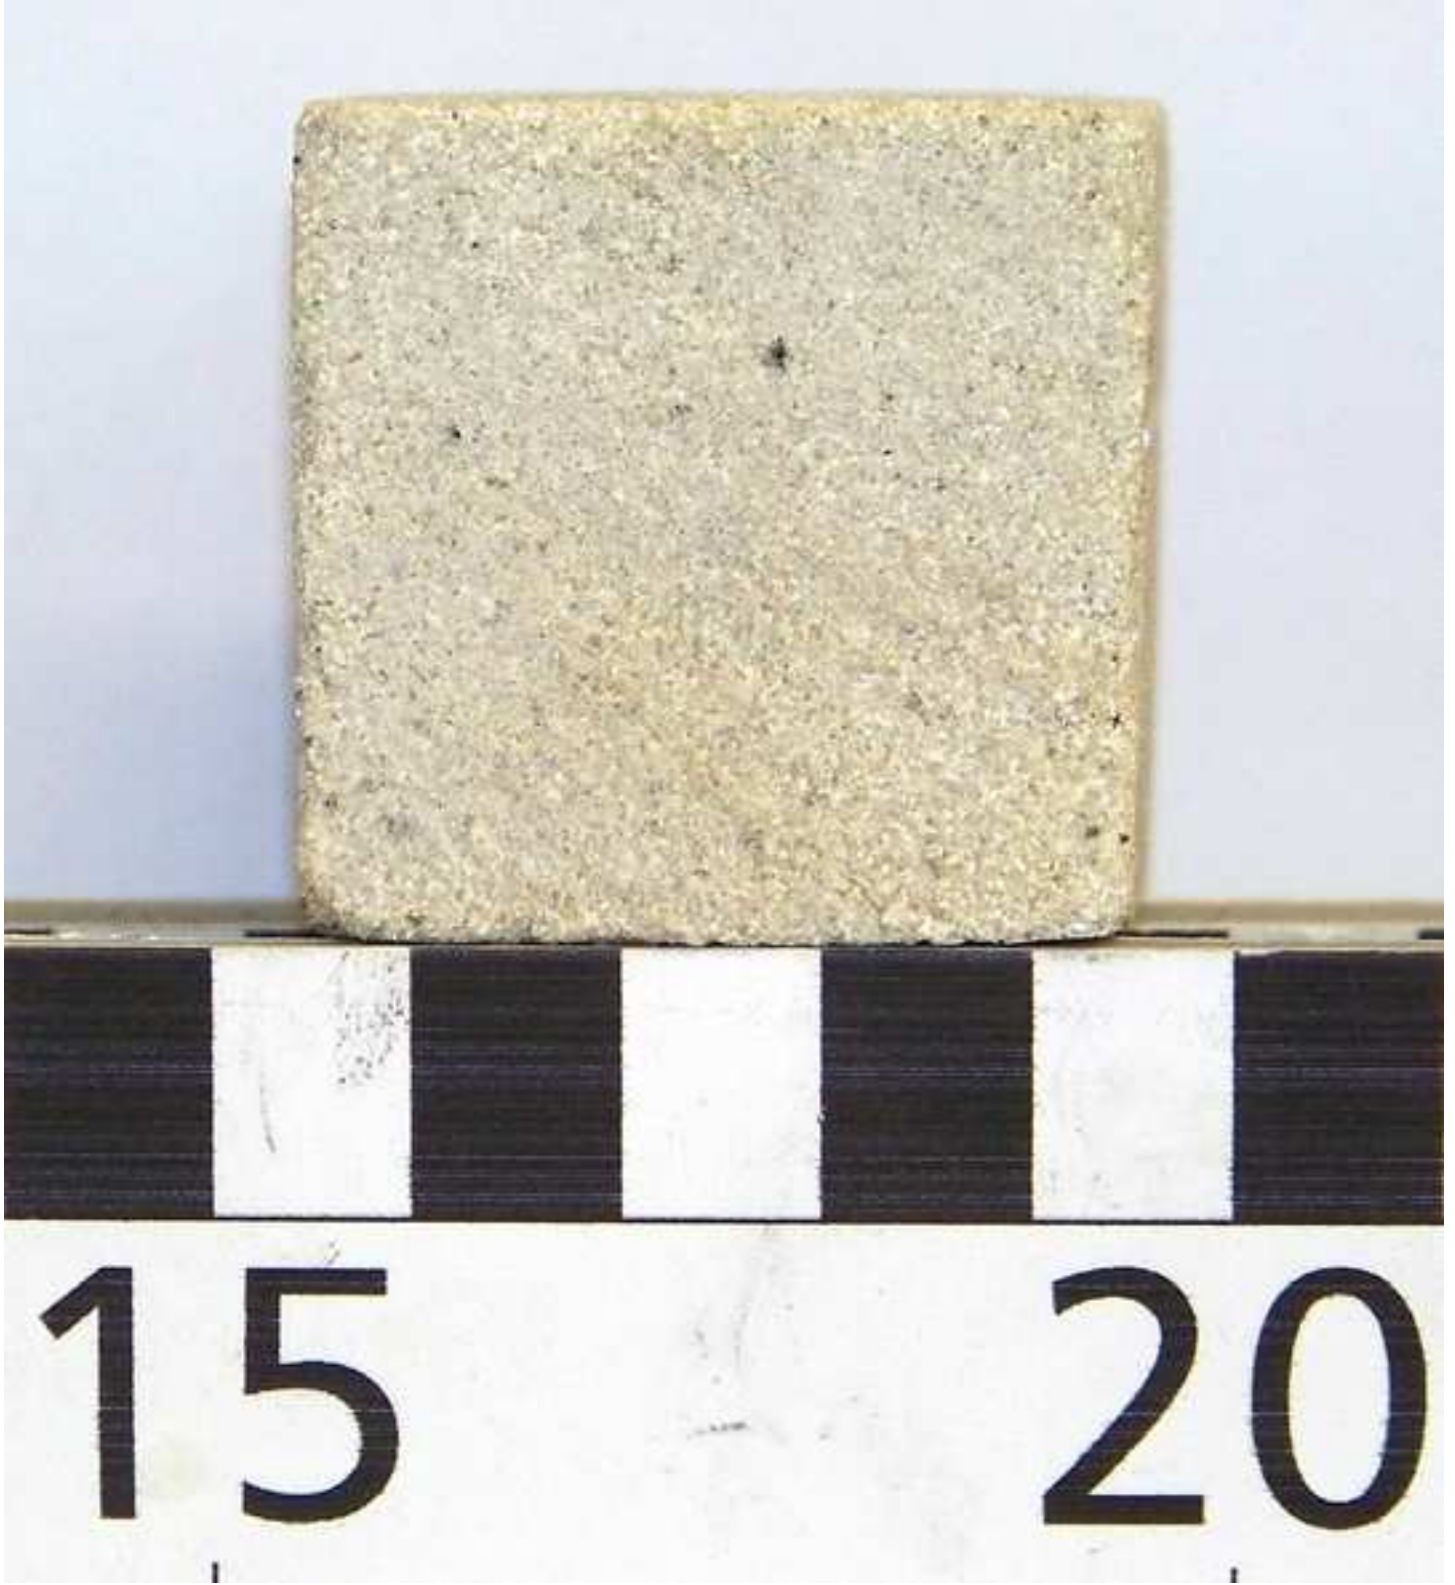
Figure 1. Petrographic analysis of the sandstone. Macroscopic ([Click here to download high resolution image](#))

The petrographic analysis (see Figure 1) shows that the rock has fine evenly-sized grains and presents medium to low cohesion and a low degree of compaction. It is composed of 65% quartz in which white grains predominate alongside reddish veins. The sandstone is a uniform, fine-grain, yellowish-grey sandstone rock with light rose-coloured tones, somewhat weak to the touch. The rock could be classified as sub-arkose [23], i.e., a sandstone rock with less than 15% of sandstone matrix, very rich in quartz and with less than 25% of feldspar in the weft.

Figure 1. Petrographic analysis of the sandstone. Macroscopic (left) and microscopic (right) photographs

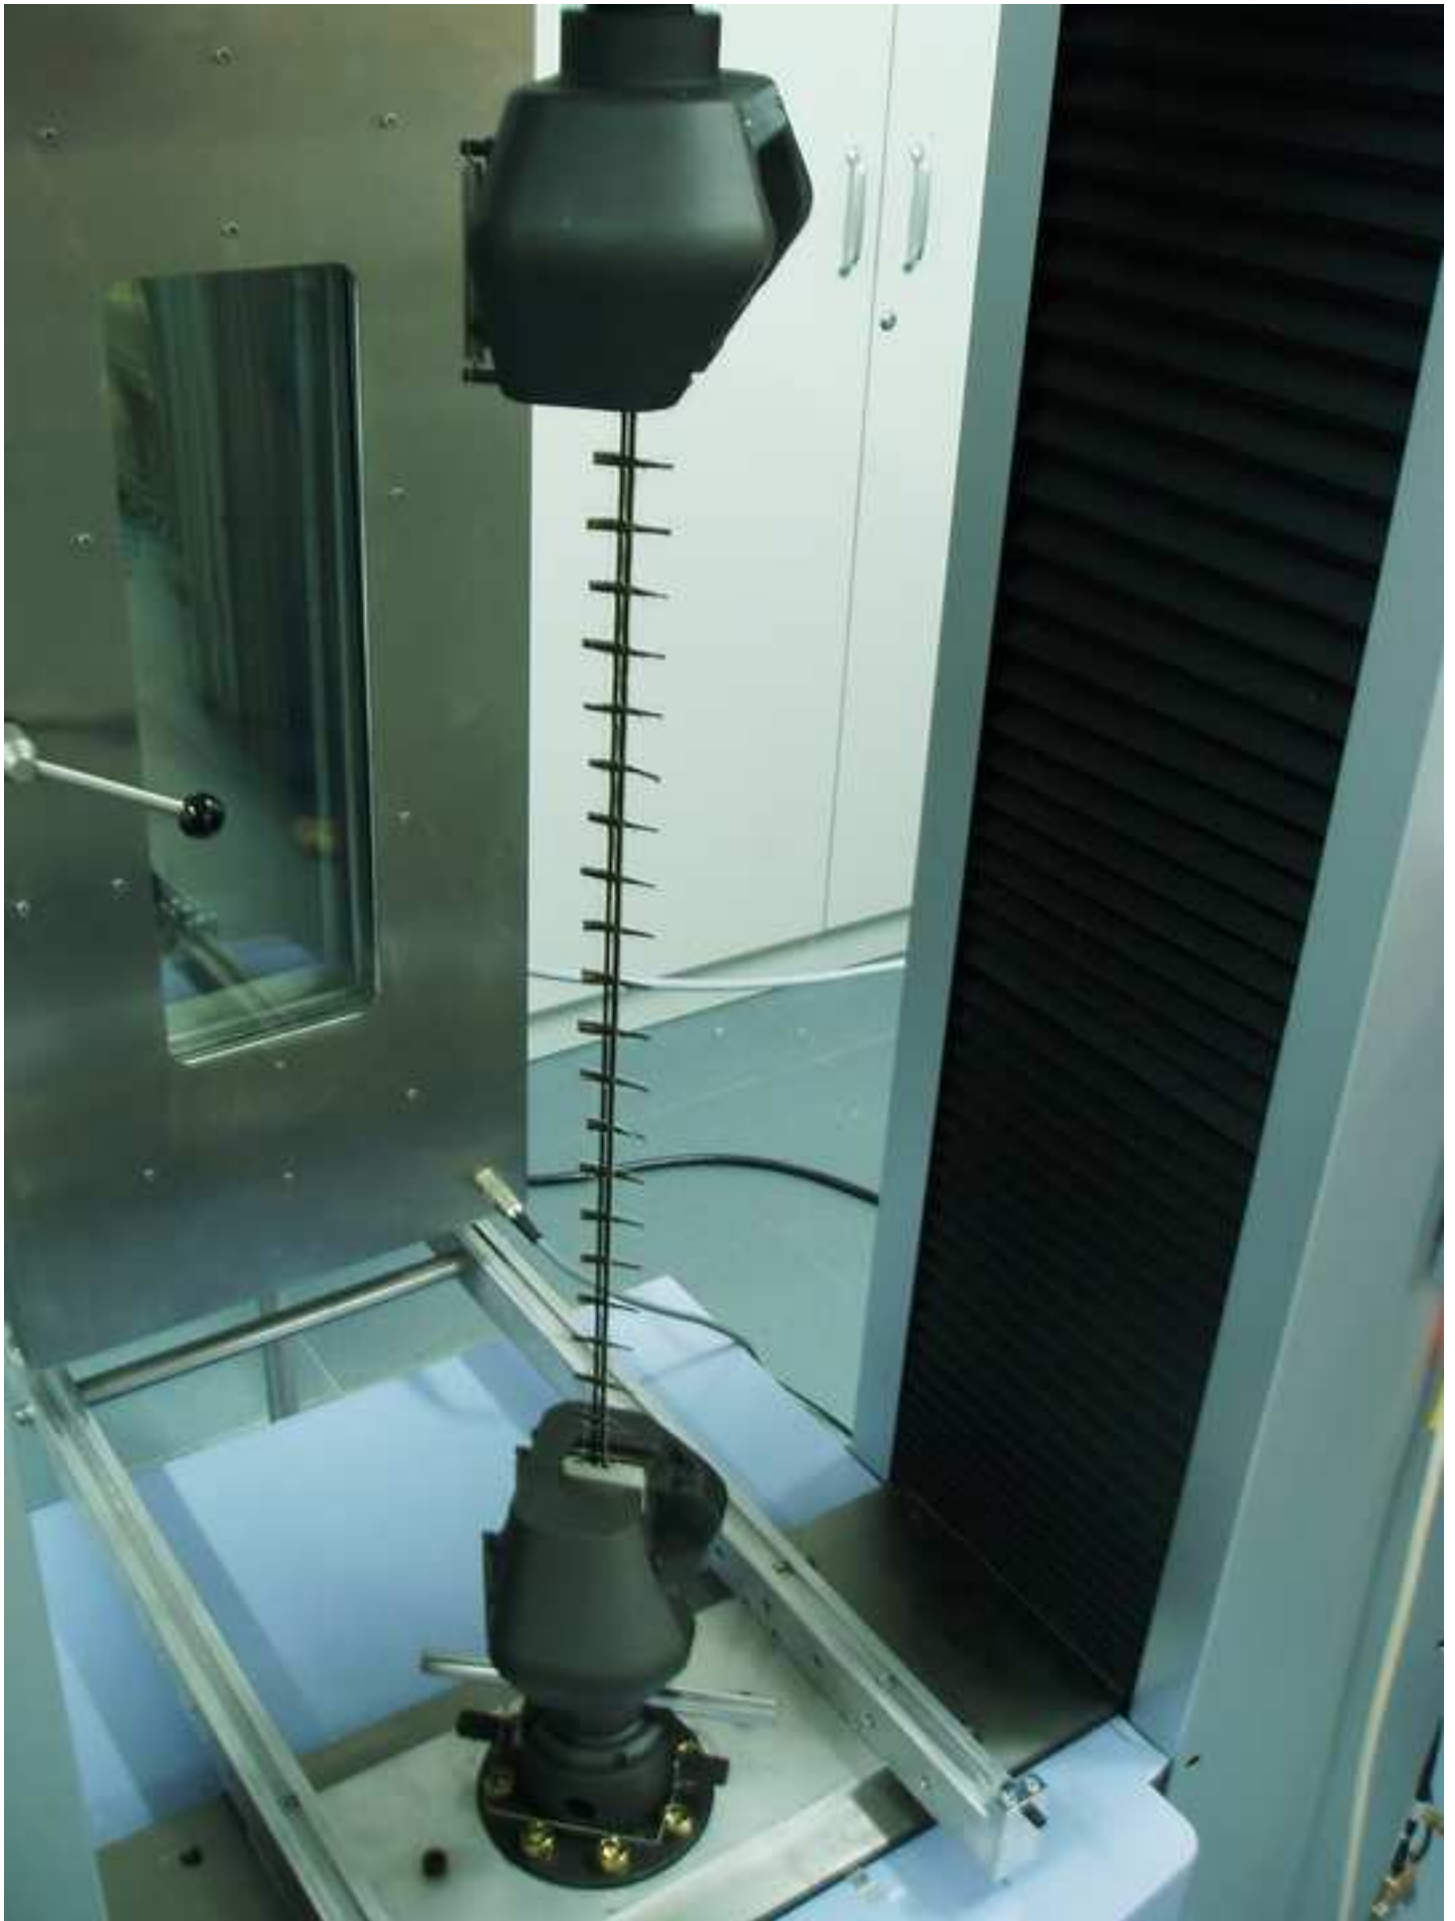
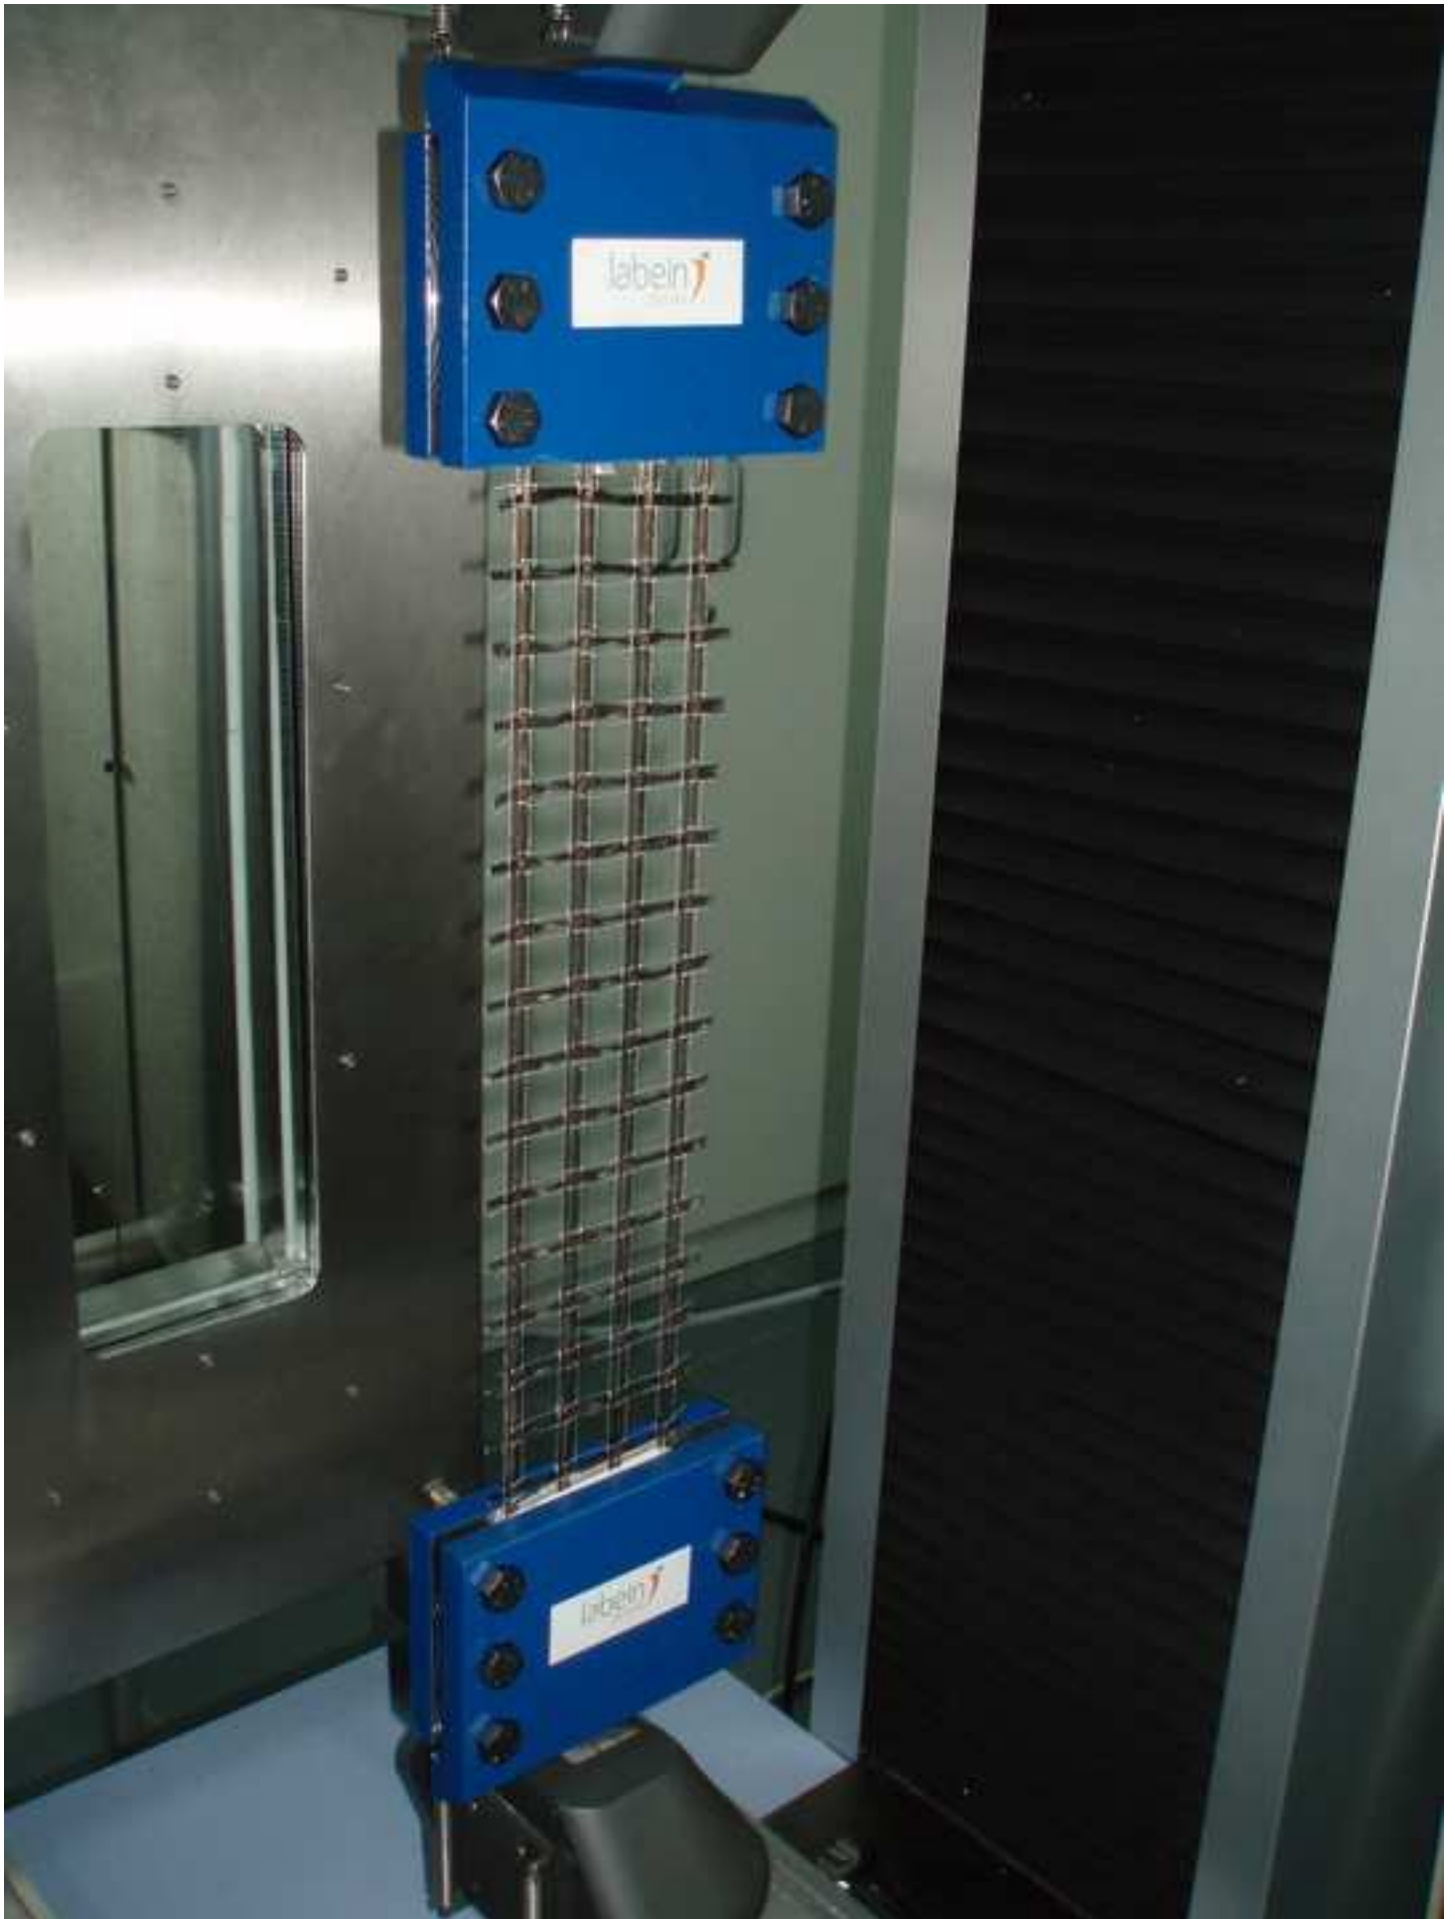
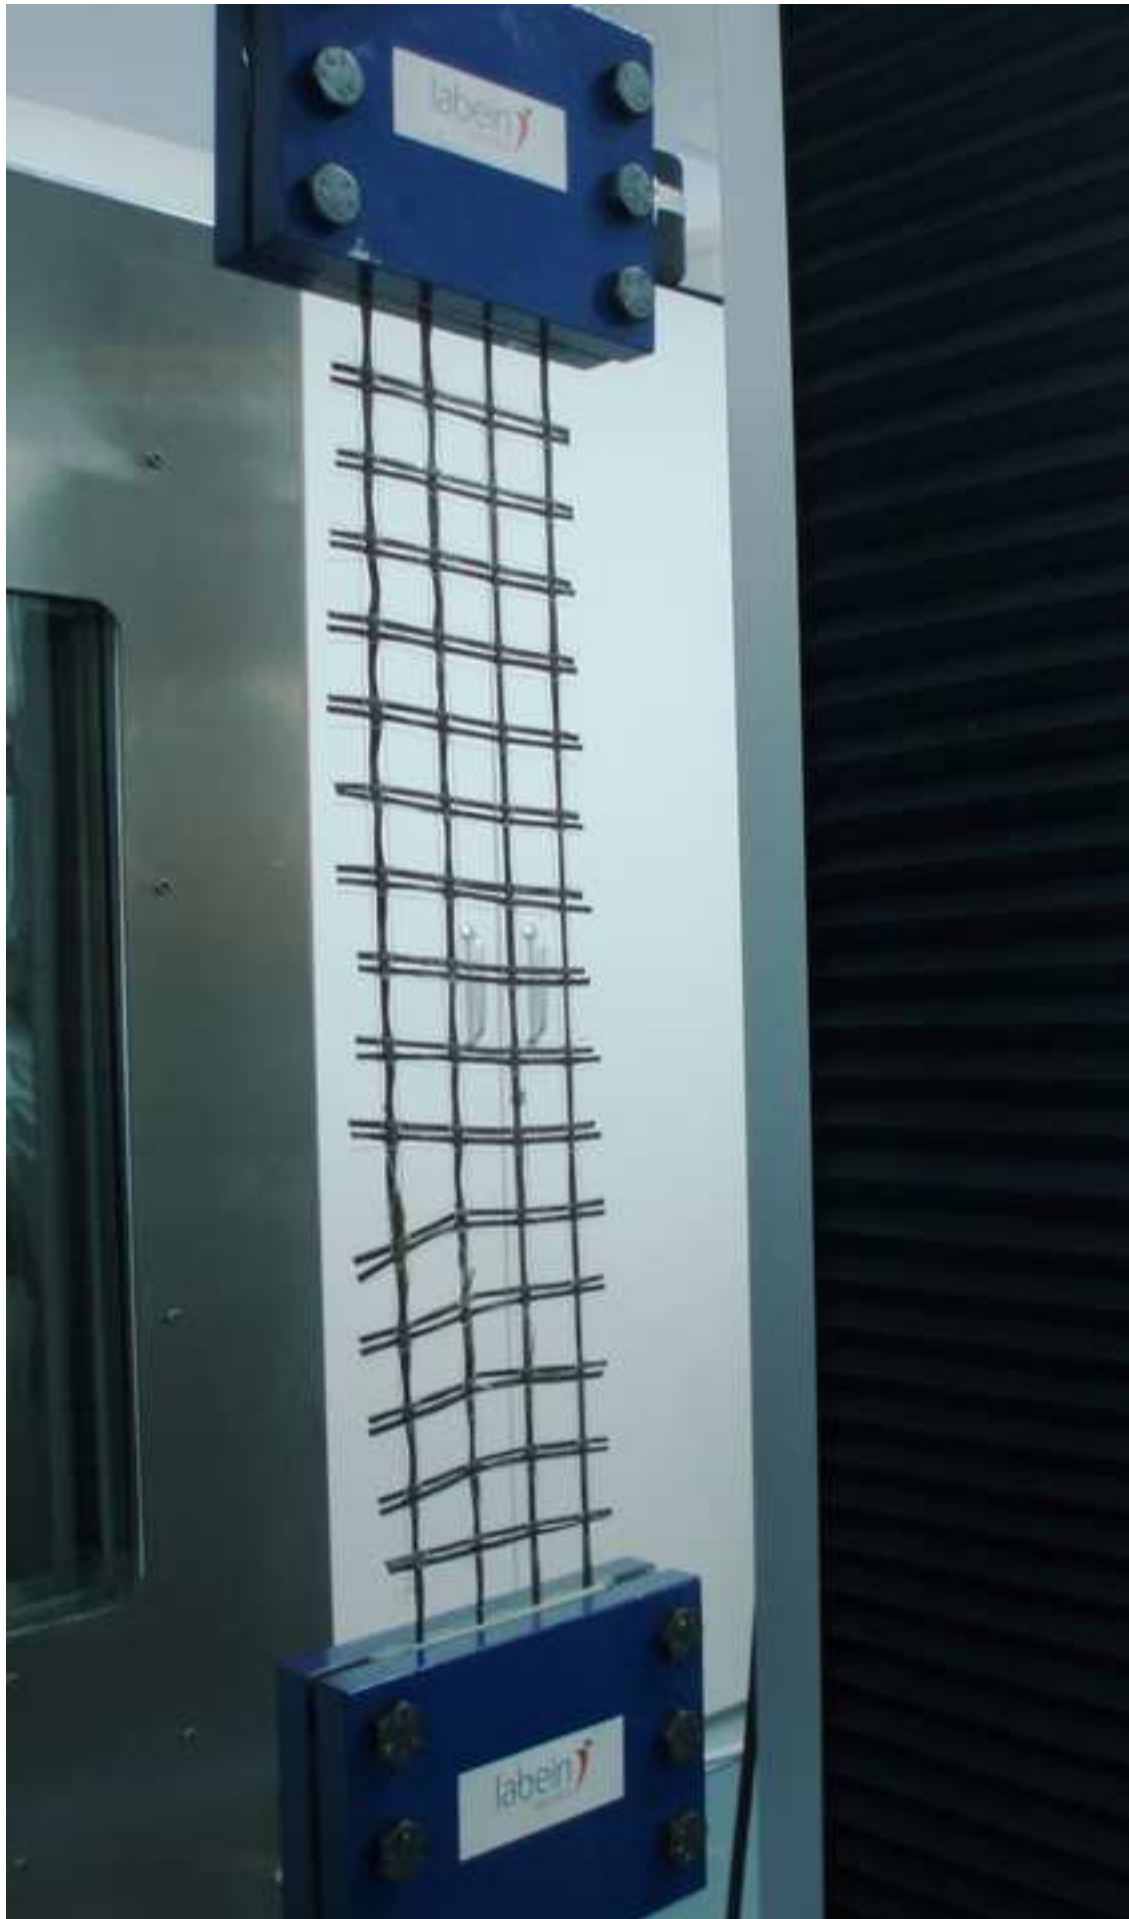
Figure 2. Pure tensile tests of several basalt textile specimens
[Click here to download high resolution image](#)

The textile has been characterised in laboratory by means of uniaxial tensile tests, varying the amount of rovings, as presented in Figure 2. The standards relating to the testing of similar products were consulted prior to the characterization of this textile. However, no explicit regulations or recommendations for testing mineral fibres woven as a mesh are available. On the whole, 40 specimens of between 400 – 500 mm long were tested in accordance with internal procedure which was based on

Having eliminated those specimens from the results that were spoilt or that had breaks near the ends, a scatter in the results was noticeable (around 10%). This scatter is explained by the processing of the fibres and the manufacture of the textile. In all cases, the development of the deformation and the failure mode are significantly affected by the practical impossibility of providing the same initial length and load to each one of the thousands of fibre strands that compose the textile. The fibres that had been subjected to greater traction were the first to break.

Comparing the results obtained in the case of one and two roves, the increment in the ultimate resistance of the specimen is approximately proportional to the number of roves; nevertheless, this not the same for a larger number of roves. In the specific case of the TL4, the ultimate resistance is 24% less compared to the ultimate resistance of the specimen with a single strand. It seems logical to think that the ultimate load of a specimen with four roves would be four times the load of a specimen with a single strand, under similar failure modes if there were no peculiarities that would make the pull non-homogeneous. On the other hand, one must highlight the fact that the failure on the specimens type TL4 has occurred close to the clamps in the majority of cases, probably due to the stress concentration. Therefore, it can be assumed that the actual tensile strength of the specimens is higher than that recorded.

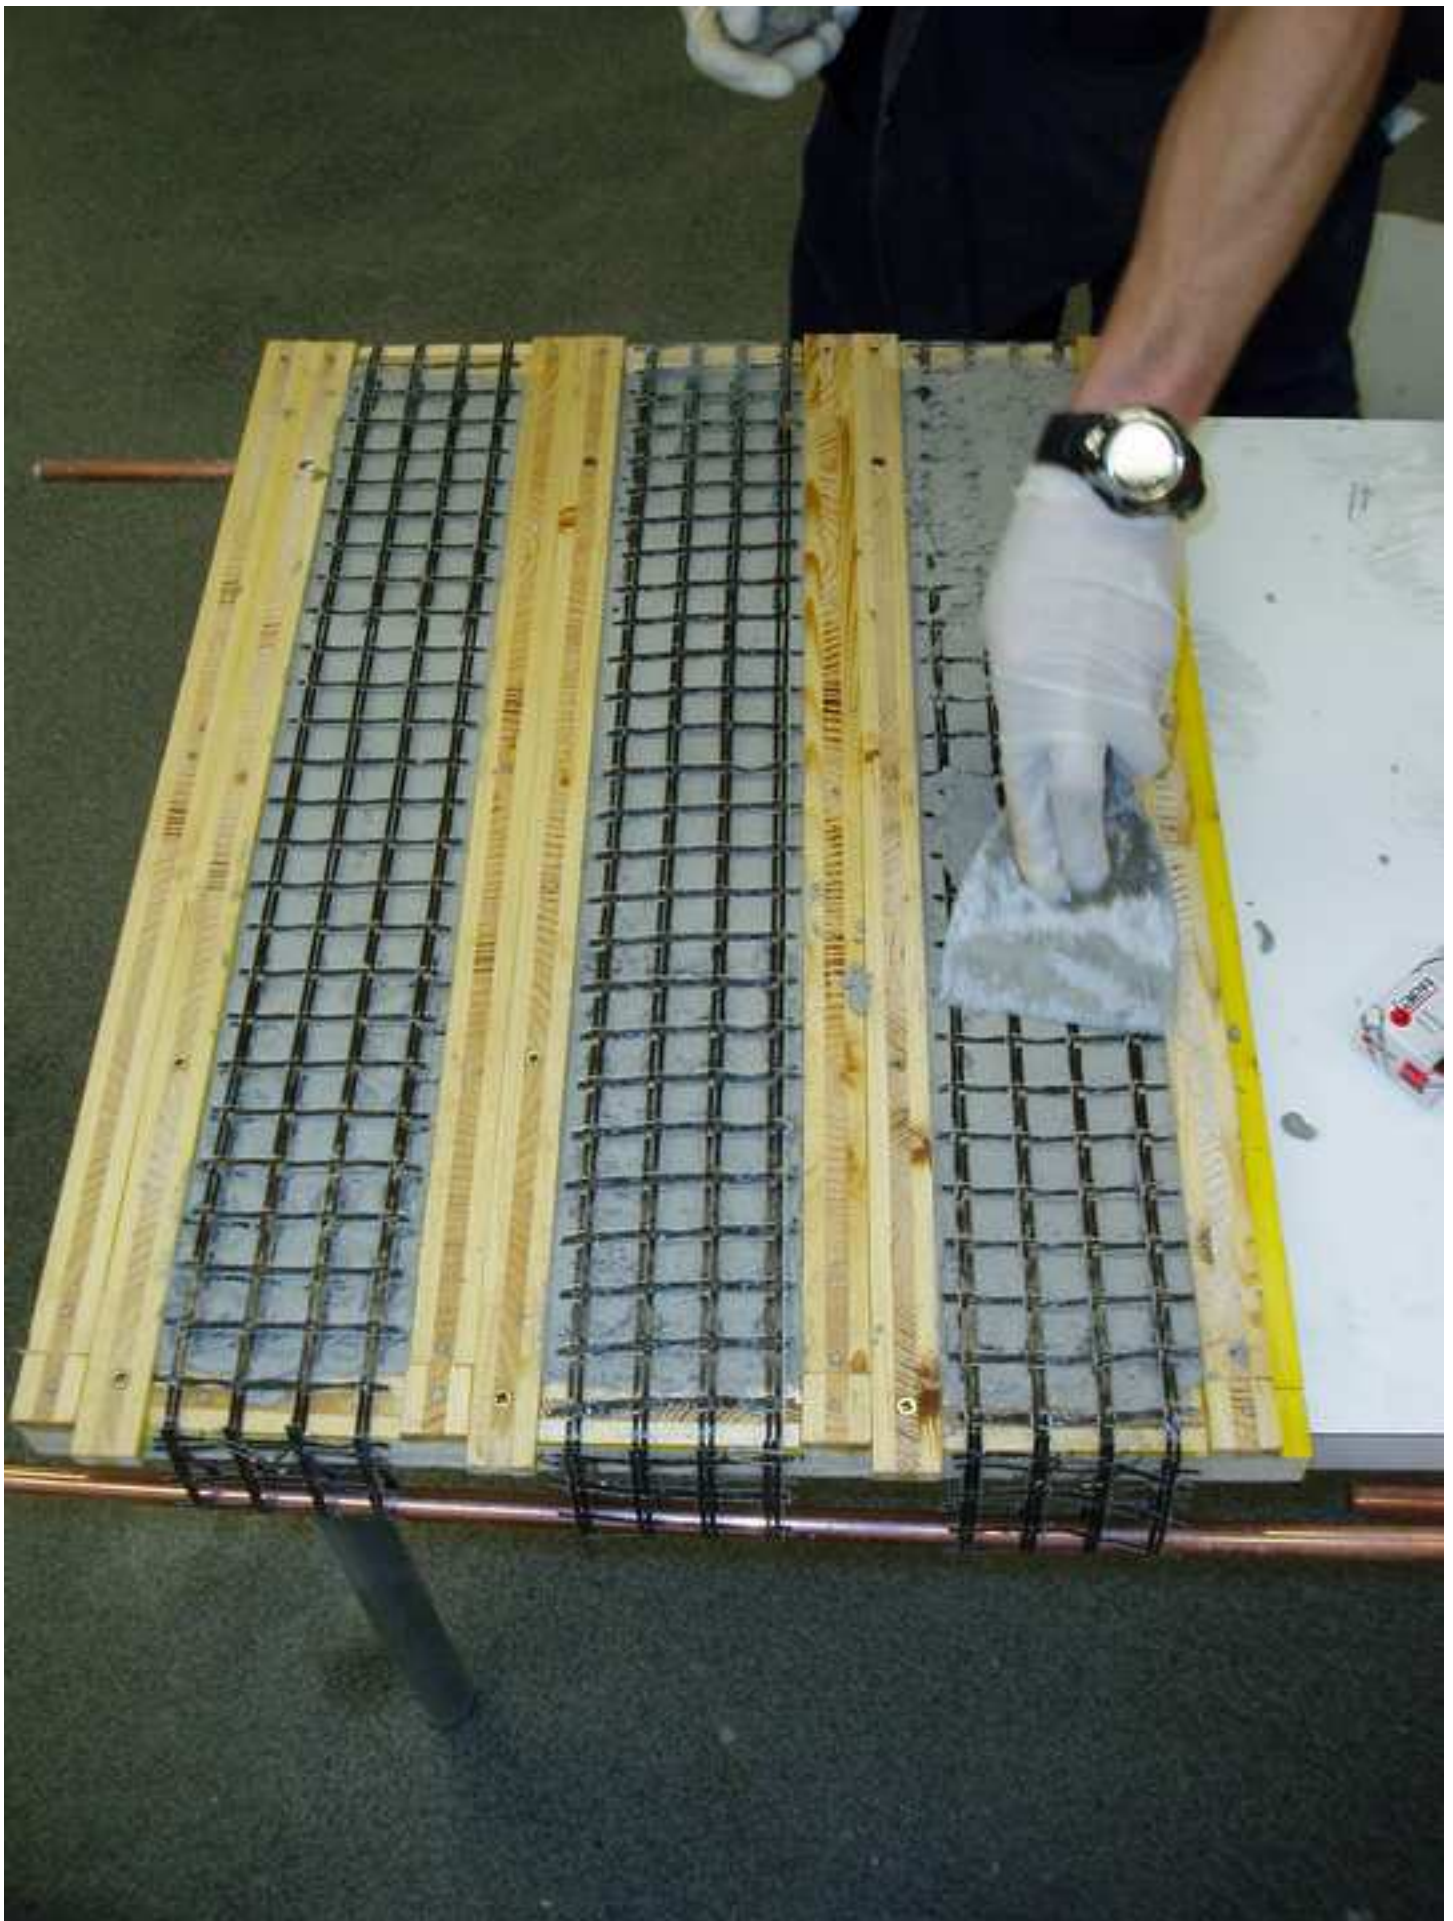
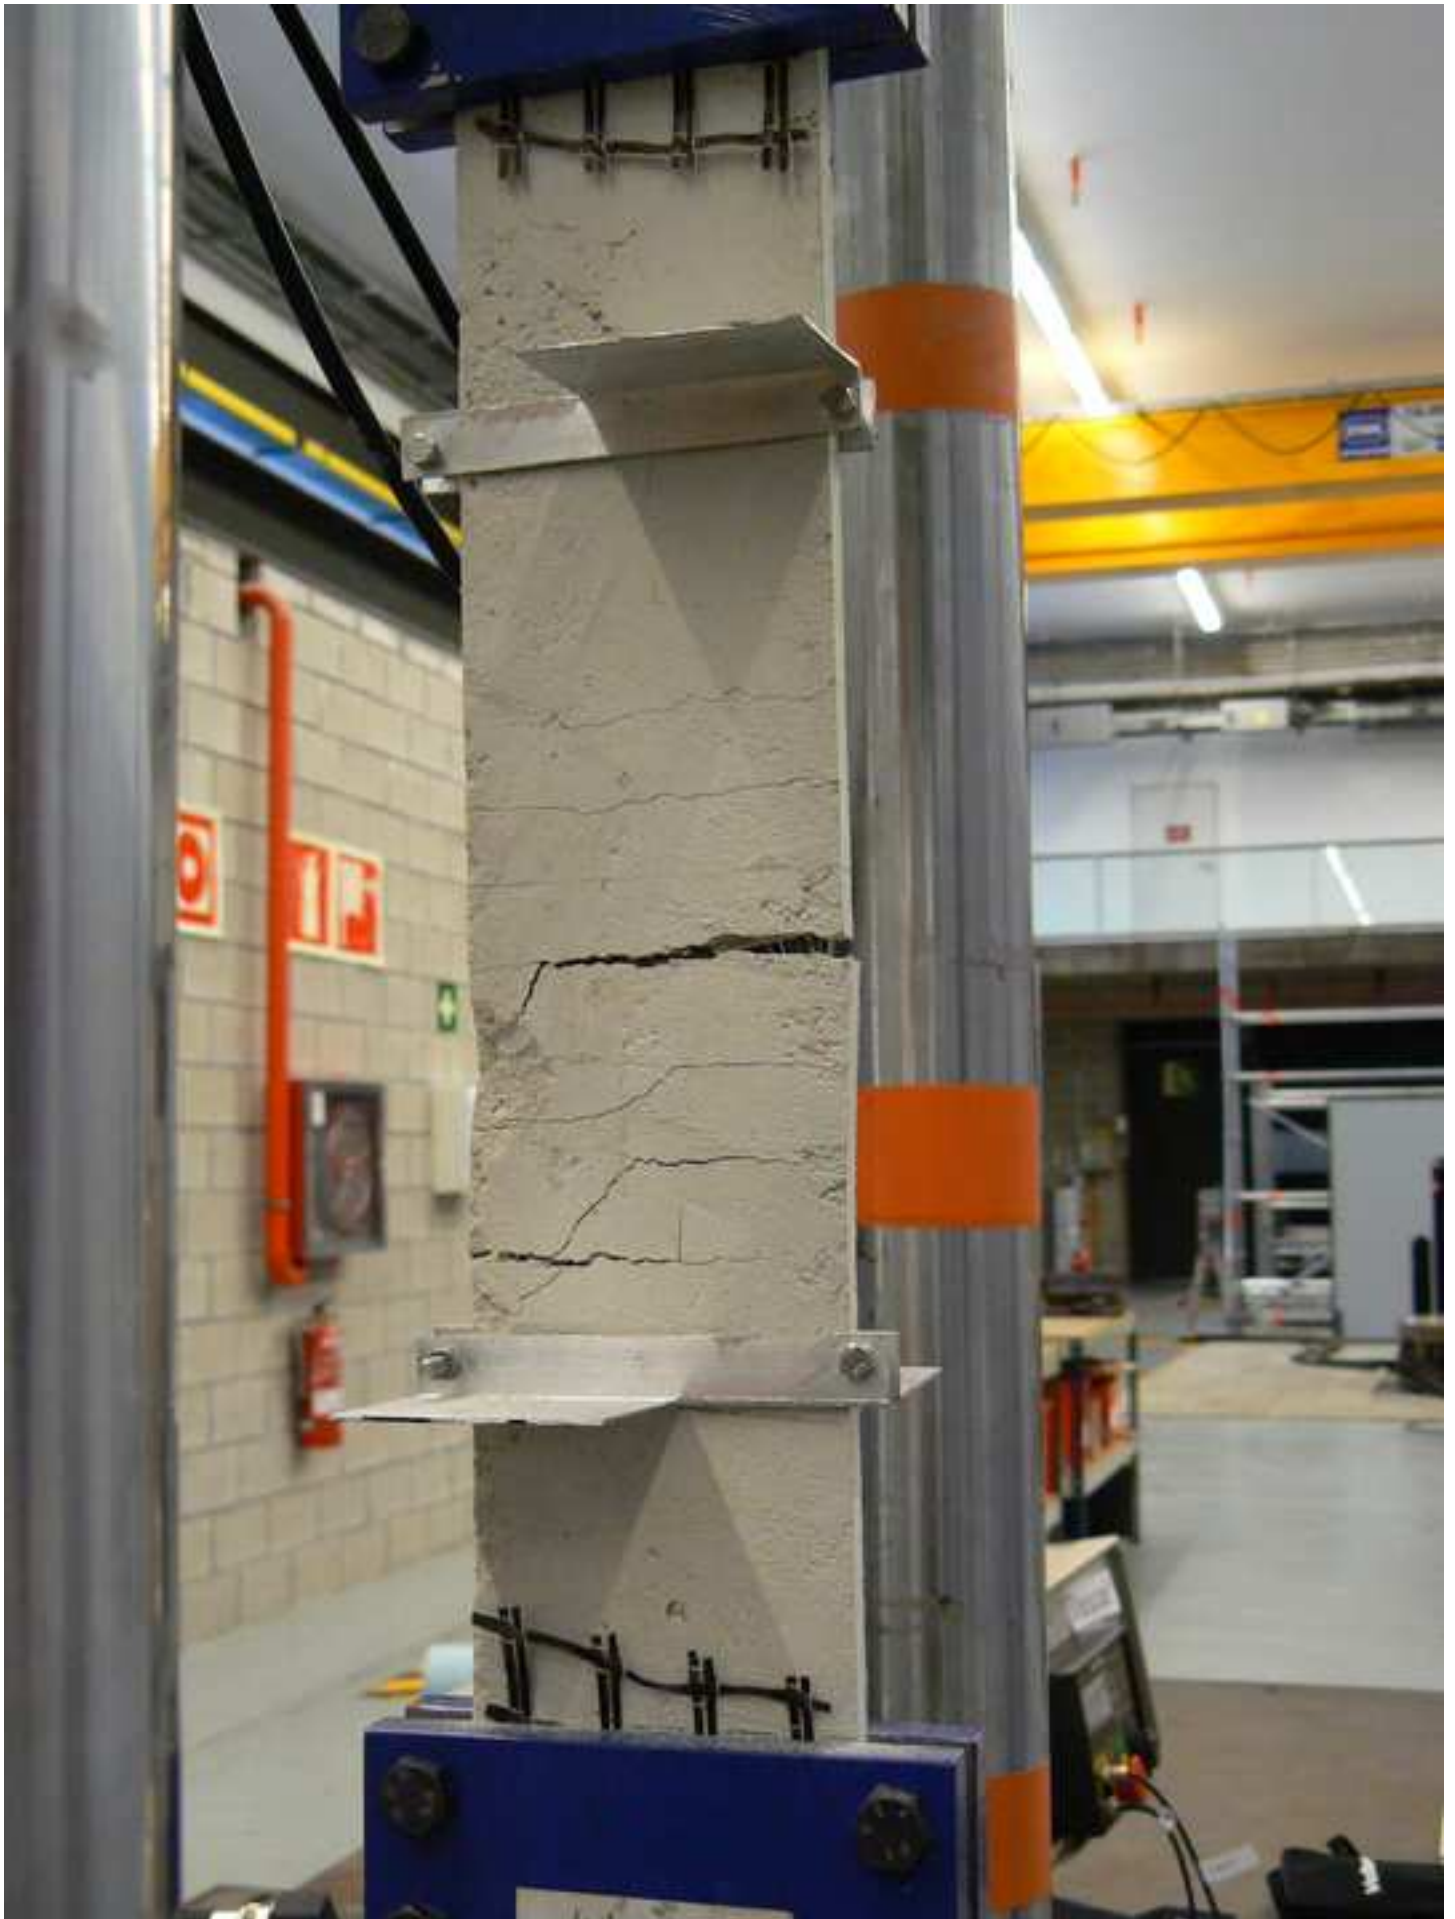
Figure 3. Preparation and testing of the TRM specimens
[Click here to download high resolution image](#)

reinforced structures, a slippage between the mortar and the textile could not be observed until the point of collapse. Tests (see Figure 3) were carried out using a speed of 0.5 mm/min. The strains within the measurement range were recorded with four *Linear Variable Displacement Transducers* (LVDTs), two on each side.

In this case, opposed to TRMA, delamination was prevented as failure happened due to breakage of the whole section. The stress-strain graphs obtained are characterized by the presence of two stages. In Stage I, even though small fissures appear, the slope is linear up to the point where the ultimate load is reached, with the exception of specimens TRMB-1, TRMB-3 and TRMB-5 which are characterized by showing an initial more unstable area, with small load losses caused by the appearance of cracks. The composite behaviour in this stage is influenced mainly by the properties of the textile. The value of the Young's modulus is higher than that of the textile. In Stage II, which starts after reaching the ultimate load, the graph shows small load oscillations caused by the failure of the strands at specific points. The stress is transmitted from one strand to the other until the whole section fails. A picture of the test is presented in Figure 3.

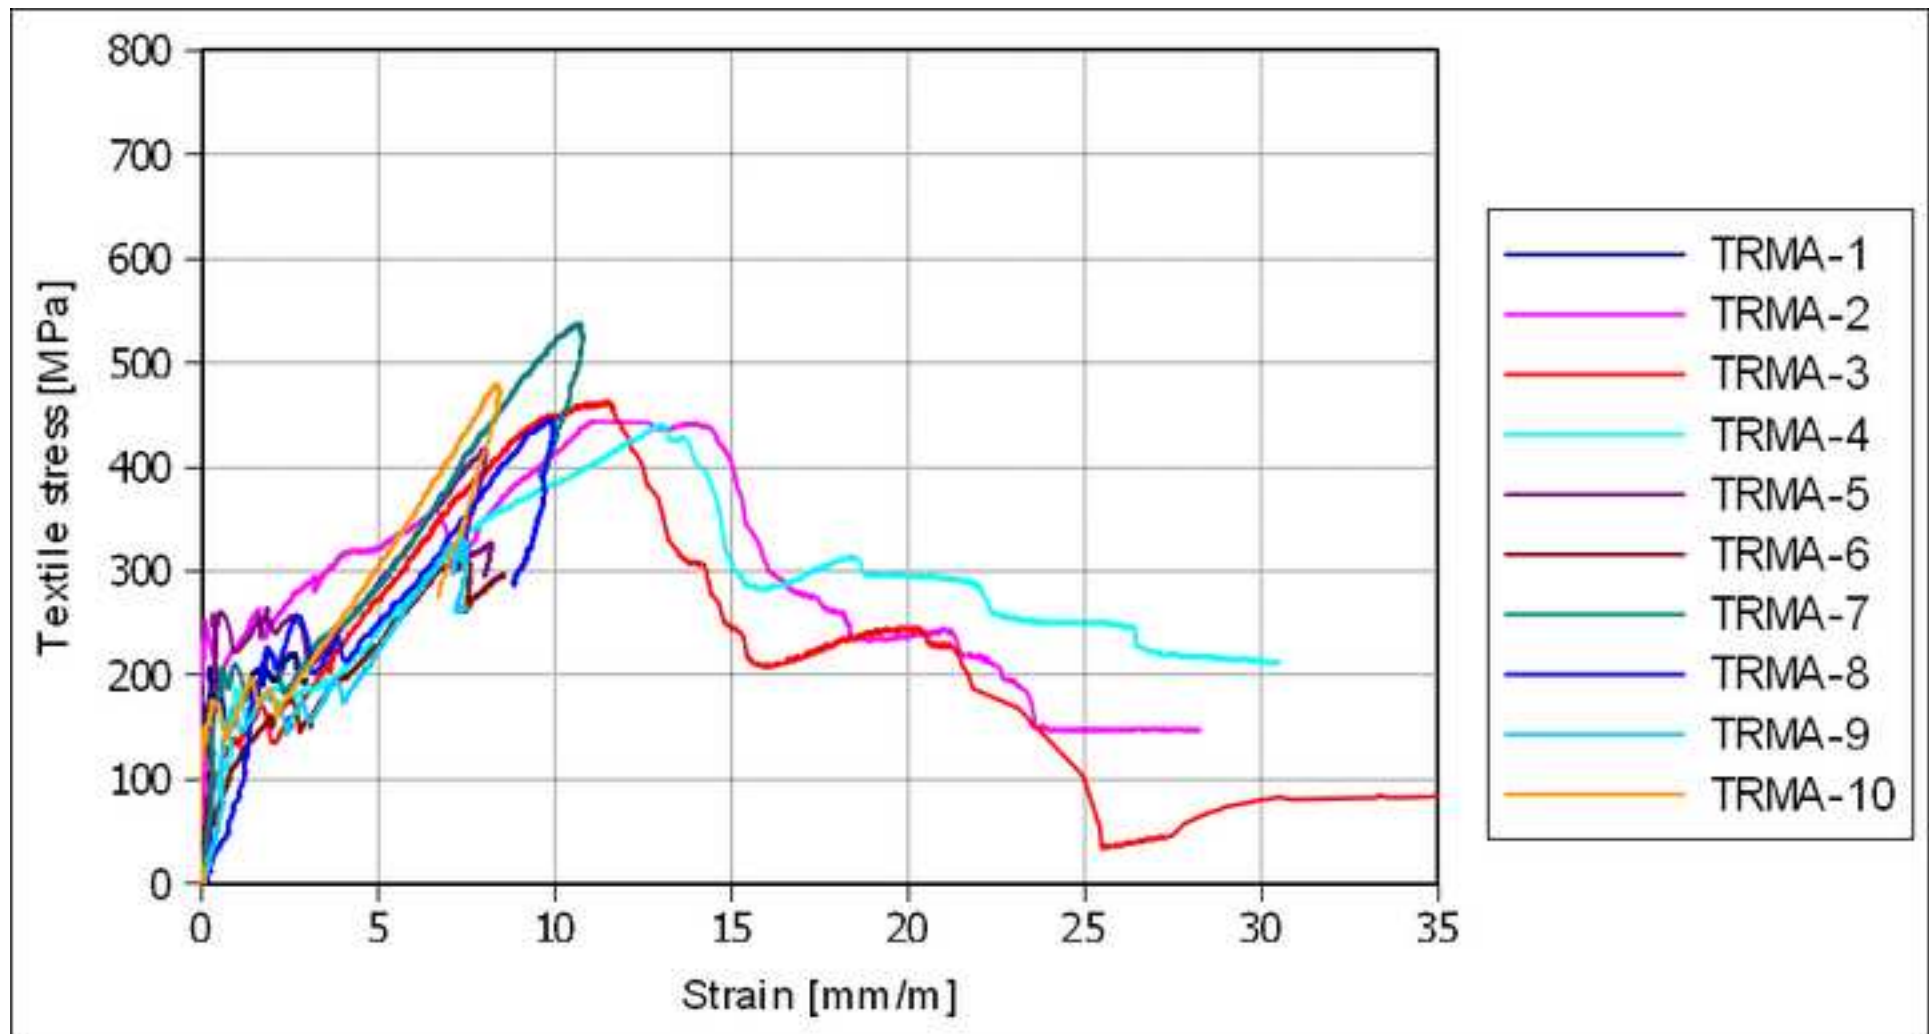
Figure 4. Textile stress-strain curves: two-ply specimen (TRMA)
[Click here to download high resolution image](#)

The stress-strain curve is characterized by three very different stages. In Stage I, the specimens show a very rigid behaviour where loads are absorbed with very little deformations. This phase ends with a load decrease due to the cracking of the matrix. In Stage II, the specimen recovers the load linearly and its behaviour is basically influenced by the mechanical properties of the textile. The width of the cracks grows due to the delamination between fibres and mortar, and leads to a loss of the tension stiffening effect. However, the transversal fibres oppose the resistance so that the load can continue to increase. At the time of reaching the ultimate strength, the fibres fail partially, the second phase ends and Stage III starts with a sudden loss of mechanical capacity. Some of the specimens suffered large deformations due to the lack of adherence between the internal strands and between the textile and the matrix.
