Title: Rehabilitation of masonry arches with compatible advanced composite material

Article Type: Special Issue: Masonry Research

Rehabilitation of masonry arches with compatible advanced composite material

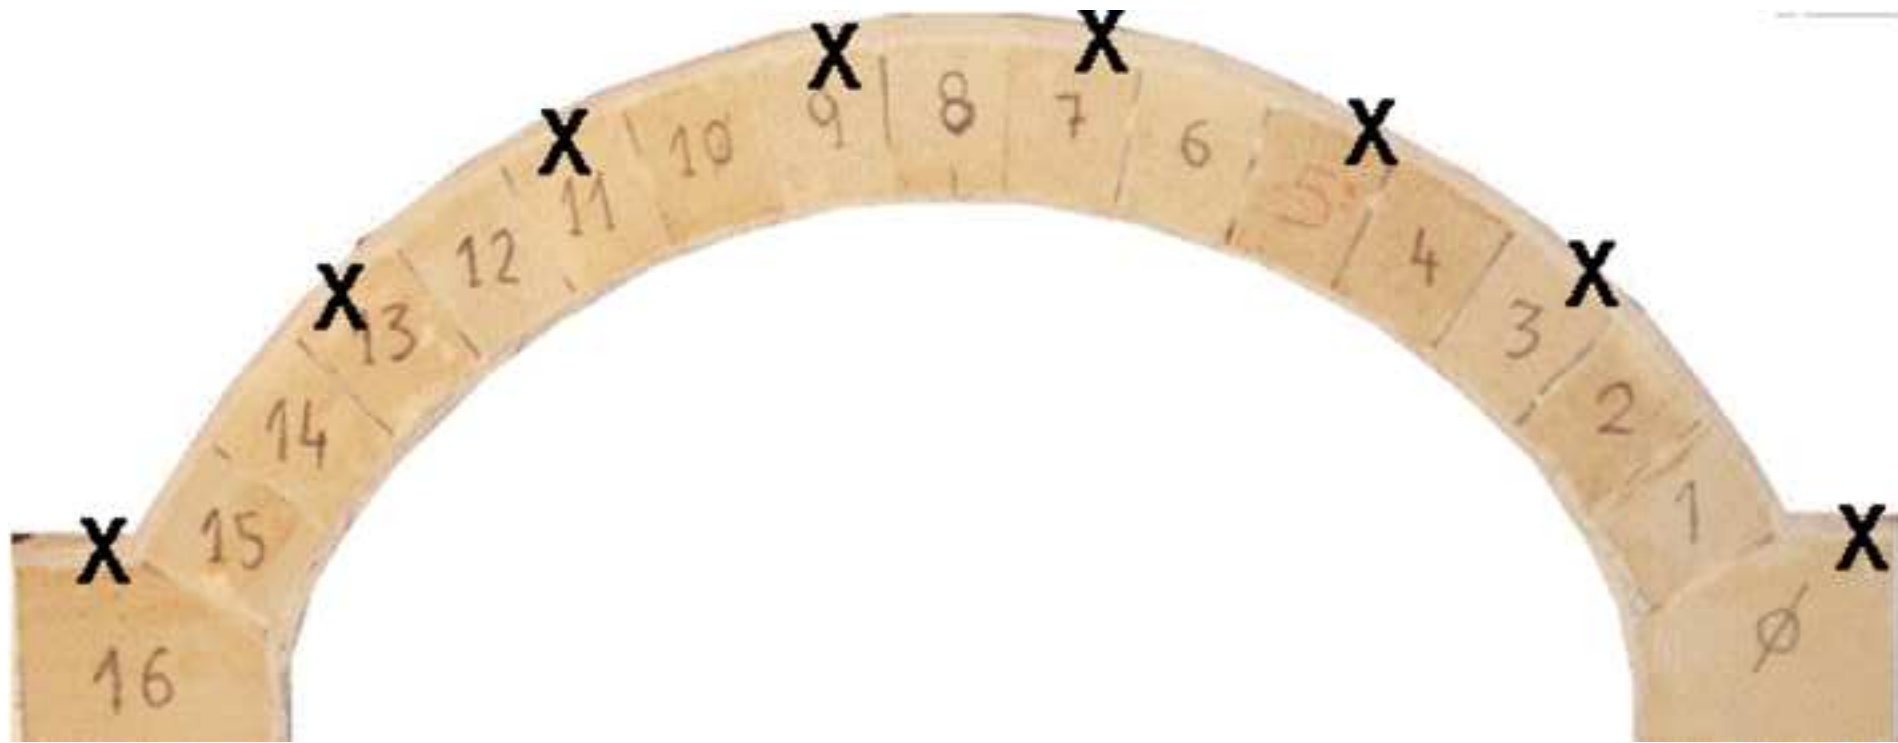
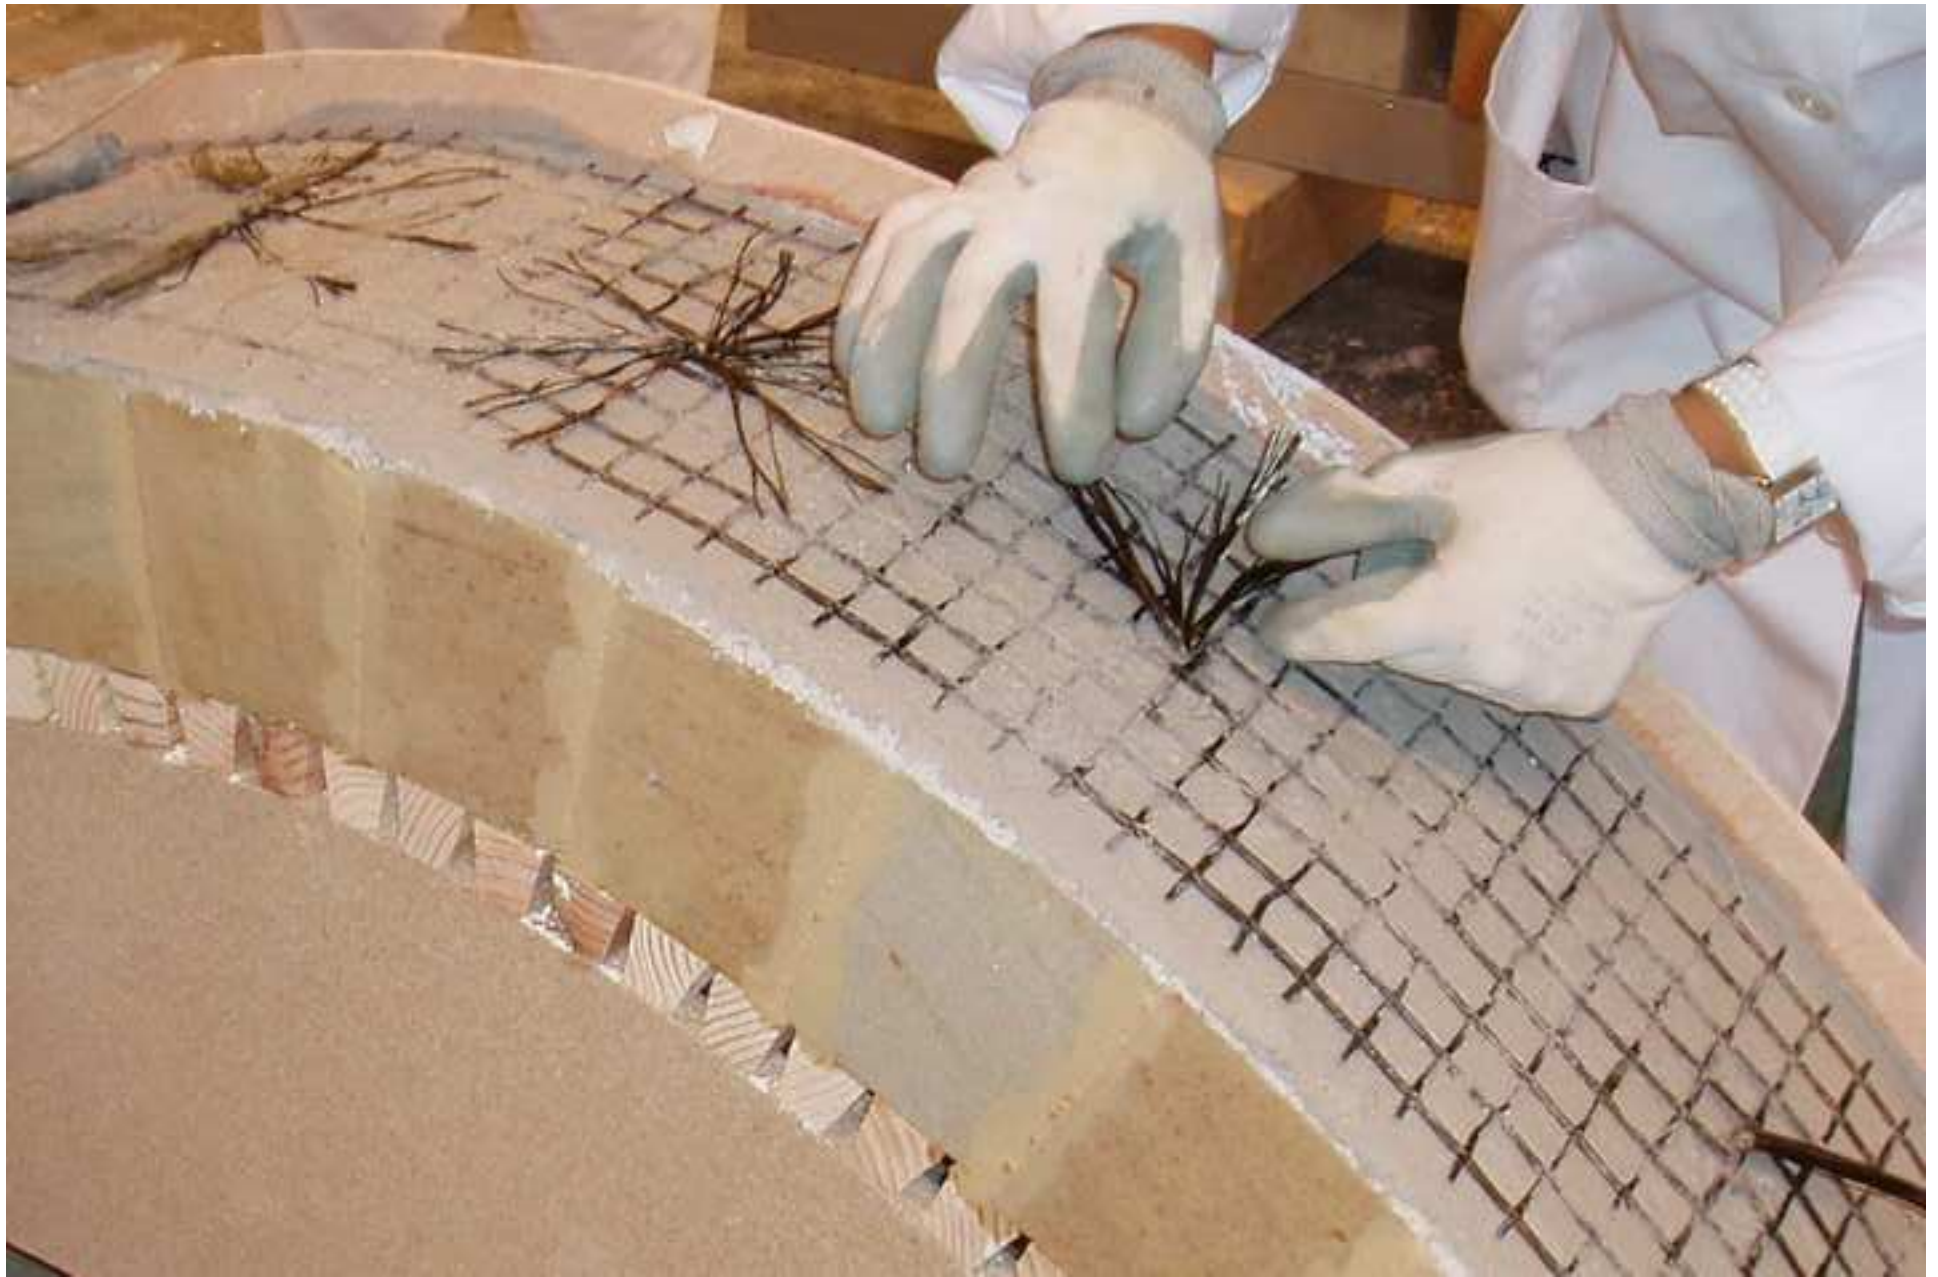
Figure 7. Spike anchors location (left) and strengthening of mas
[Click here to download high resolution image](#)

With reference to the spike anchors, the study of their effectiveness is a difficult task. The arch structures apparently remained unaltered up to the point where the hinges started to form, for which reason it was not possible to verify whether the anchors had any effect. Furthermore, it is difficult to guarantee the good execution of these anchorages, so after the tests, the quality of execution was verified. It was observed that various anchors were pulled out from the voussoirs fairly easily. Nevertheless, there was no debonding of the strengthening strips in this area. This fact means that the reinforcement-substrate interface could be enough to ensure adherence between the two, without the need for anchors. However, a further in-depth study is being carrying out in TECNALIA in order to study this fact and the load transmission between the anchor and the substrate. Up until now, several single-lap shear test were performed on different type of specimens varying the bonded length and in most of the situations, failure occurred in the BTRM so it was not due to loss of adherence in the reinforcement-substrate interface.

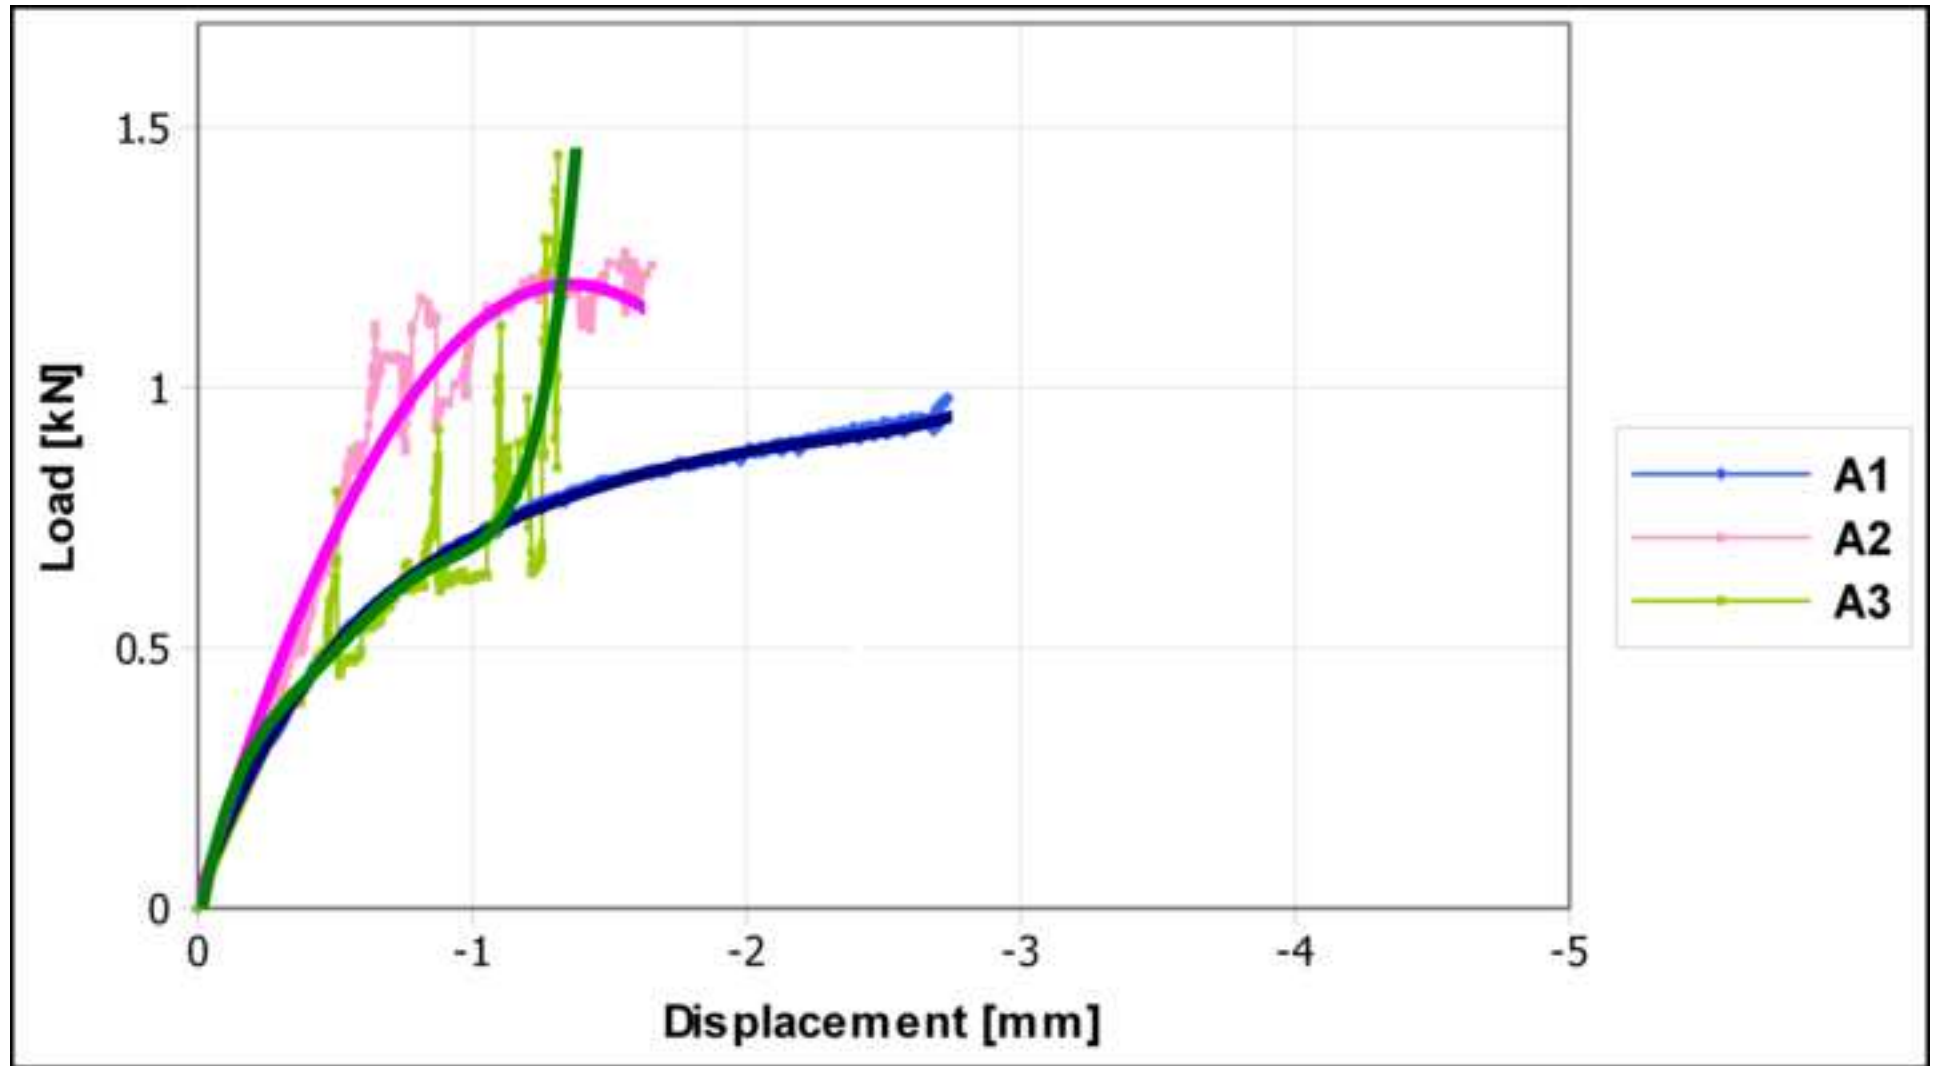
Figure 8. Load-Displacement of load application point for non-st
[Click here to download high resolution image](#)

In the case of arch A1 (built without any mortar), the load was progressively applied until it reached the maximum value of 0.98 kN. The failure was characterised as sudden and without large deformations compared to strengthened arches (presented later on).

Arch A2 and A3 underwent load swings as a result of the settlements of the voussoirs due to irregular crushing of the jointing mortar. After reaching the ultimate load (1.3 kN and 1.45 kN, respectively), failure was brought about by the formation of four hinges that turned the structure into a mechanism. From this stress-strain stage, it does not seem adequate to do an analysis or comparison between the samples, as they are already converted into a mechanism.

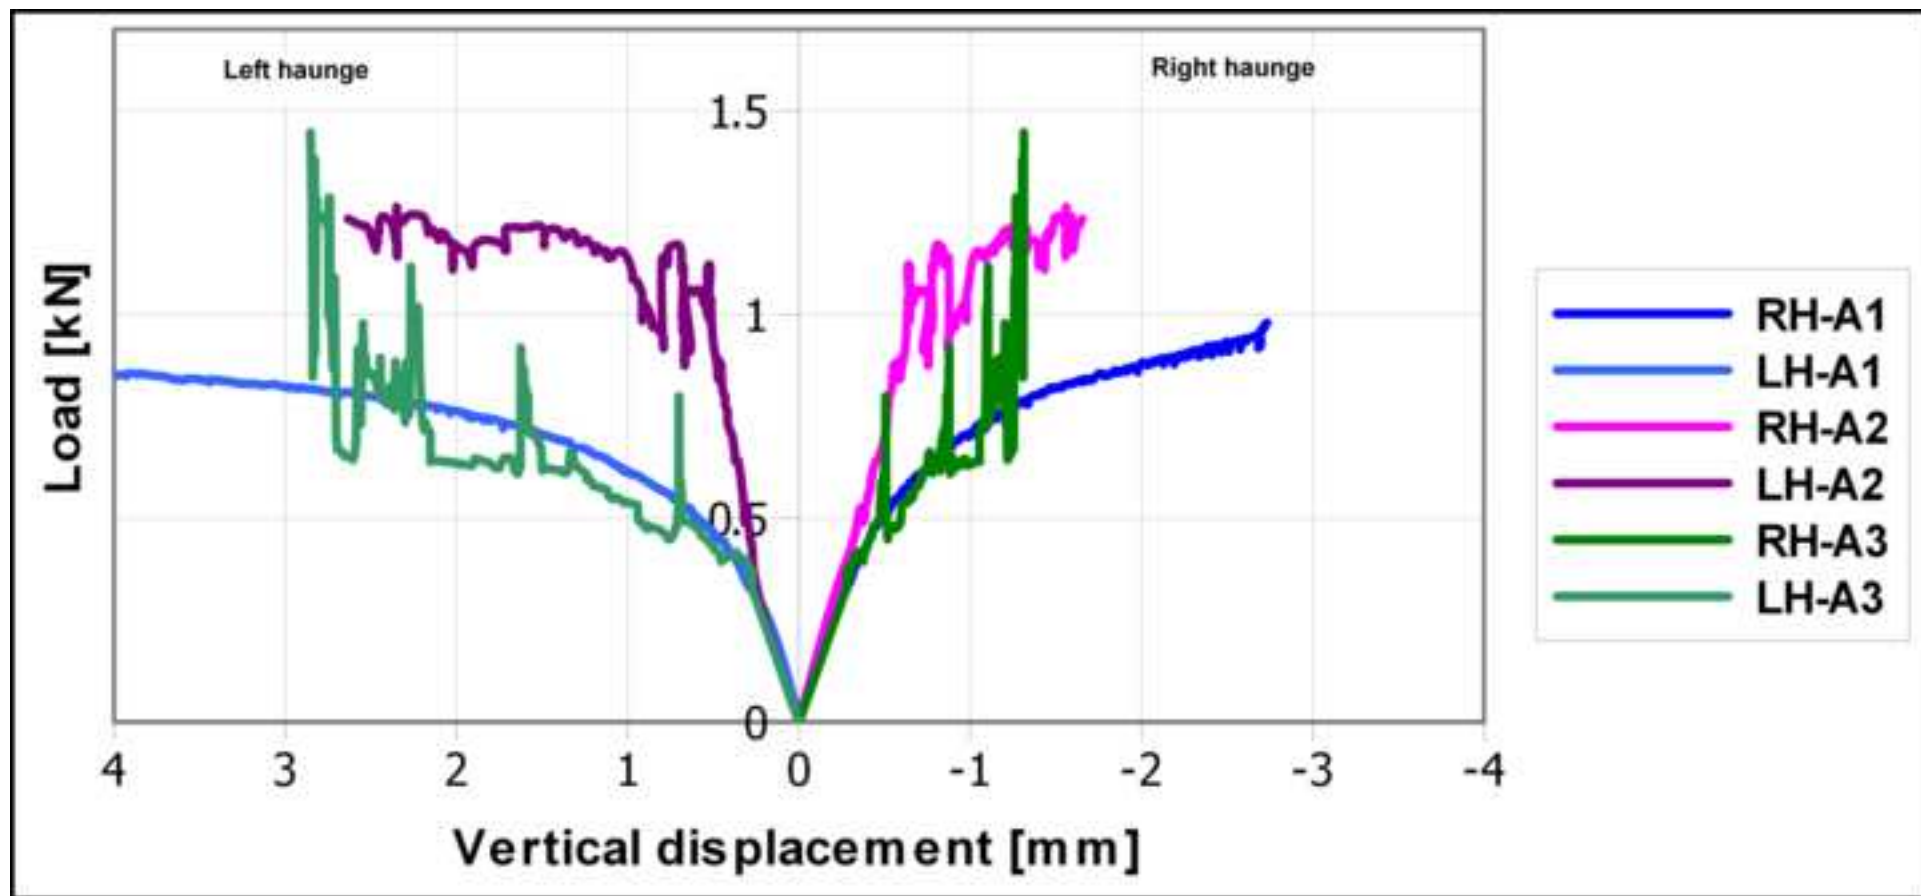
Figure 9. Comparison of the displacement of the left and right h
[Click here to download high resolution image](#)

Figure 9 compares the displacements measured by means of LVDTs in the right haunch (load application point) and left haunch (opposite point). The loss of load corresponds with settlements due to jointing mortar crushing (as the deformation of the voussoirs is neglected) while the increase means that voussoirs are together again and the load is recovered. These settlements are registered in all voussoirs. As it is evident, the load causes also the displacement of the voussoirs located on the left haunch but with higher magnitude than the load application point, as the small movements of the voussoirs located in between are added.

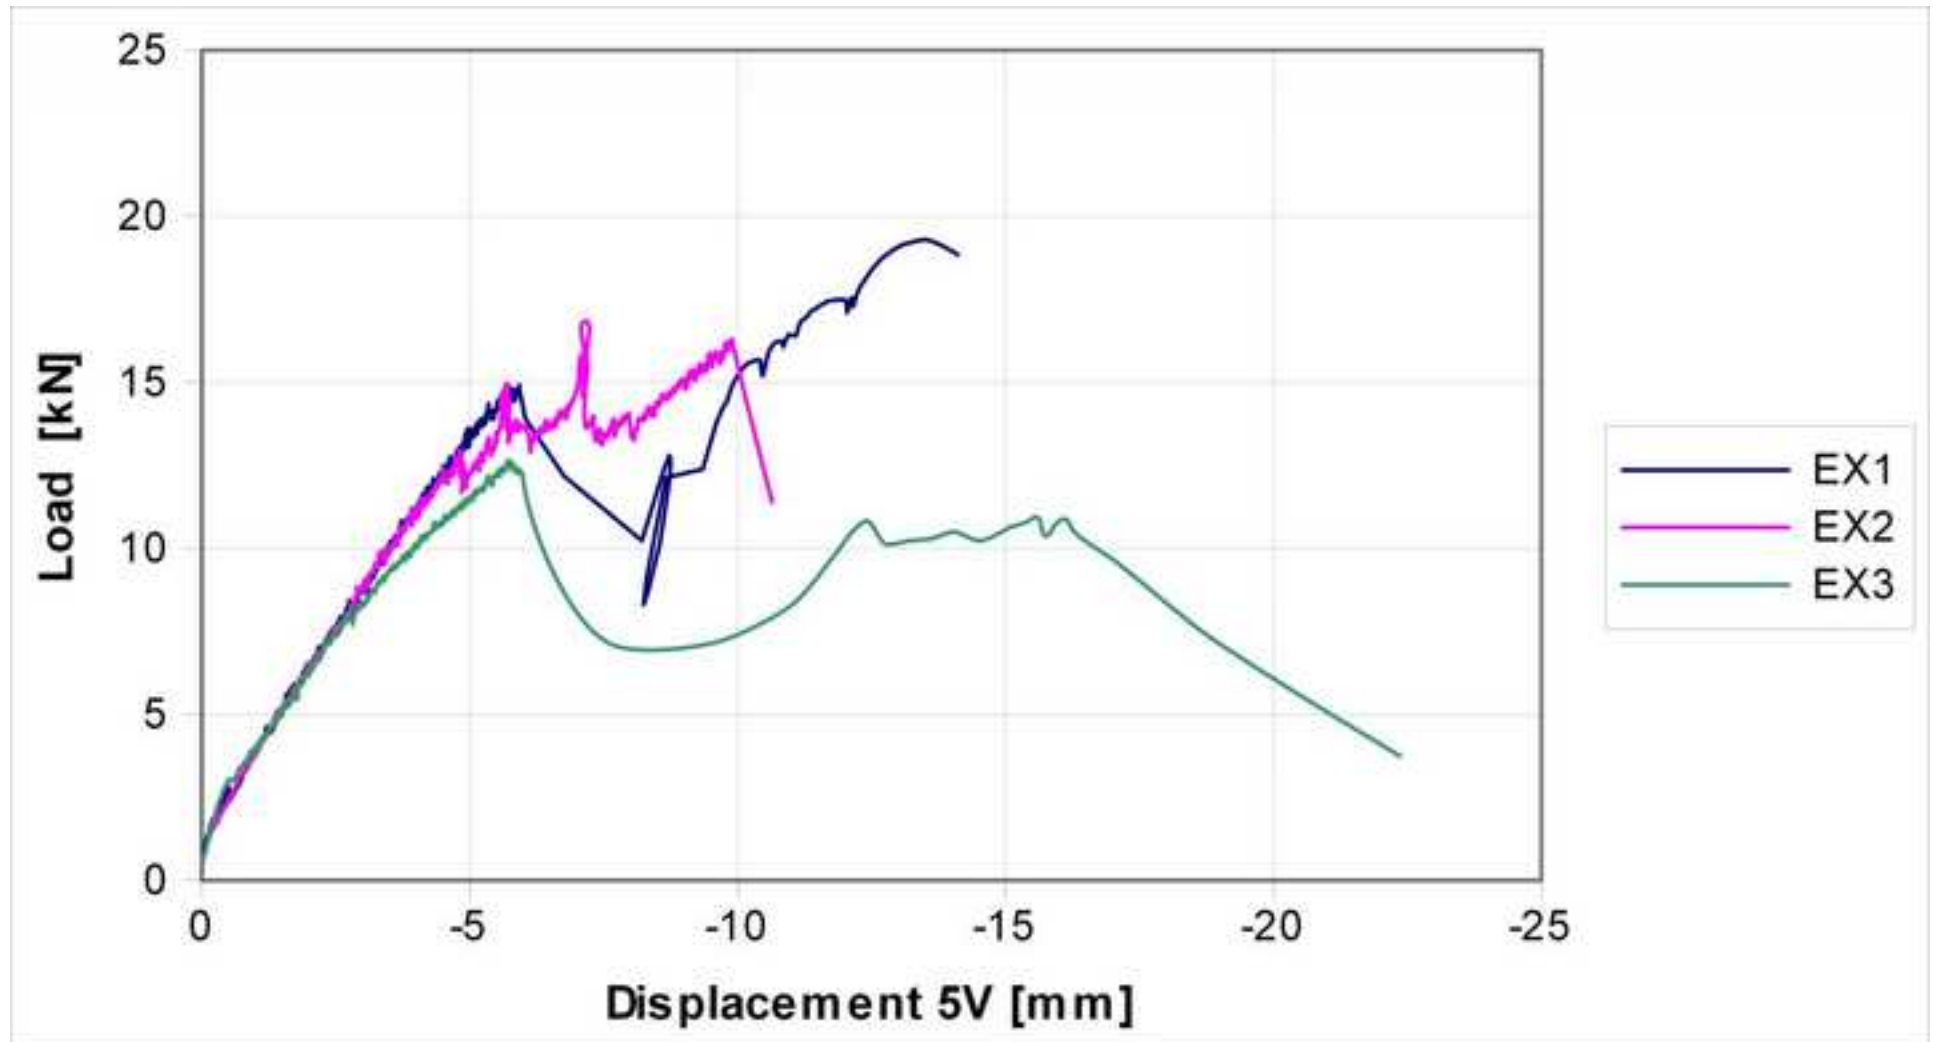
Figure 11. Load/Displacement of load application point for arche
[Click here to download high resolution image](#)

It was observed that the strengthening system in arches EX1 and EX2 delayed hinge formation on the intrados of the arch. In the case of EX1, although a slight sliding at the keystone was also observed, failure was caused by breakage of the BTRM in the area under tensile stress, whereas in the case of EX2, the collapse was caused by debonding of the strengthening system under a smaller load than in the former case. In the case of arch EX3, collapse was caused by crushing of a voussoir that had been weakened at its source of origin, although it was possible to observe the improvement of the arch's overall strength, as it was capable of maintaining a 10 kN of load at its plateau.

Regarding the tests carried out on strengthened arches, the experimental data showed a considerable increase in the resistive capacity of the arches strengthened along their external surface (see Table 7), 13 times larger compared to the non-strengthened arches. Likewise, a higher degree of structural ductility was observed as it was 3 times higher than non-strengthened arches.

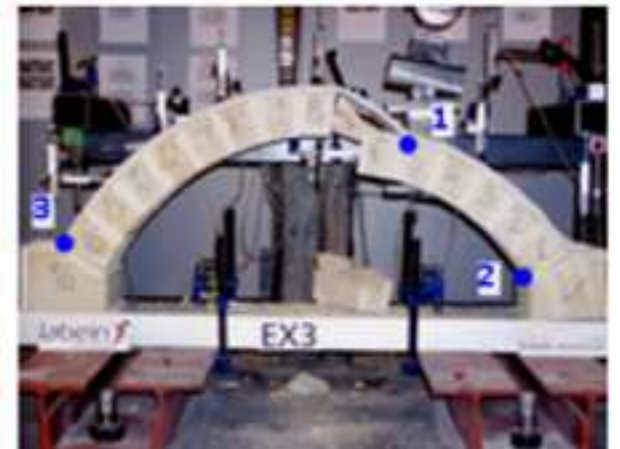
Figure 12. Location and order of appearance of the hinges on arc
[Click here to download high resolution image](#)

Figure 12 presents the location and order of formation of the hinges on the arches. In some cases, it was not possible to determine the order of appearance of the hinges because final failure occurred suddenly.

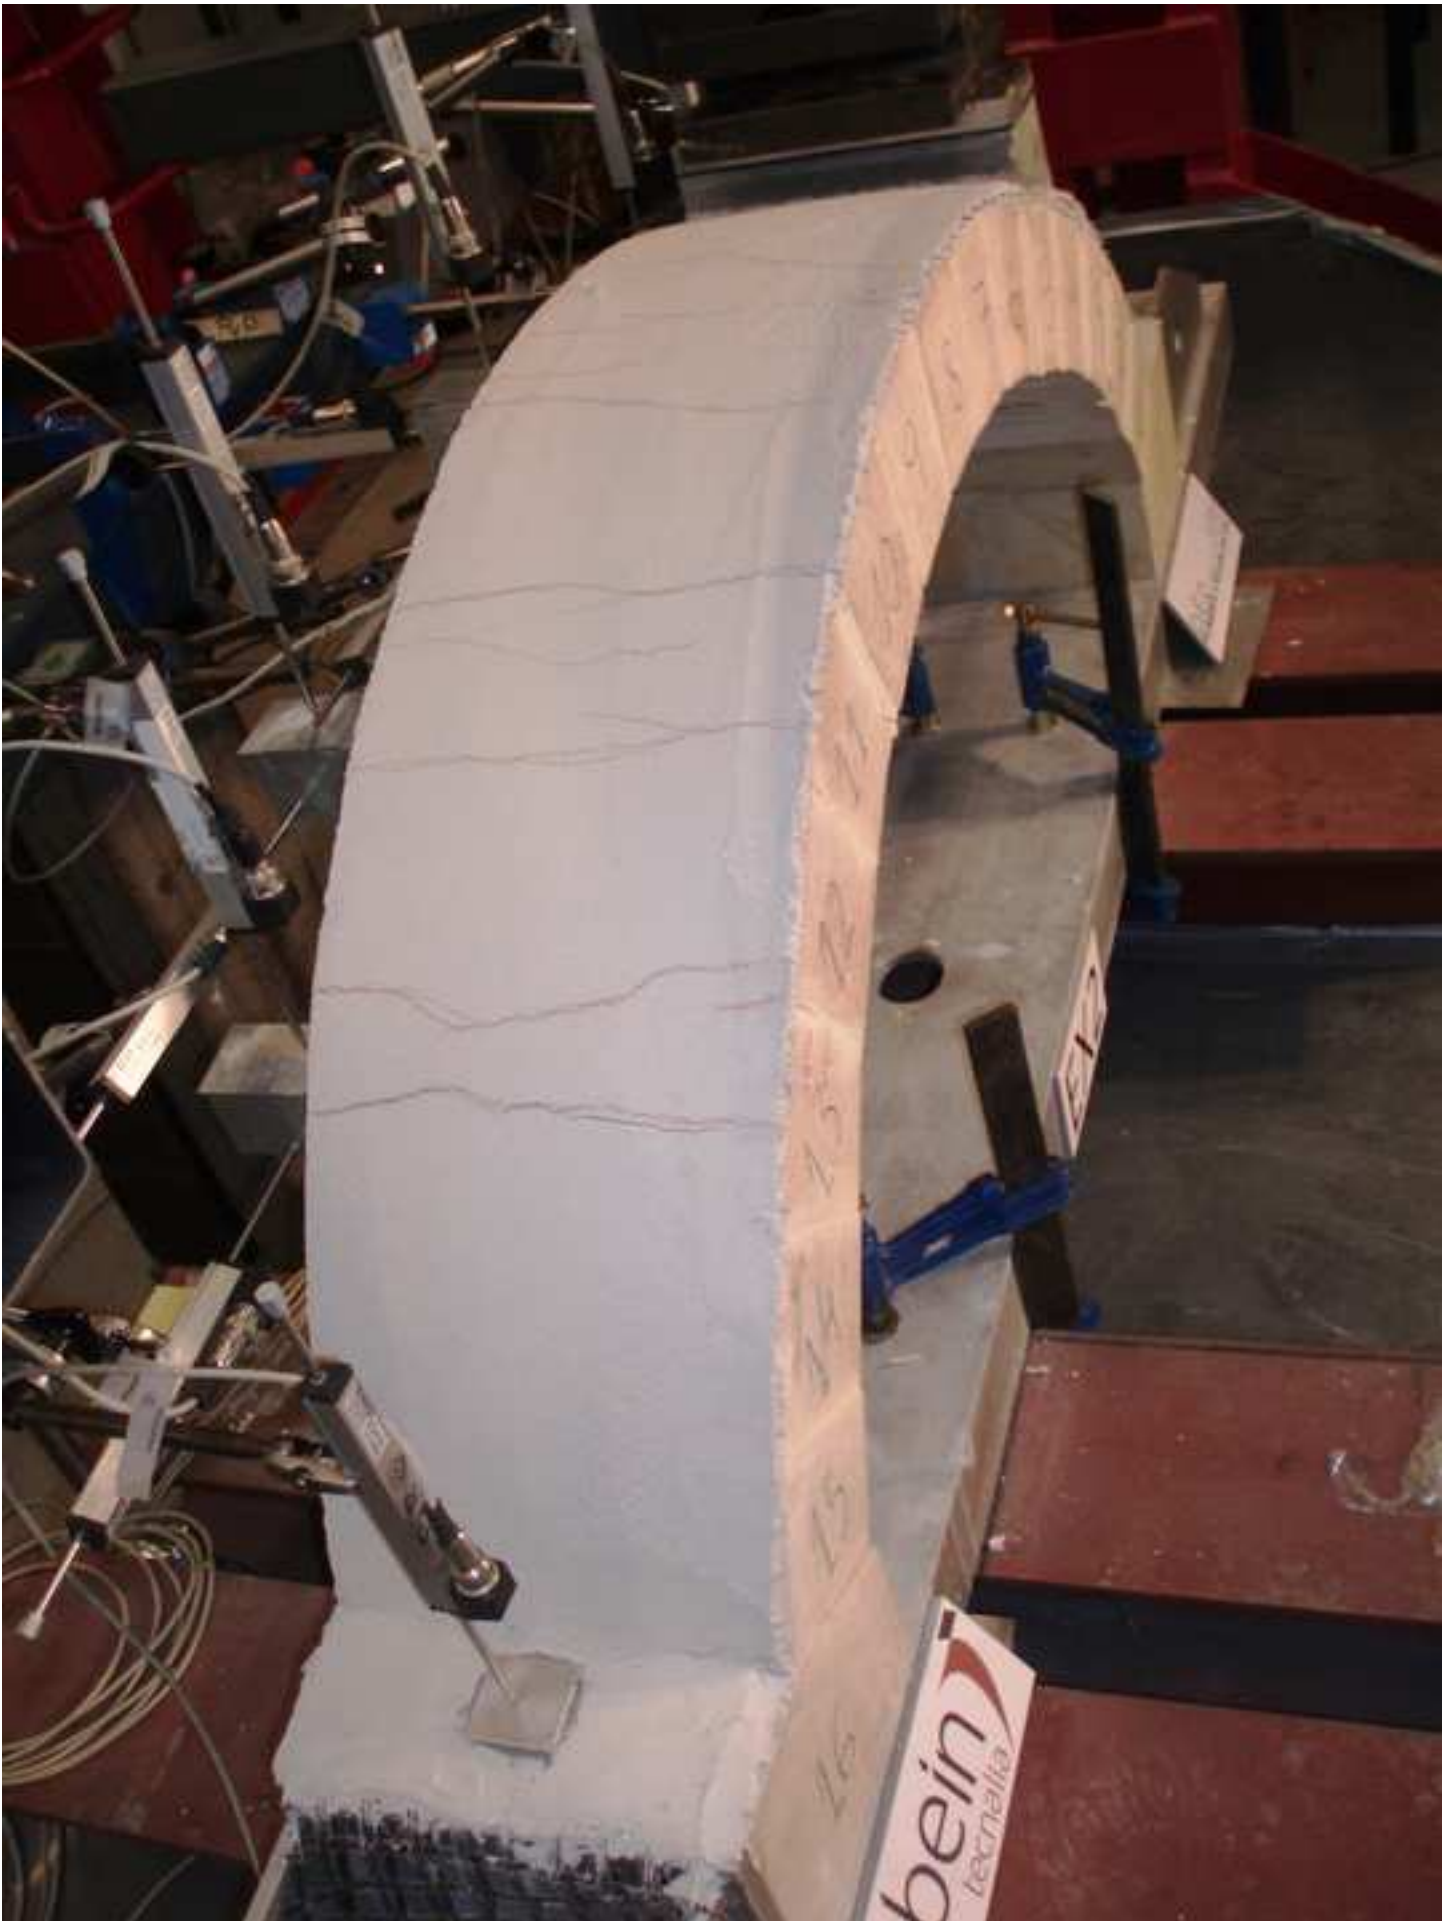
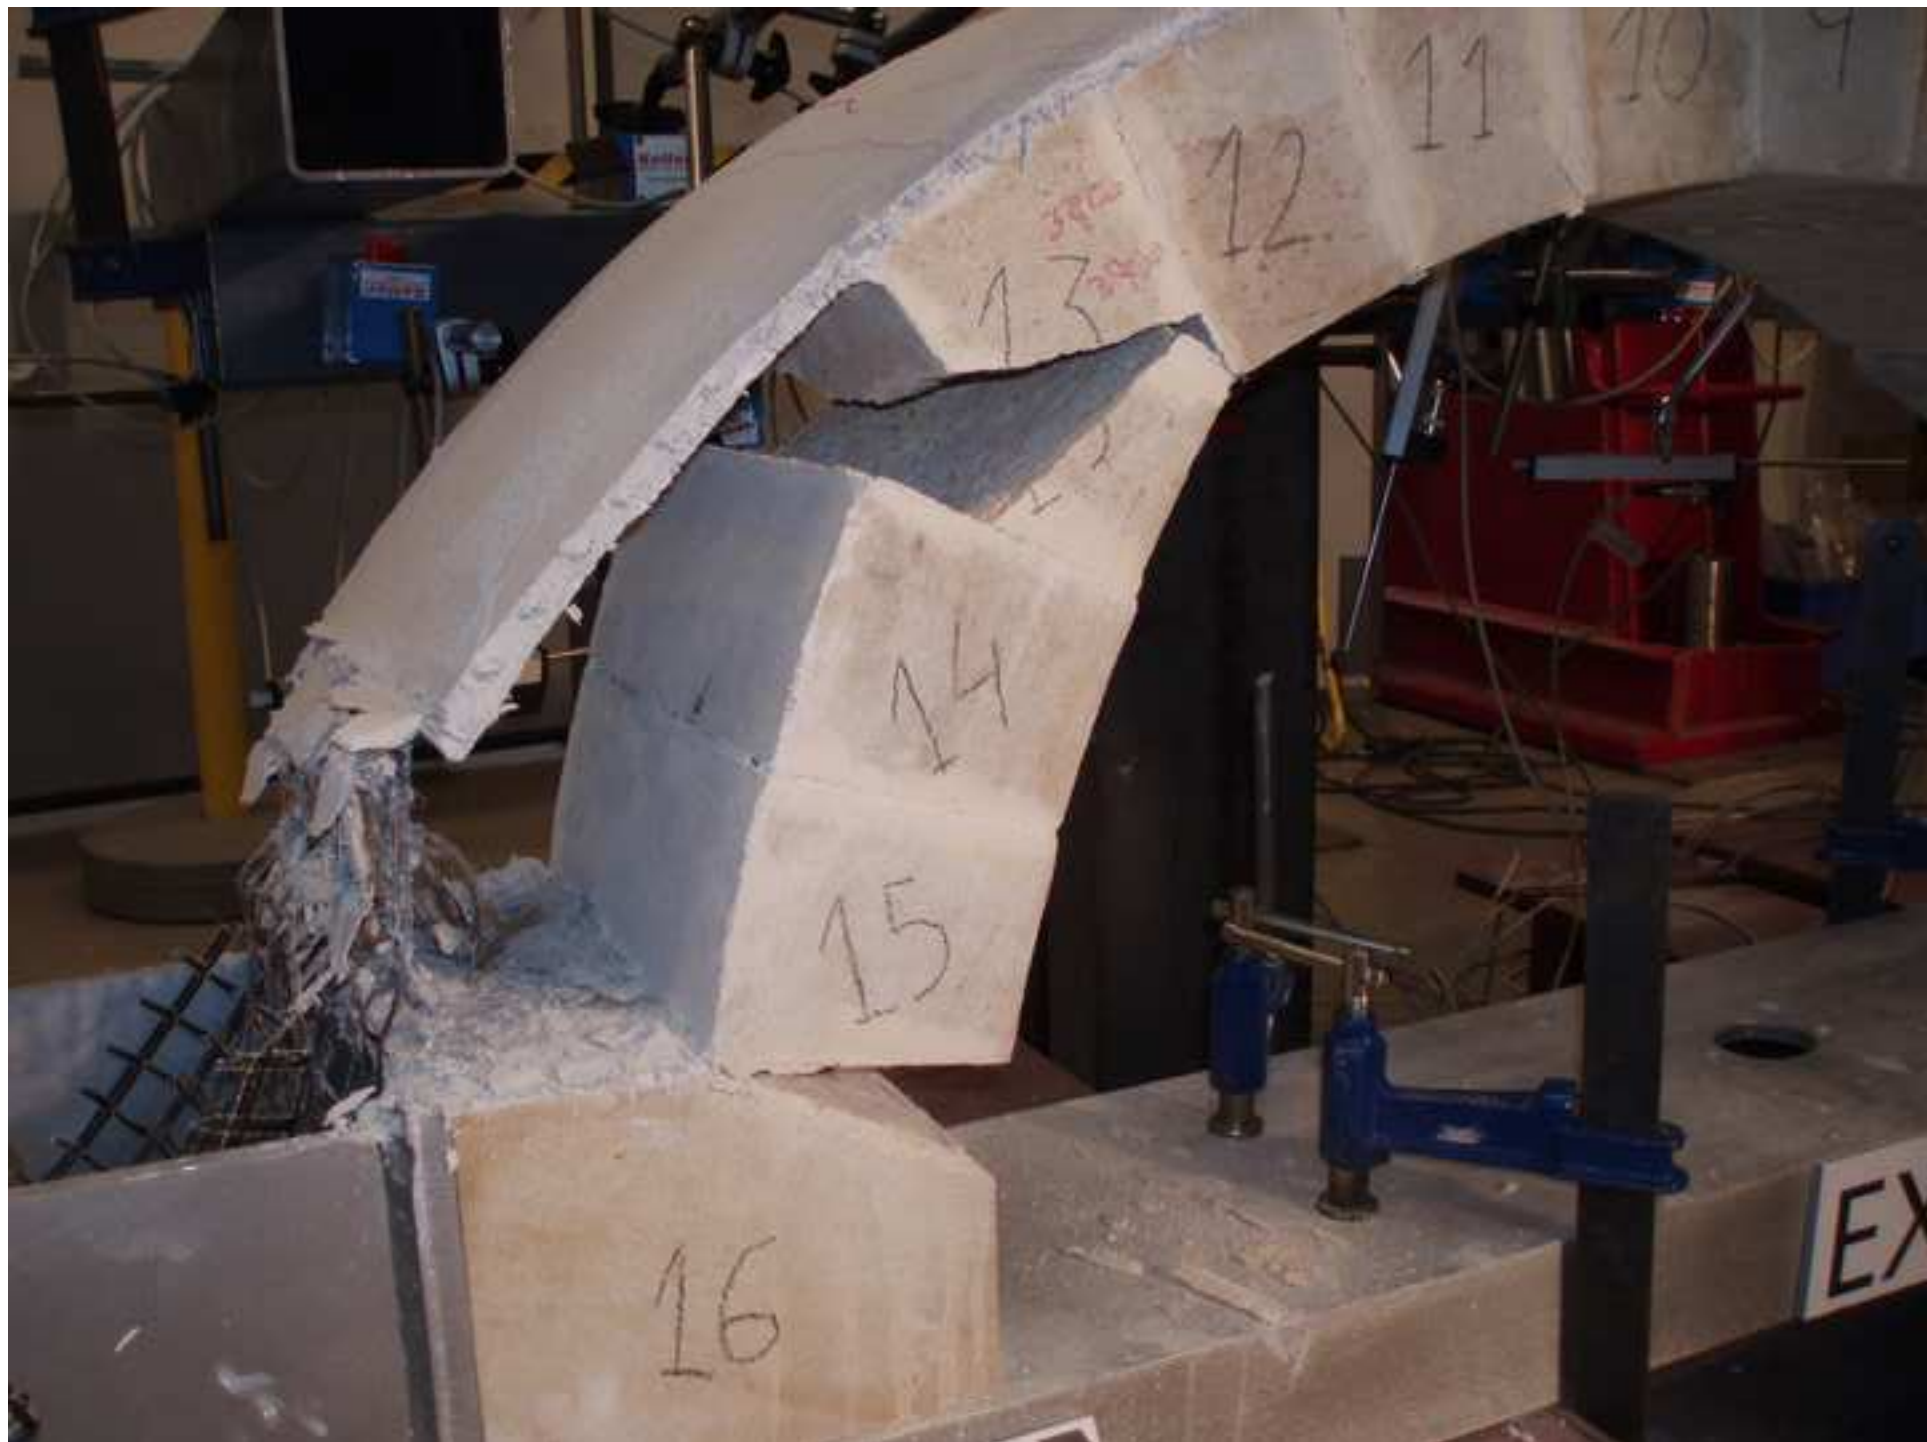
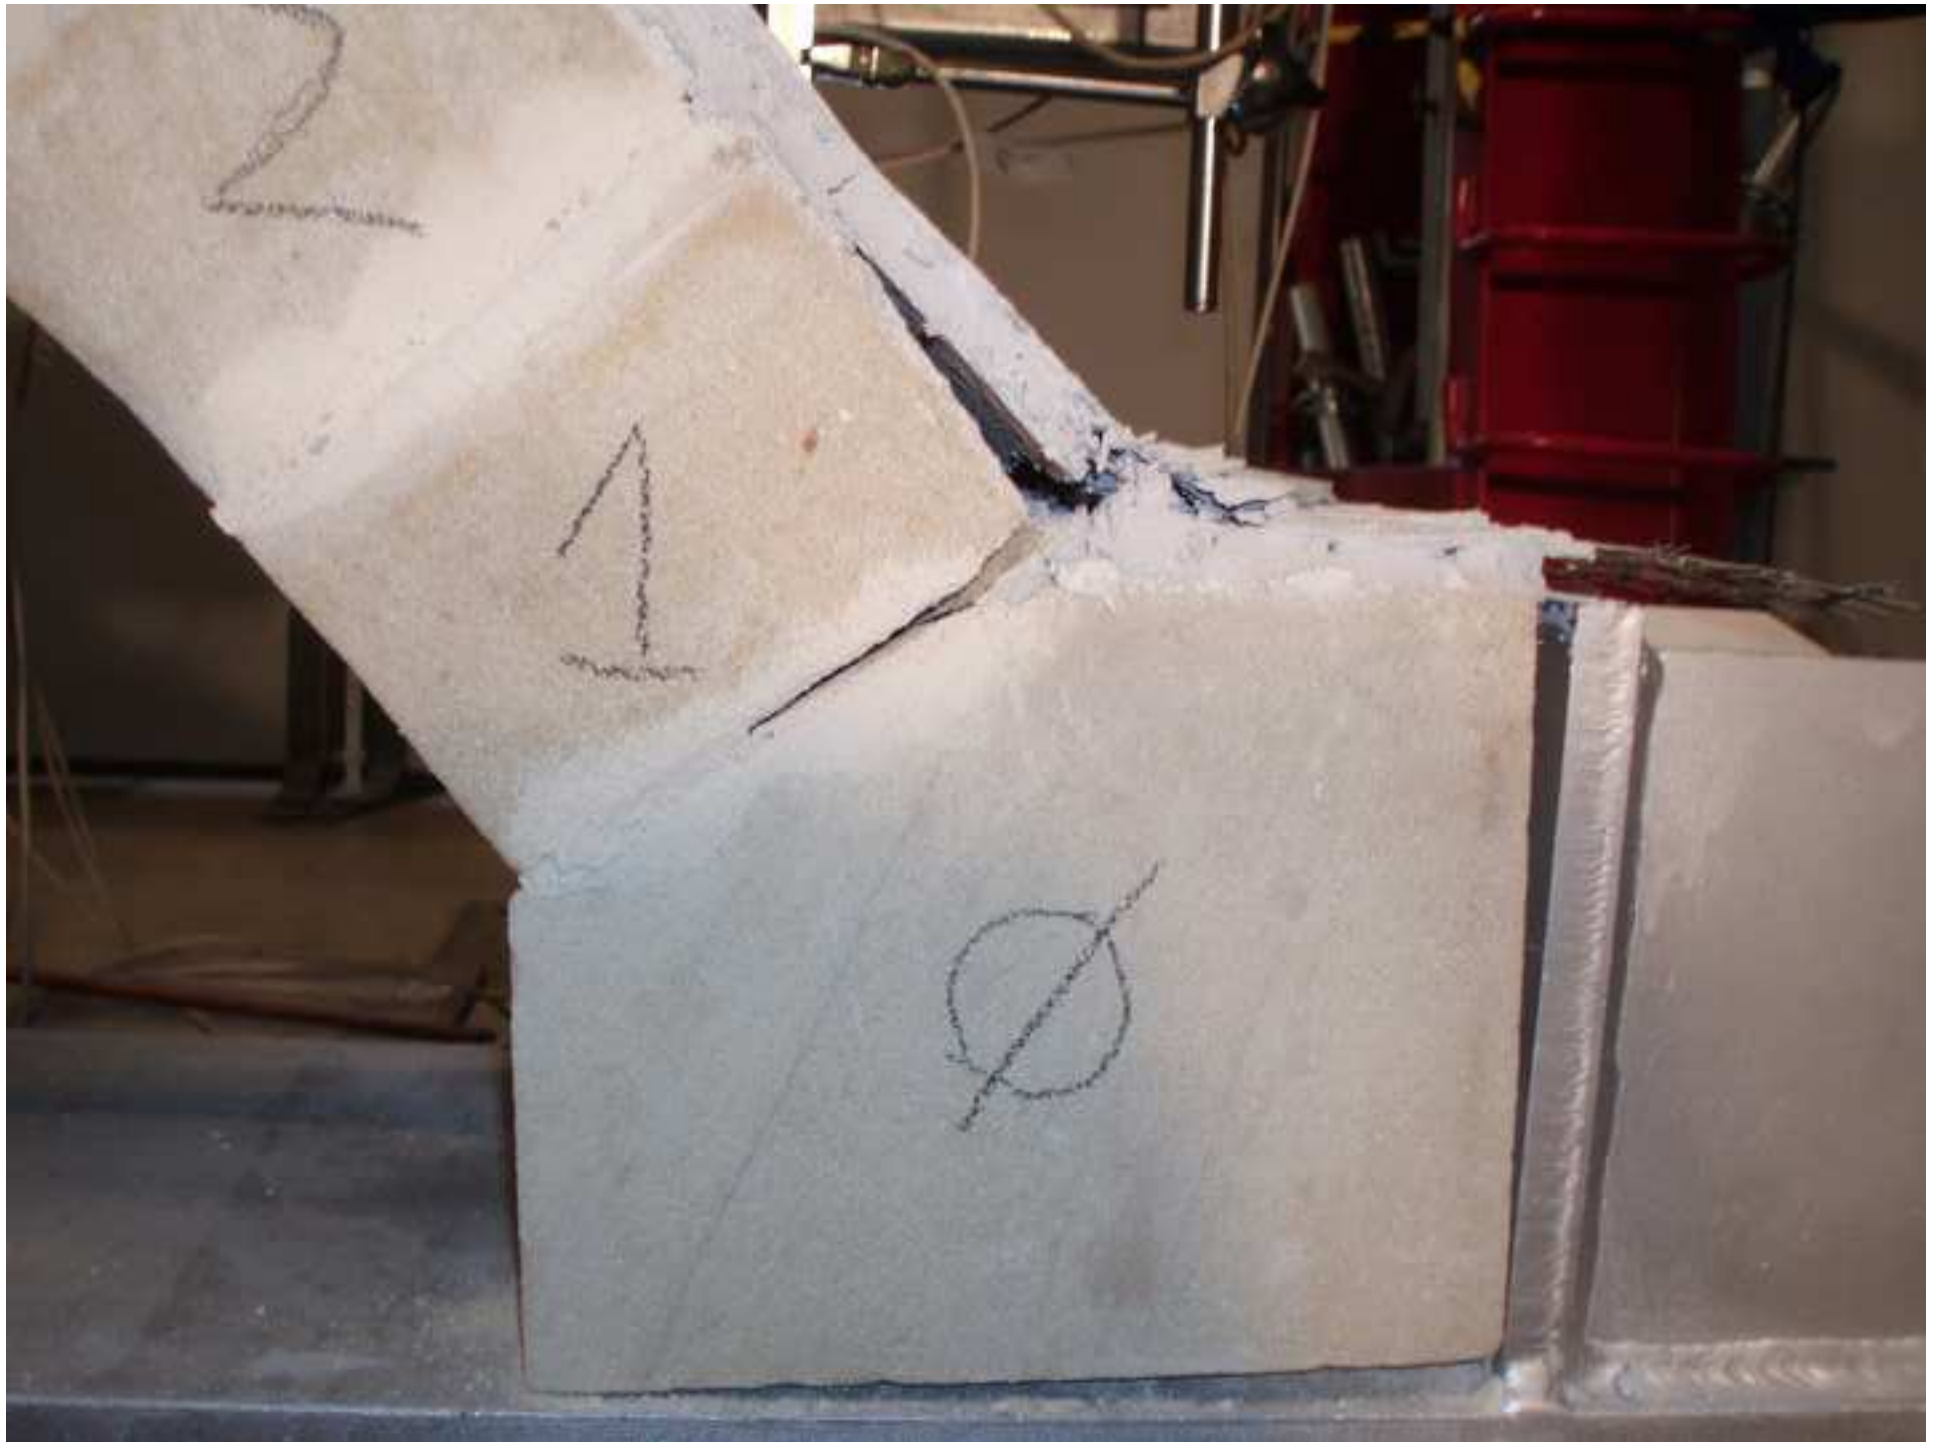
Figure 13. Detailed photographs of arch EX2
[Click here to download high resolution image](#)
