1
2
3 **Textile Reinforced Mortar as strengthening material for masonry**
4 **arches**
5
6
7

The Strengthening of Masonry Arches with Textile-Reinforced Mortar

Keywords: masonry, arch, strengthening, composites, TRM

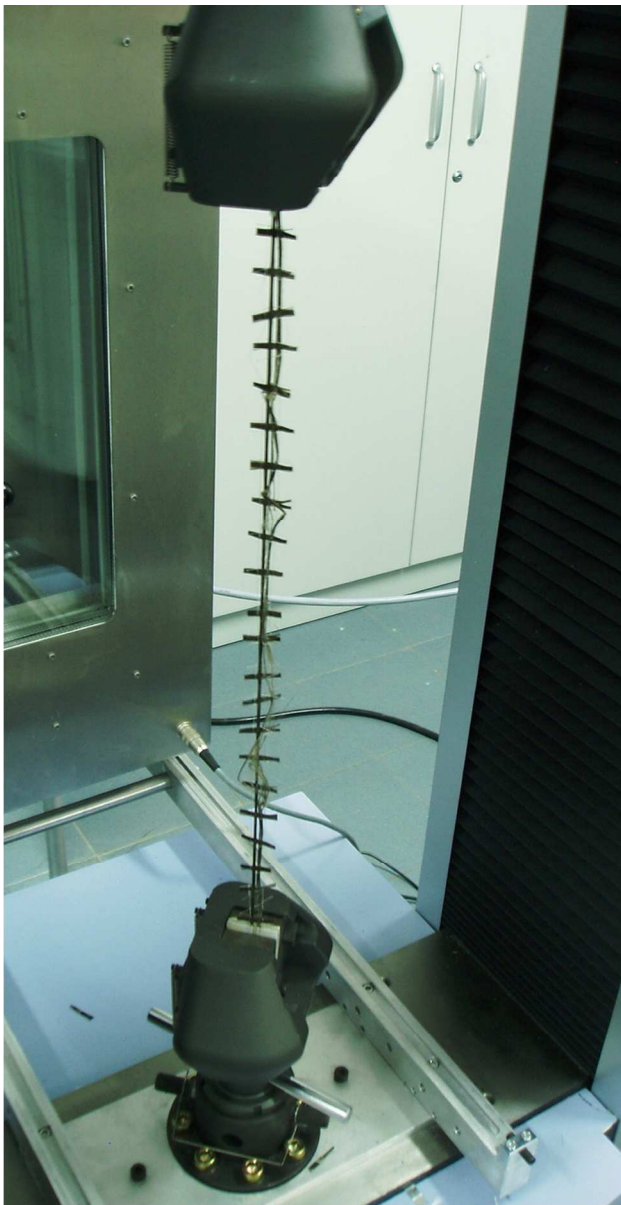
Pure tensile tests of basalt textile specimens
70x135mm (300 x 300 DPI)

The textile has been characterised in laboratory by means of uniaxial tensile tests, varying the amount of rovings and testing direction, as presented in Figure 1: one (TL1), two (TL2) and four (TL4) roving specimens were tested in longitudinal directions and four (TT4) roving specimens tested in transversal direction. On the whole, 40 specimens of 400 and 500 mm long were tested in accordance with internal procedure which was based on Standard ASTM D5034, as no explicit regulations or recommendations for testing mineral fibres woven as a mesh are available. The testing machine displacement rate was 5mm/min.

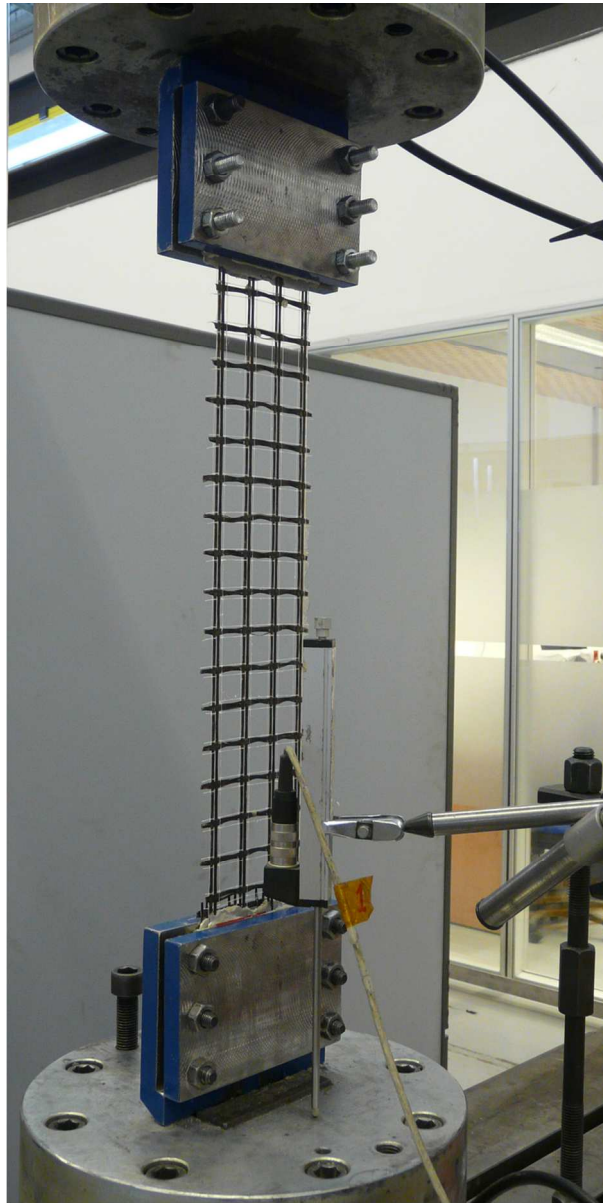
Test set up for pure tensile test of BTRM specimen
70x139mm (300 x 300 DPI)

With the purpose of analysing BTRM tensile behaviour, specimens with cross-sectional area of $100 \times 10 \text{ mm}^2$ and a length of 500 mm were prepared and tested (Figure 2). The specimens were built with one or two layers of basalt textile which was embedded in cement-free MAS mortar (M1 and M2 specimens). These internal layers ($800 \times 100 \text{ mm}^2$) were positioned in the middle of the cross section and had excess length at each end. Furthermore, so as to promote the failure of the specimen in its middle-third portion, the ends of the specimen were reinforced with two additional textile layers of $200 \times 100 \text{ mm}^2$. Slippage between strands and also between the textile and the mortar took place during testing of the M1 type specimens. For this reason, in order to prevent slippage in subsequent tests (M2 type specimens), the gripping device compressed not only the compound material but also the excess textile. After casting, the specimens were kept in a saturated atmosphere for seven days and were then stored for 21 days in a controlled environment (18°C and $60\% \text{RH}$).

The specimens were tested in a universal testing machine and the deformations, within the measurement range, were recorded with four Linear Variable Displacement Transducers (LVDTs), two on each side. The displacement ratio of the test was 0.5 mm/min for M1 specimens and 0.3 mm/min for M2. The tensile test results are presented in Figure 3.

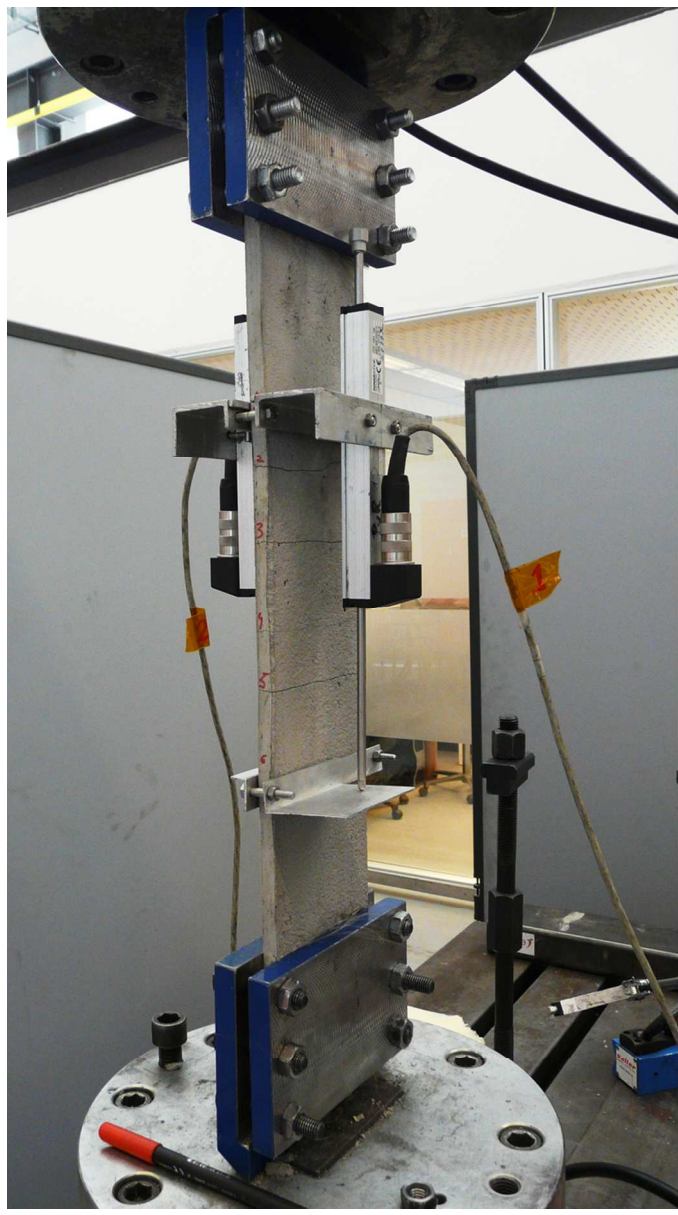
BTRM stress-strain curve for specimen types M1 (left) and M2 (right).
70x125mm (300 x 300 DPI)

BTRM stress-strain curve for specimen types M1 (left) and M2 (right).
99x52mm (300 x 300 DPI)

BTRM stress-strain curve for specimen types M1 (left) and M2 (right).
99x56mm (300 x 300 DPI)

The stress-strain curves (Figure 3) are characterized by the presence of three phases, more defined for M1. In the first phase, Stage I, the specimens showed very rigid behaviour when loads were absorbed with very little deformation; this stiffness reflects

1
2
3 the E-modulus of the mortar. This phase ended when the first crack in the mortar
4 appeared and, consequently, the load decreased. The second phase, Stage II, is known as
5 the multiple cracking stage (Hegger et al., 2006). When the mortar tensile strength was
6 exceeded, the first crack formed and the whole tensile force was carried by the textile
7 reinforcement, which had to be able to resist the load acting on the building. Under
8 increased tensile force, new cracks appeared in the specimens. Due to the bond between
9 yarns and mortar, forces were initiated in the matrix, until the tensile strength of the
10 mortar was reached once more and a new crack therefore formed. The distance between
11 cracks and their width is influenced by the reinforcement-matrix bond and the failure
12 strain of the mortar. Stage II ended when no further cracks occurred. This cracking of
13 Stage II causes a delay achieving the ultimate load and increases the deformation

17
18
19
20
21
22
23
24
25
26
27
28
29
30
31
32
33
34
35 In the third phase, Stage III, the specimen recovered the linear load (with a lower slope
36 than that obtained in Stage I) and only the fibres carried extra load up to the failure
37 point of the composite. The stiffness at this third stage was similar to the elastic
38 modulus of the textile reinforcement (not of the fibres) and its behaviour is basically
39 influenced by the mechanical properties of the textile. The width of the cracks grew due
40 to delamination between fibre and mortar, and led to a loss of the tension stiffening
41 effect. However, the resistance of the transversal fibres meant that the load could
42 continue to increase.

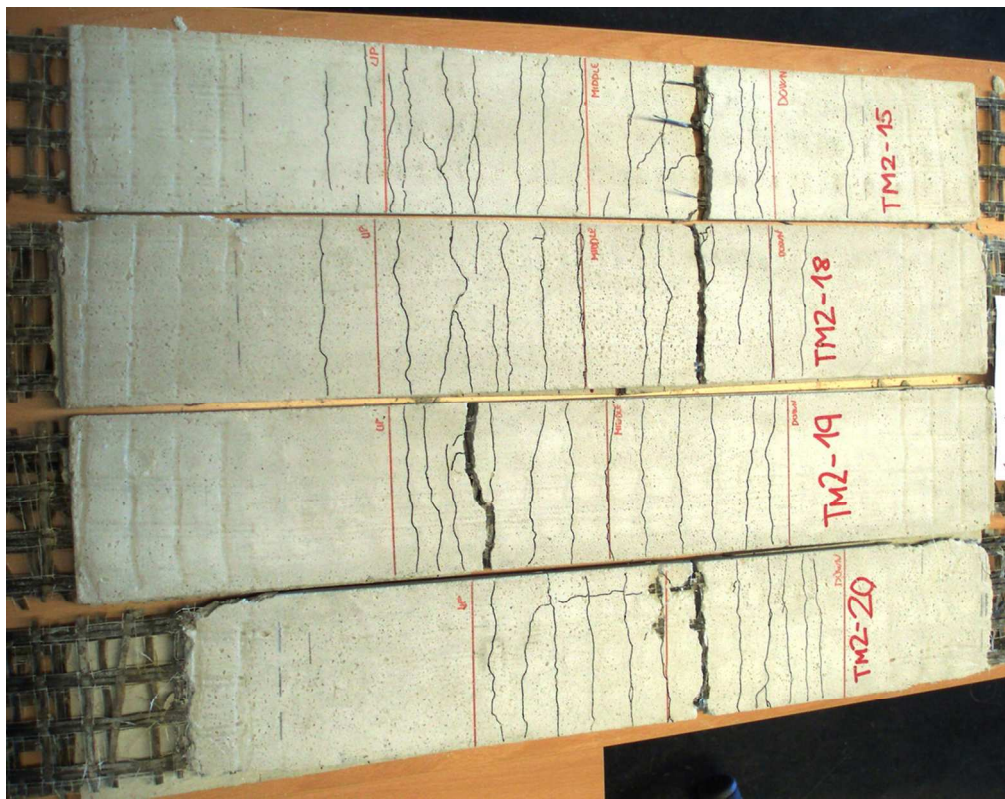
Cracks formed during pure tensile tests of BTRM of M1 (left) and M2 (right) specimens
99x75mm (300 x 300 DPI)

Cracks formed during pure tensile tests of BTRM of M1 (left) and M2 (right) specimens 99x79mm (300 x 300 DPI)

5 Failure occurred due to rupture of the whole section. While specimens reinforced with
6 one single textile fabric broke smoothly, in the other series the failure was brittle, i.e. an
7 instantaneous loss of bearing capacity. Crack spacing and crack width were dependent
8 on the type and quantity of reinforcement, the bond behaviour between textile and the
9 matrix and the mortar failure strain. The increase of the reinforcement ratio affected the
10 crack pattern (see Figure 4), which strongly influenced the behaviour of the composite:
11 the number of cracks formed was increased and the distance between them was reduced.
12 It was also noted that the increase in the number of layers shortened the length of Stage
13 II. The formation of more cracks favoured the start of the third stage of the curve.
14
15
16
17
18
19
20
21
22
23
24

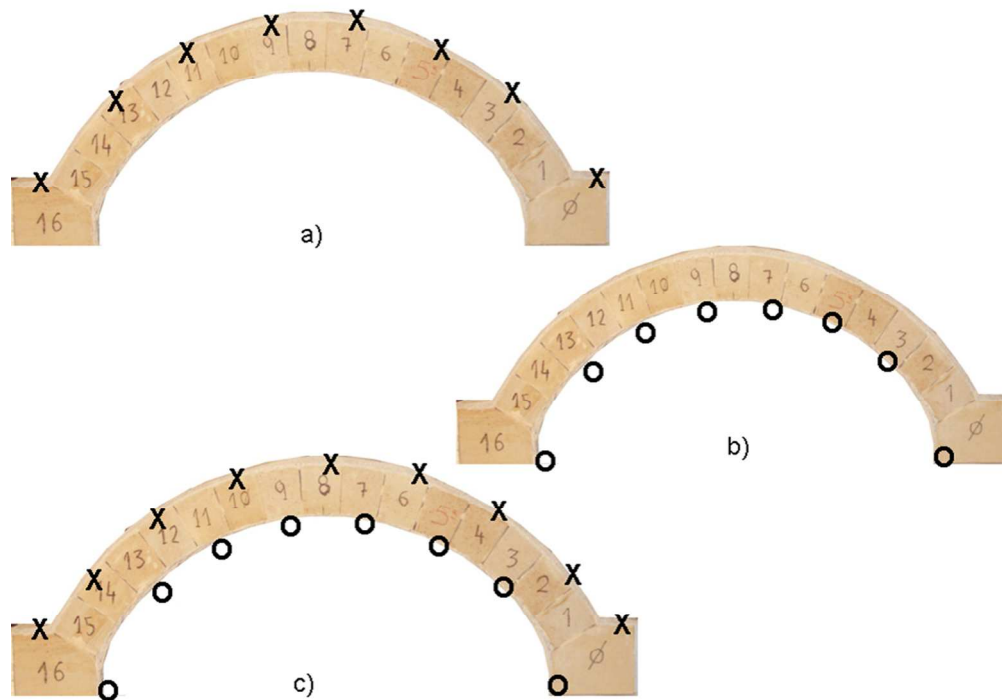
Left, numbering of voussoirs and location of spike anchors: a) for arches strengthened on the extrados, b) on the intrados and c) on both surfaces. Right, image of the spike anchors.
81x60mm (300 x 300 DPI)

Left, numbering of voussoirs and location of spike anchors: a) for arches strengthened on the extrados, b) on the intrados and c) on both surfaces. Right, image of the spike anchors.
99x83mm (300 x 300 DPI)

28
29
30
31
32
33
34 Tests were carried out by displacement control applied at the quarter of the span
35 (voussoir number 5, see Figure 6) until failure at a speed of 0.12 mm/min and both
36 horizontal and vertical displacements of alternate voussoirs were recorded during the
37 tests by means of 10 LVDTs. Likewise, displacement outside the vertical plane of the
38 keystone and the stability of the abutments were recorded. Finally, LVDTs were set up
39 to record any possible rotation of the voussoir where the load was applied, in order to
40 monitor the verticality of the applied displacement more closely. In total, 14
41 displacement meters were used. The applied load was measured using a load cell.
42
43
44
45
46
47
48
49
50
51
52
53
54
55
56
57
58
59
60

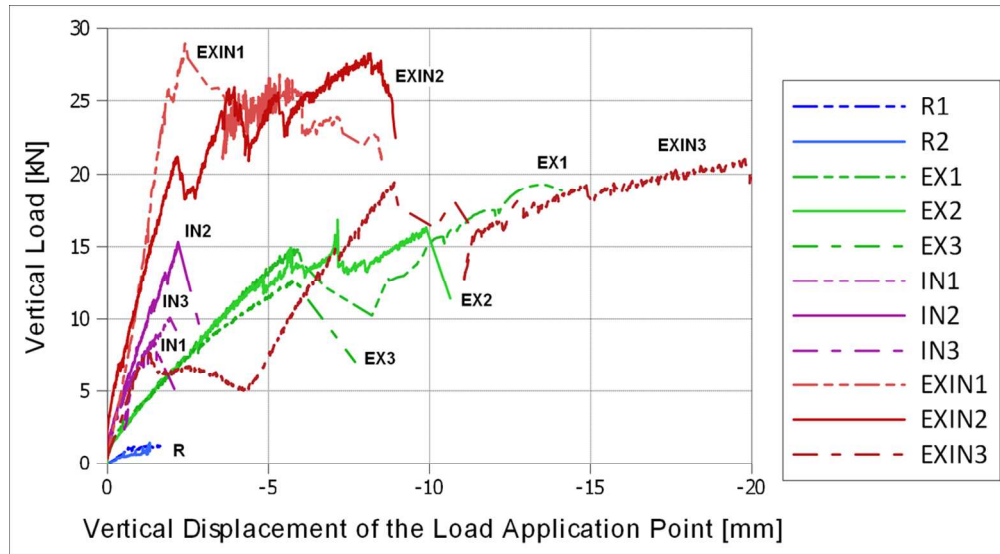
Vertical load vs displacement of the load application point for each arch.
109x60mm (300 x 300 DPI)

1
2
3 Figure 8 presents the obtained experimental results of every arch up to the failure
4 moment, applied vertical load on voussoir number 5 versus its vertical displacement, in
5 order to analyse its overall structural behaviour.
6
7
8
9

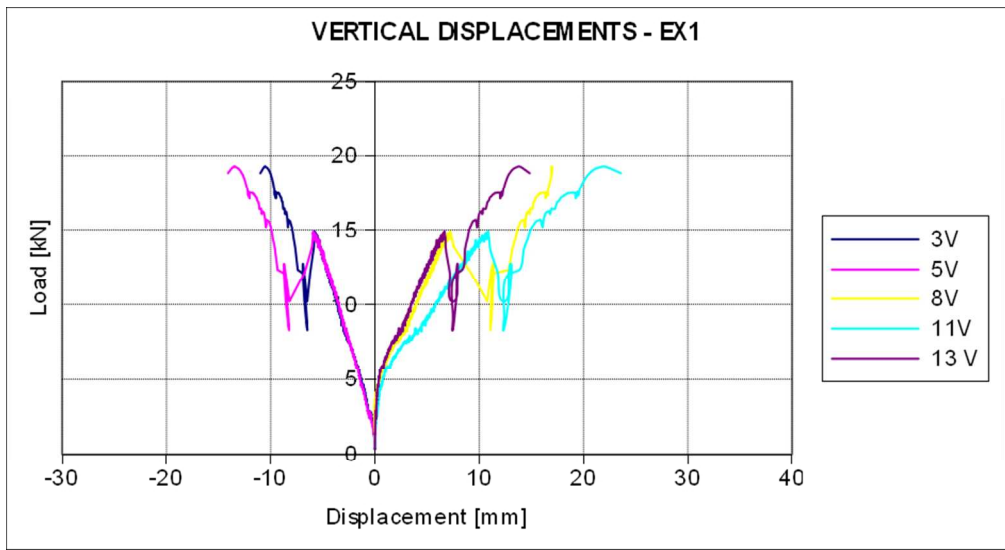
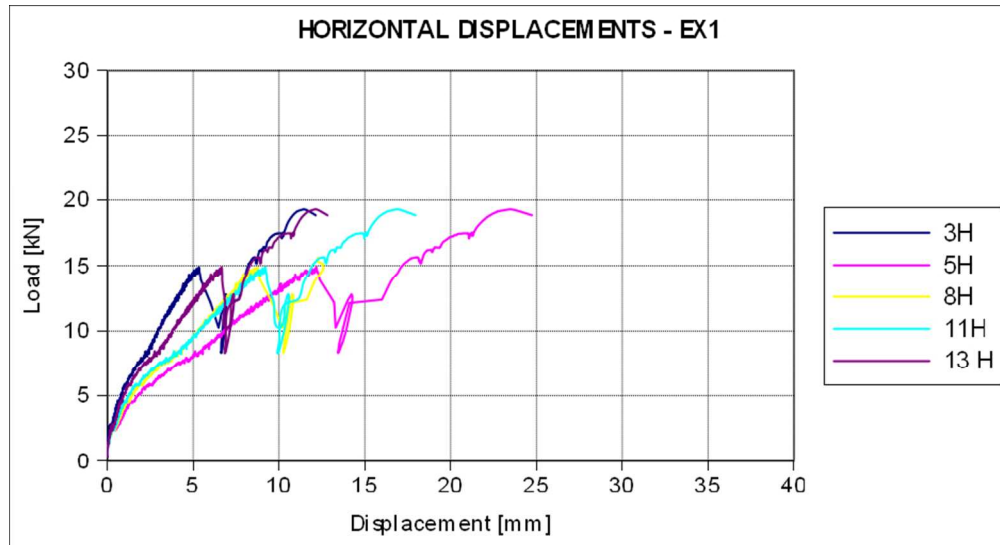
Vertical load vs vertical (left) and horizontal (right) displacement in different voussoirs of arch EX1
79x43mm (300 x 300 DPI)

30
31 For the sake of simplicity, only load and displacements registered for arch EX1 are
32
33 shown in Figure 9, where it is corroborated that the displacements correspond with the
34
35 movements of the structures presented in Figure 10.
36
37
