THE EVOLUTION OF LATE MEDIEVAL SEIGNIORIAL RESIDENCES IN THE BASQUE COUNTRY. ANALYSIS OF THE GUEVARA PALACE AND ITS CONSTRUCTIVE SYSTEM

D. LUENGAS-CARREÑO¹, M. CRESPO DE ANTONIO¹ & S. SANCHEZ-BEITIA¹
¹Higher Technical School of Architecture, UPV/EHU

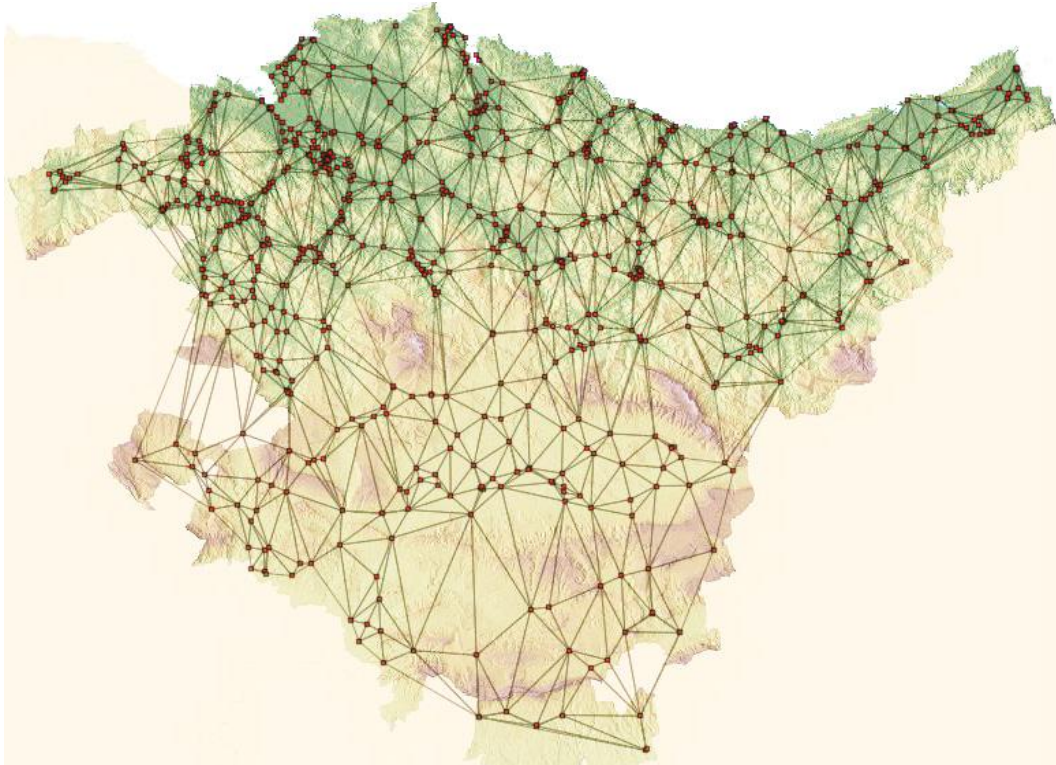
Figure 1: The Tower Houses system of the Basque Country.

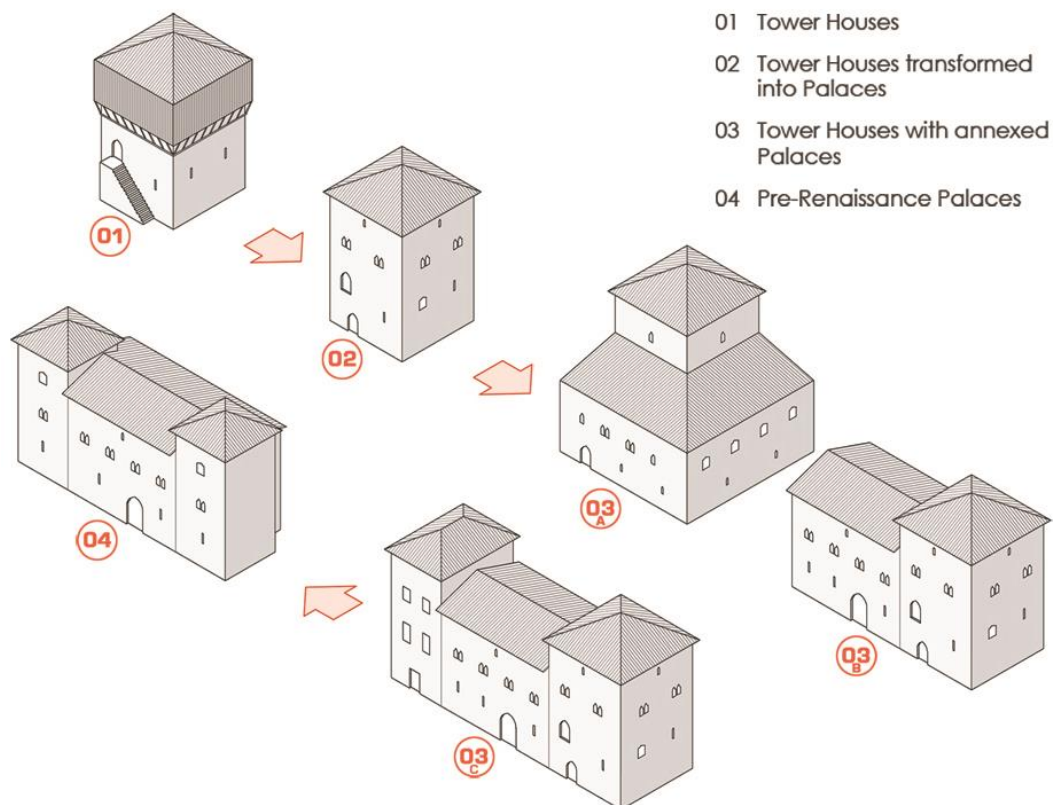
Figure 2: The evolution of Late-medieval Seigniorial Residences in the Basque Country

By contrast, other nobles preferred to build annexed Palaces to their Tower Houses, preserving the original construction (fig. 2). These new residential spaces were more luminous and better equipped than previous ones. The annexed Palaces could be disposed parallel to the main façade or they could be built around the tower, sometimes using original perimeter stone fence walls.

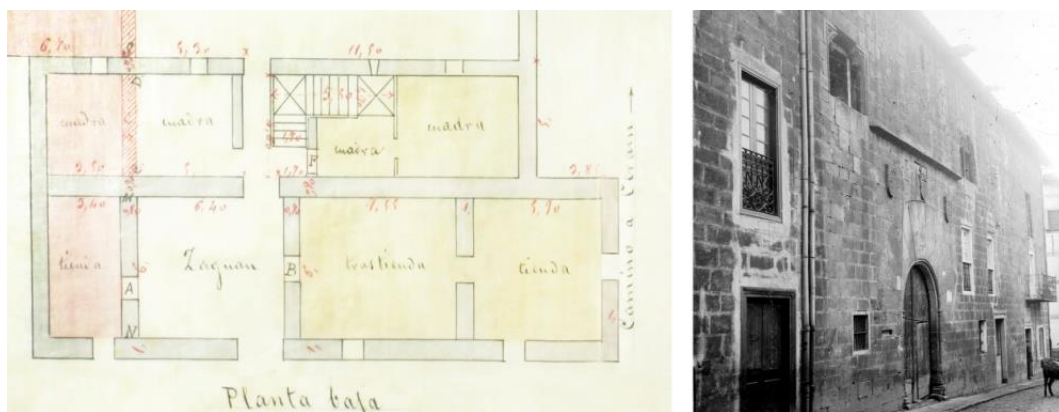
Figure 3: The photograph of 1915 and the subdivision drawings of 1888, where the southern part is painted in red, the central part appears in white and the northern part is in yellow.

On May 6 of 1888, the Guevara Palace was purchased by Esteban Zurbano, who subdivided it into three different lots. In the subdivision works, new walls were raised and some elements were bricked up, as evidenced by the architectural drawings of 1888 (fig. 3).

Another important document of this period is a photograph of 1915, obtained in the General Archive of Gipuzkoa, fig. 3. Taking into consideration the differences between this image and the architectural drawings of 1888, main façade was substantially transformed in this period.

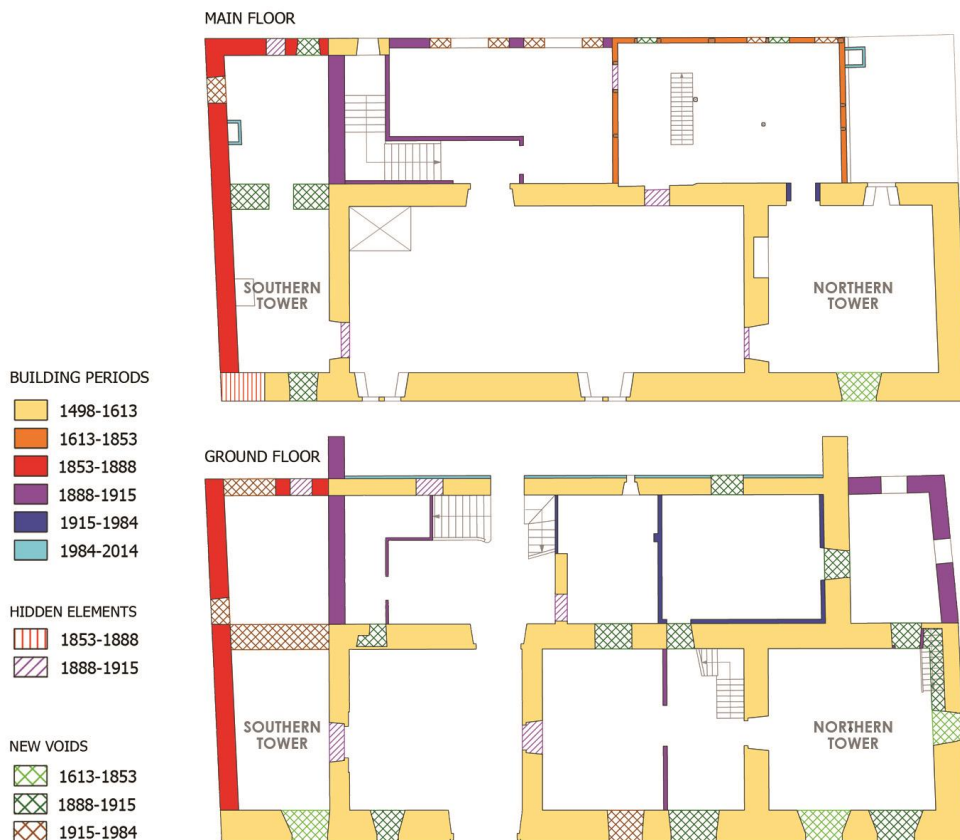
Figure 5: Building periods of the main and ground floor

The most relevant remains of this period are the cuts produced by the demolition of the side towers (fig. 4, units 39, 27 and 28). During this refurbishing work, a double trefoiled window and an ogee-headed arrowslit were bricked up (fig. 4, units 36 and 37). In the southern part, a new poor masonry rear façade and dividing wall were built, fig. 5.

In this building period few changes were made. Three new brick walls were raised in the back area in order to build a new kitchen. In the southern subdivision, a masonry inner wall was demolished, some windows were bricked up and new voids were opened in the dividing wall, fig. 5.

During the refurbishment of the central subdivision, some brick walls were erected in order to create new rooms, fig. 5. Additionally, two double trefoiled windows and a small ogee-headed window were repaired (fig. 4, units 25, 26 and 29).

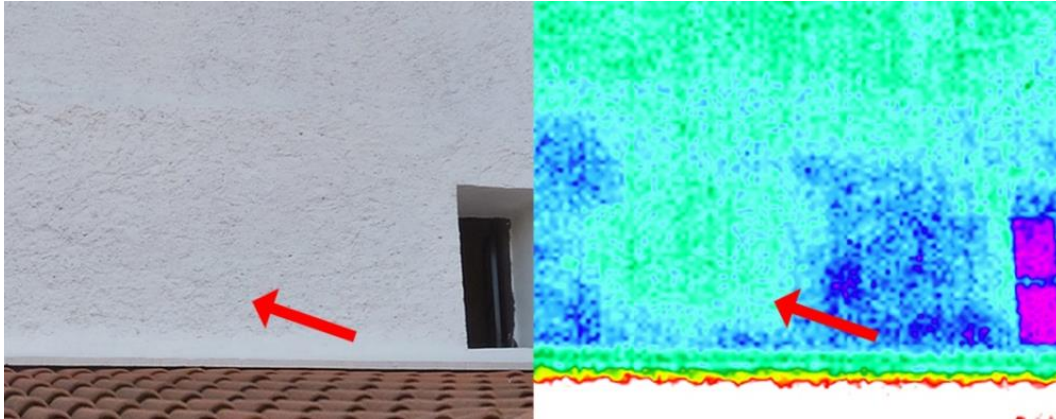
Figure 6: Hidden window in the rear façade

The thermal imaging camera revealed a significant number of hidden architectural elements, such as rear façade windows (fig. 6), which appear in the drawings of 1888. Additionally, this camera was used to distinguish between the paste covered original and not original walls, owing to the difference of emissivity of the materials of both types of walls.

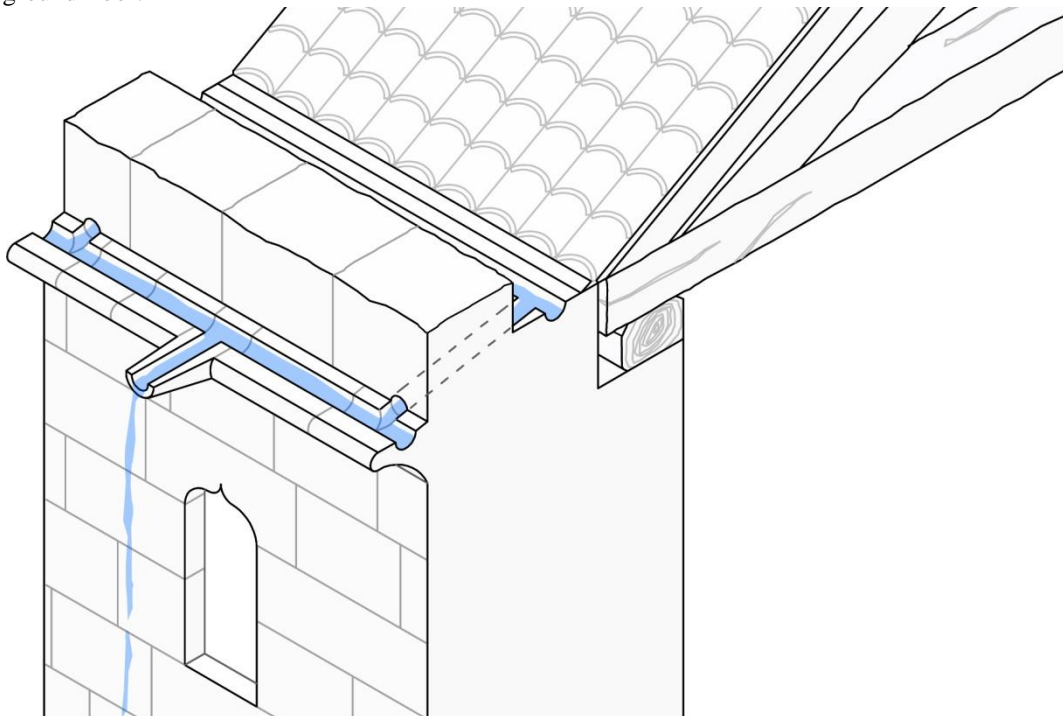
Figure 7: The original roof and the stone-carved rainwater conduit

In the top of the main façade a horizontal stone-carved conduit was found, which served to channel the rainwater to five gargoyles. Therefore, the original roof had a double water gutter, as it is shown in the fig. 7. Taking into account other best-preserved Pre-Renaissance Palaces [6], the roof of the side towers should have been built with similar structure, but there is no evidence.

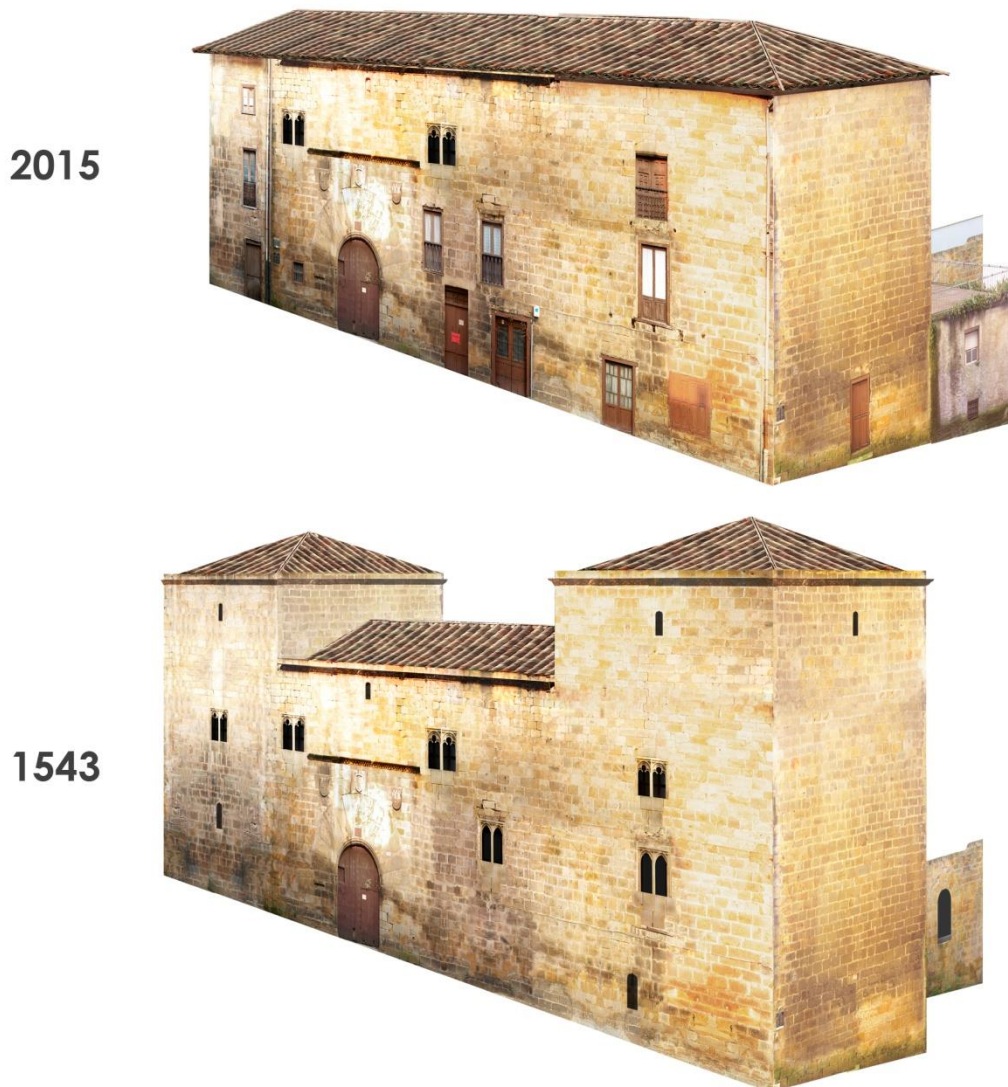
Figure 8: 3D reconstruction of the palace

The original Guevara Palace had few windows and doors (fig.8), which were simply organized. The main façade had a single entry: the large round arched doorway. This architectural element, which was formed by thirteen voussoirs of 1.6m in length, was 3.33m high and 2.32m wide. This door gap size made possible to enter on horseback inside the palace. The doorway was ornamented with two side renaissance columns and three gothic shields. Nevertheless, there are no architectural remains, according to the historical documents; the rear façade had a doorway in the ground floor.

Moreover, the building has preserved a significant number of oak timber structural elements, as it is shown in fig. 8. In the mezzanine floor, the side timber beams were held up by stone brackets and the central beams were embedded into the walls. In the north part of the first floor, the structure rested directly on the projecting part of the stonework. However, in the central part, the structure was supported by two timber sleepers, which were supported by stone brackets. The central roof was held up by five king post trusses. No original timber elements were found in the south part.

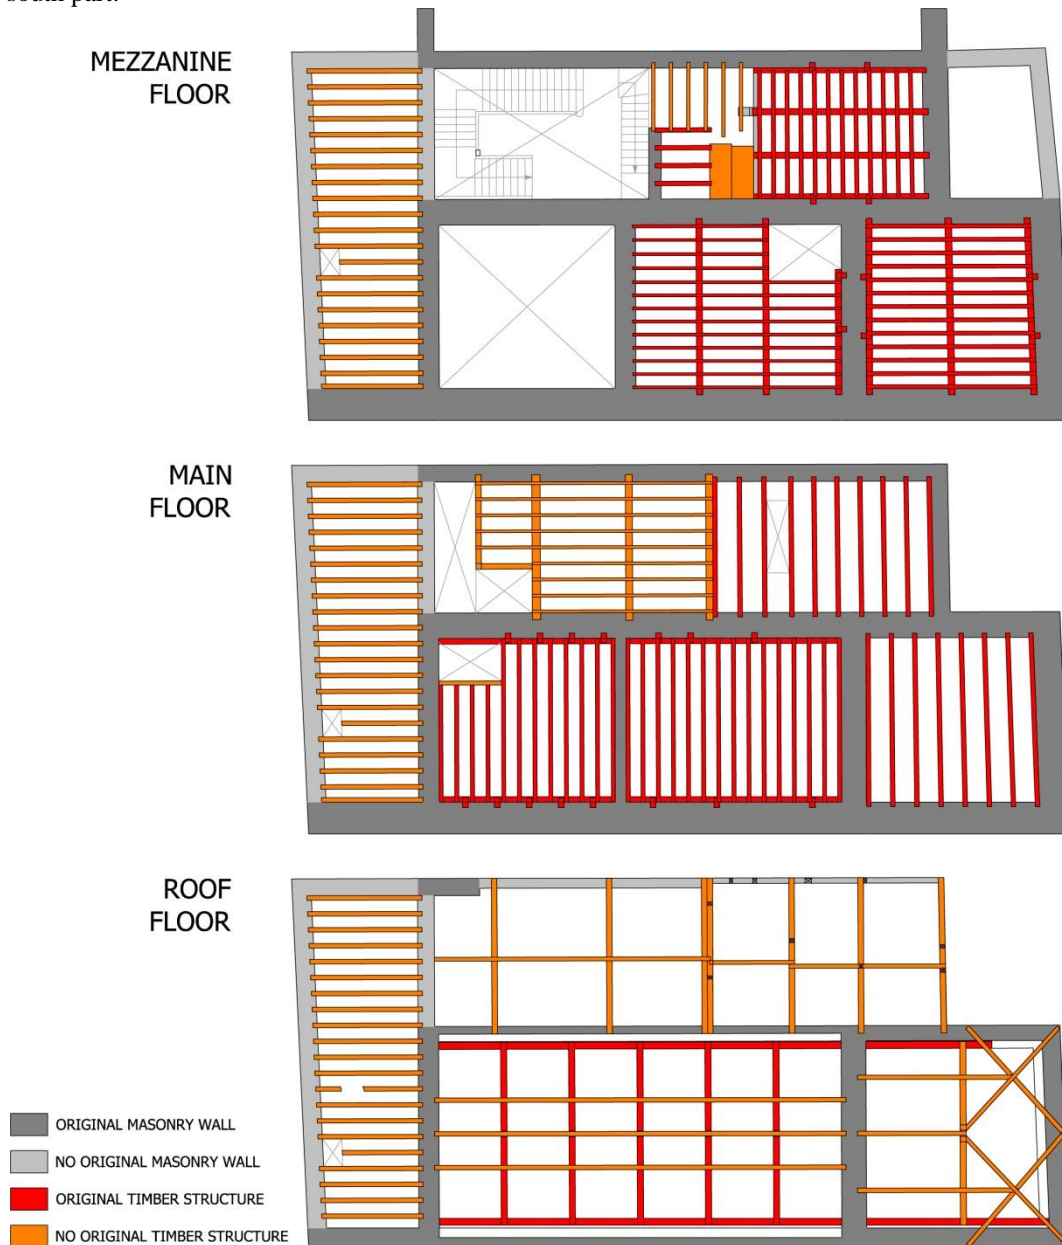
Figure 9: Original timber and masonry elements
