Sección de artículos / Papers section

Publicación / Publication		
Comunicación en un congreso / Lecture in a congress		
NOMBRE:	Measuring the Changes 13 th FIG International Symposium on Deformation Measurements and Analysis 4 th IAG Symposium on Geodesy for Geotechnical and Structural Engineering	:NAME
LUGAR:	Lisboa (Portugal) / Lisbon (Portugal)	:PLACE
FECHA:	12 –15 mayo 2008 / May 12 – 15 2008	:DATE
ACTAS:	No disponibles / not available	:PROCEEDINGS
FECHA:		:DATE
WEB:	http://www.fig.net/commission6/lisbon_2008/papers/pas12/ ... pas12_02_vallemelon_mc045.pdf	:WEB
NOTAS:		:NOTES
Artículo en revista / Journal paper		
NOMBRE:		:NAME
EDITOR:		:EDITOR
NUMERO:		:NUMBER
FECHA:		:DATE
ISBN:		:ISBN
ISSN:		:ISSN
WEB:		:WEB
PAGINAS:		:PAGES
NOTAS:		:NOTES
Otro / Other		
DETALLES:		:DETAILS

Evaluation of the conventional surveying equipment applied to deformation analysis of heritage buildings. A case study: the bell tower of Santa María la Blanca church in Agoncillo (La Rioja, Spain)

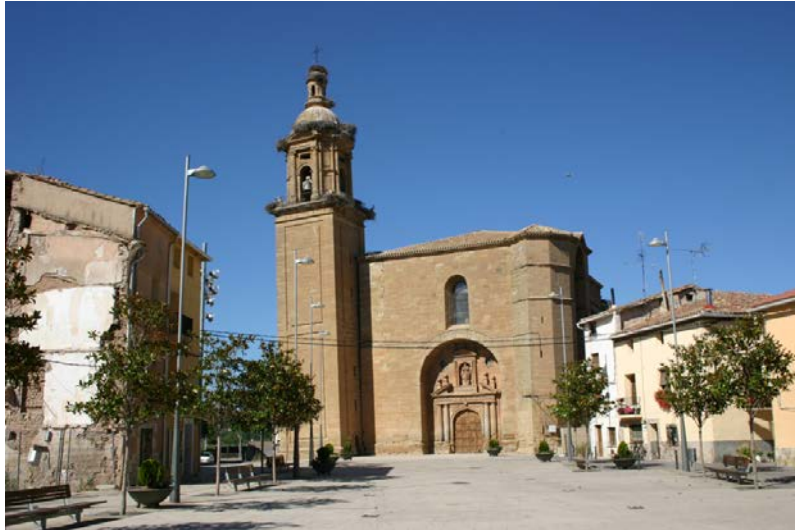
Figure 1: Santa María la Blanca's church and its leaning bell tower

the 17th century, the side chapels were added during the 18th century and the bell tower, which is the main subject of this study, started to be built in 1794 (Moya Valgañón, 1975). This source does not mention any of the currently visible pathologies: the west façade (in which the door is embedded) presents many cracks of considerable size and the tower that joints it on the north appears noticeably detached with a leaning of about 2 degrees; in spite of this, consulted neighbours say that they have always known the tower in that way; however, they disagree whether they have noticed an increase in the number or size of the cracks and the leaning of the tower.

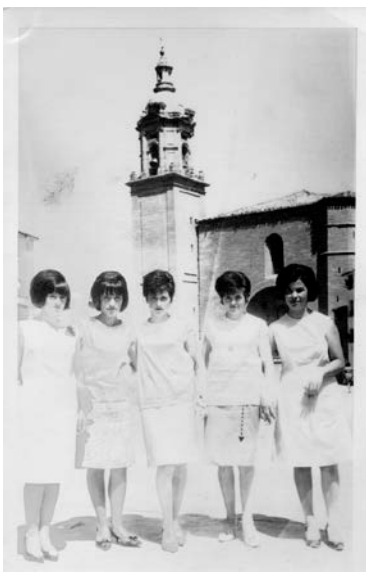
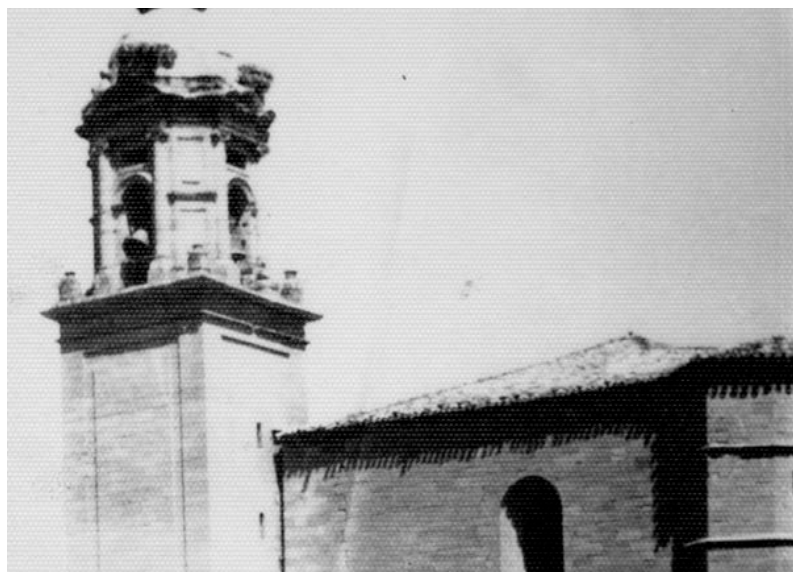
Figure 2: Photograph of the 60's (full and detail) where the detachment and crack are already noticeable.

At the present time, we are gathering old photographs that can elucidate this matter. Up to now, we have collected some interesting photographs from the sixties in which we can see both the detachment of the tower and the presence of cracks. Although these photographs do not provide any metric data, at least they reflect a slow evolution of the movements. Consequently and in spite of its appearance, we cannot exclude, right from the beginning, that we will not detect any movement during the two years that the study will span.

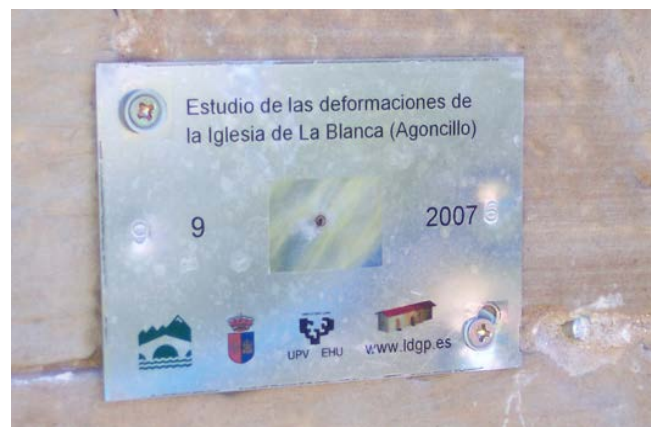
Figure 4: Plate with information about the project and nail (bottom right).

Several doubts arose when determining the most suitable sort of target for the observation, in the end, we decided to use two alternatives and analyse which one behaves better: the first one is a set of plates of stainless steel (100 x 70 mm) with its number carved and an adhesive stick with all the information about the project, the observation point is a hole of 1 mm diameter in the middle. During the campaign, these targets permit an easy location and identification, nevertheless, the central point does not always have a clear definition. On the other hand, we have embedded stainless steel nails of 5 mm diameter with a cross engraved on their head; these nails were placed near the plates. Generally, pointing at the nail is more accurate than pointing at the plate; nonetheless, they would be rather difficult to locate without the plates. Anyhow, before we can state which kind of target is more appropriate we have to see how time will affect them.

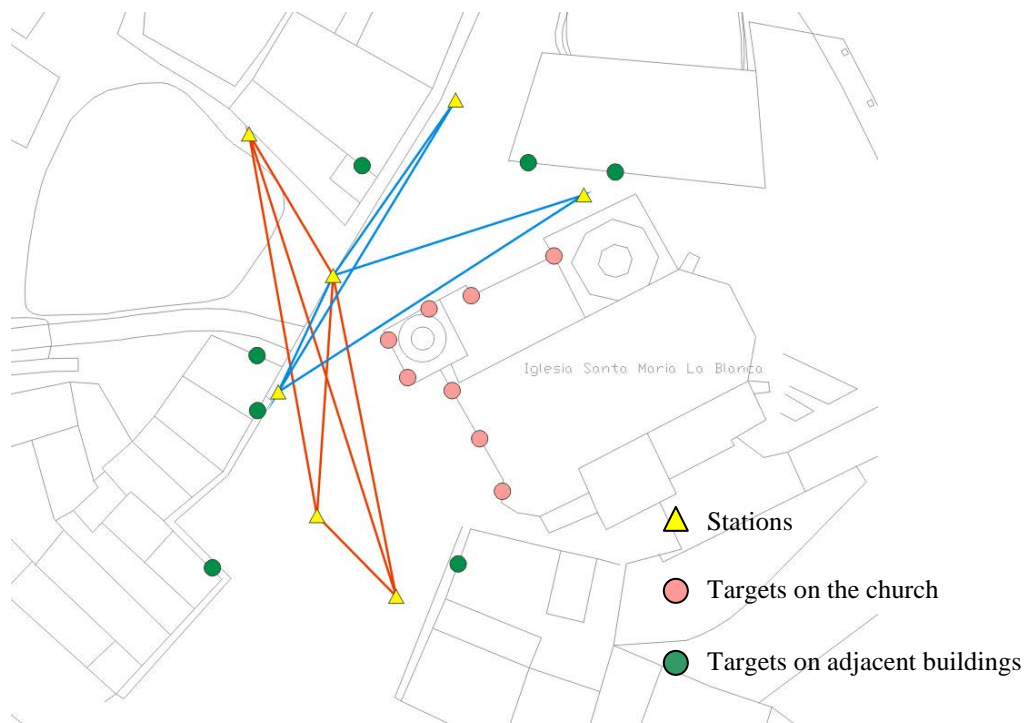
Figure 6: Plan sketch of the layout of the targets and stations.

The construction of pillars was not an option, neither for the budget nor for the nuisances that they would cause to the neighbours, we must bear in mind that the square is a public space that, among other uses, is the place of a weekly market (on Fridays, which prevents observing this day). Therefore, we resort to set up the total station (in this project, we are using a Leica TCR1205 R300²) over a combination of tripod and tribrach like a kind of forced centering equipment. We complete the group of observation placing three additional tripods with tribrach and prism. A second group of four tripods is necessary to cover all targets; however, if both groups can be observed on the same day, it is possible to share a point, as it is shows in the following image:

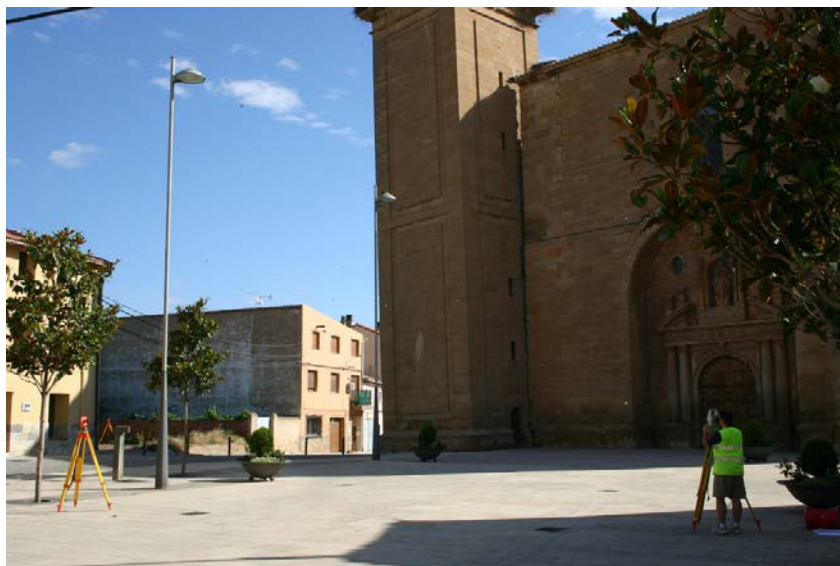
Figure 7: Set up of the surveying field work

Each target is observed from three different references, following the well-know sequence $DP_{reference}-DP_{target}-RP_{target}-RP_{reference}$ (DP: direct position, RP: reverse position). The configuration was designed so that each target is observed from at least three stations.
