Evaluation of black crust formation and soiling process on historical buildings from the Bilbao metropolitan area (North of Spain) using SEM/EDS and Raman microscopy

Estefanía Calparsoro,[1] Maite Maguregui,[2,*] Anastasia Giakoumaki,[3] Héctor Morillas,[3] Juan Manuel Madariaga[3]

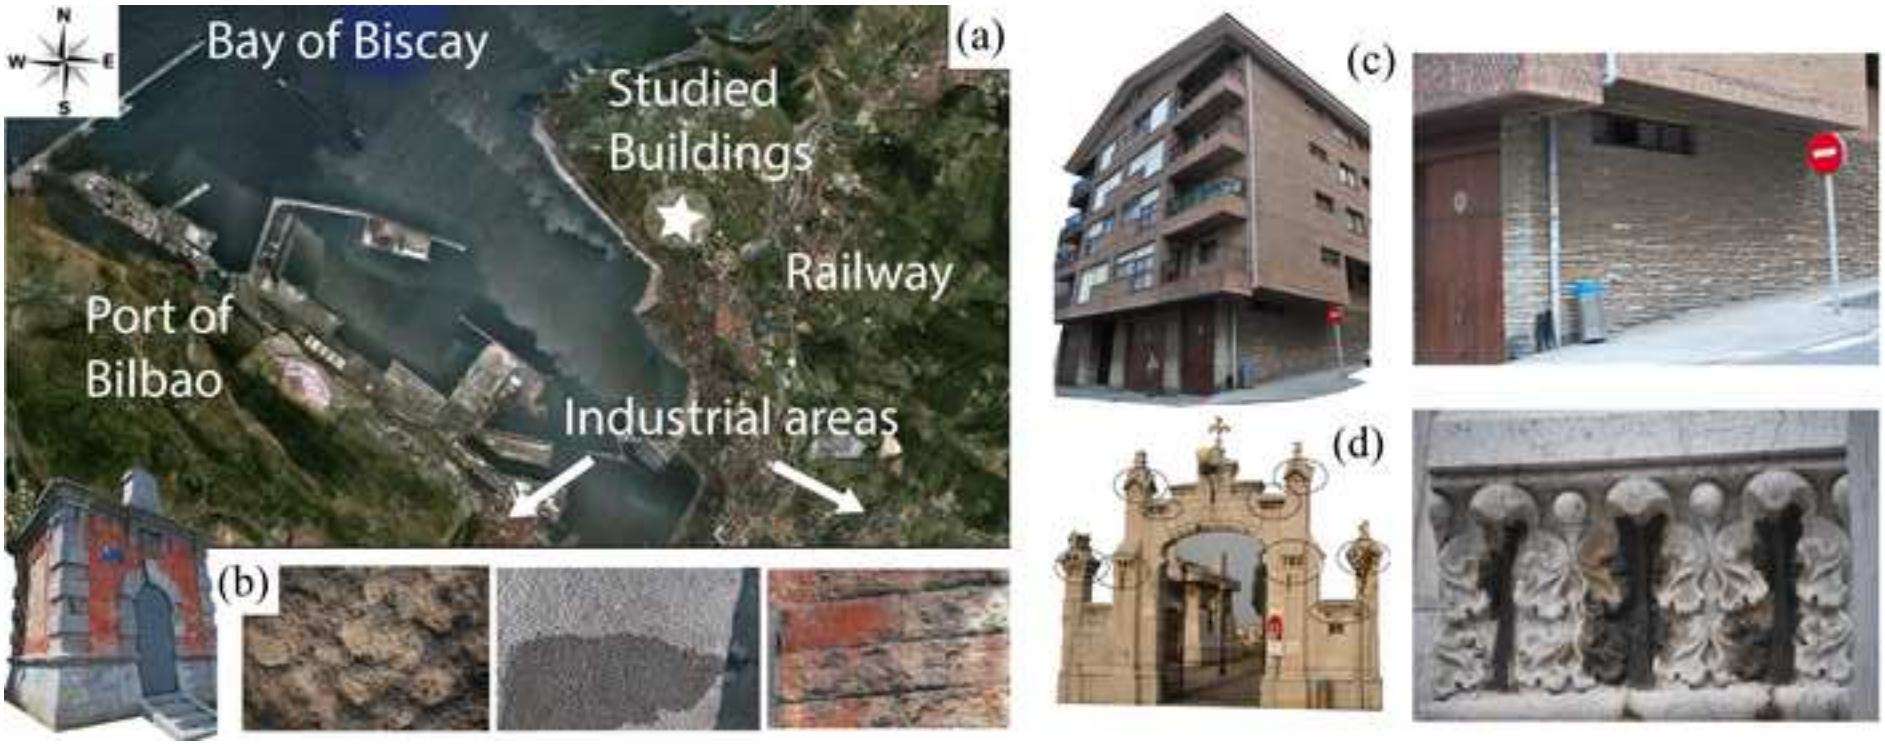
Click here to download Figure Figure 1.tif

Figure 1. (a) Detail of the sampling location, (b) Malacate building and detail of its deteriorations patterns in sandstone, limestone and brick (from right to left), (c) Talaieta street building and a zoom of the soiling process and (d) Cemetery and detail of black crusts on it.

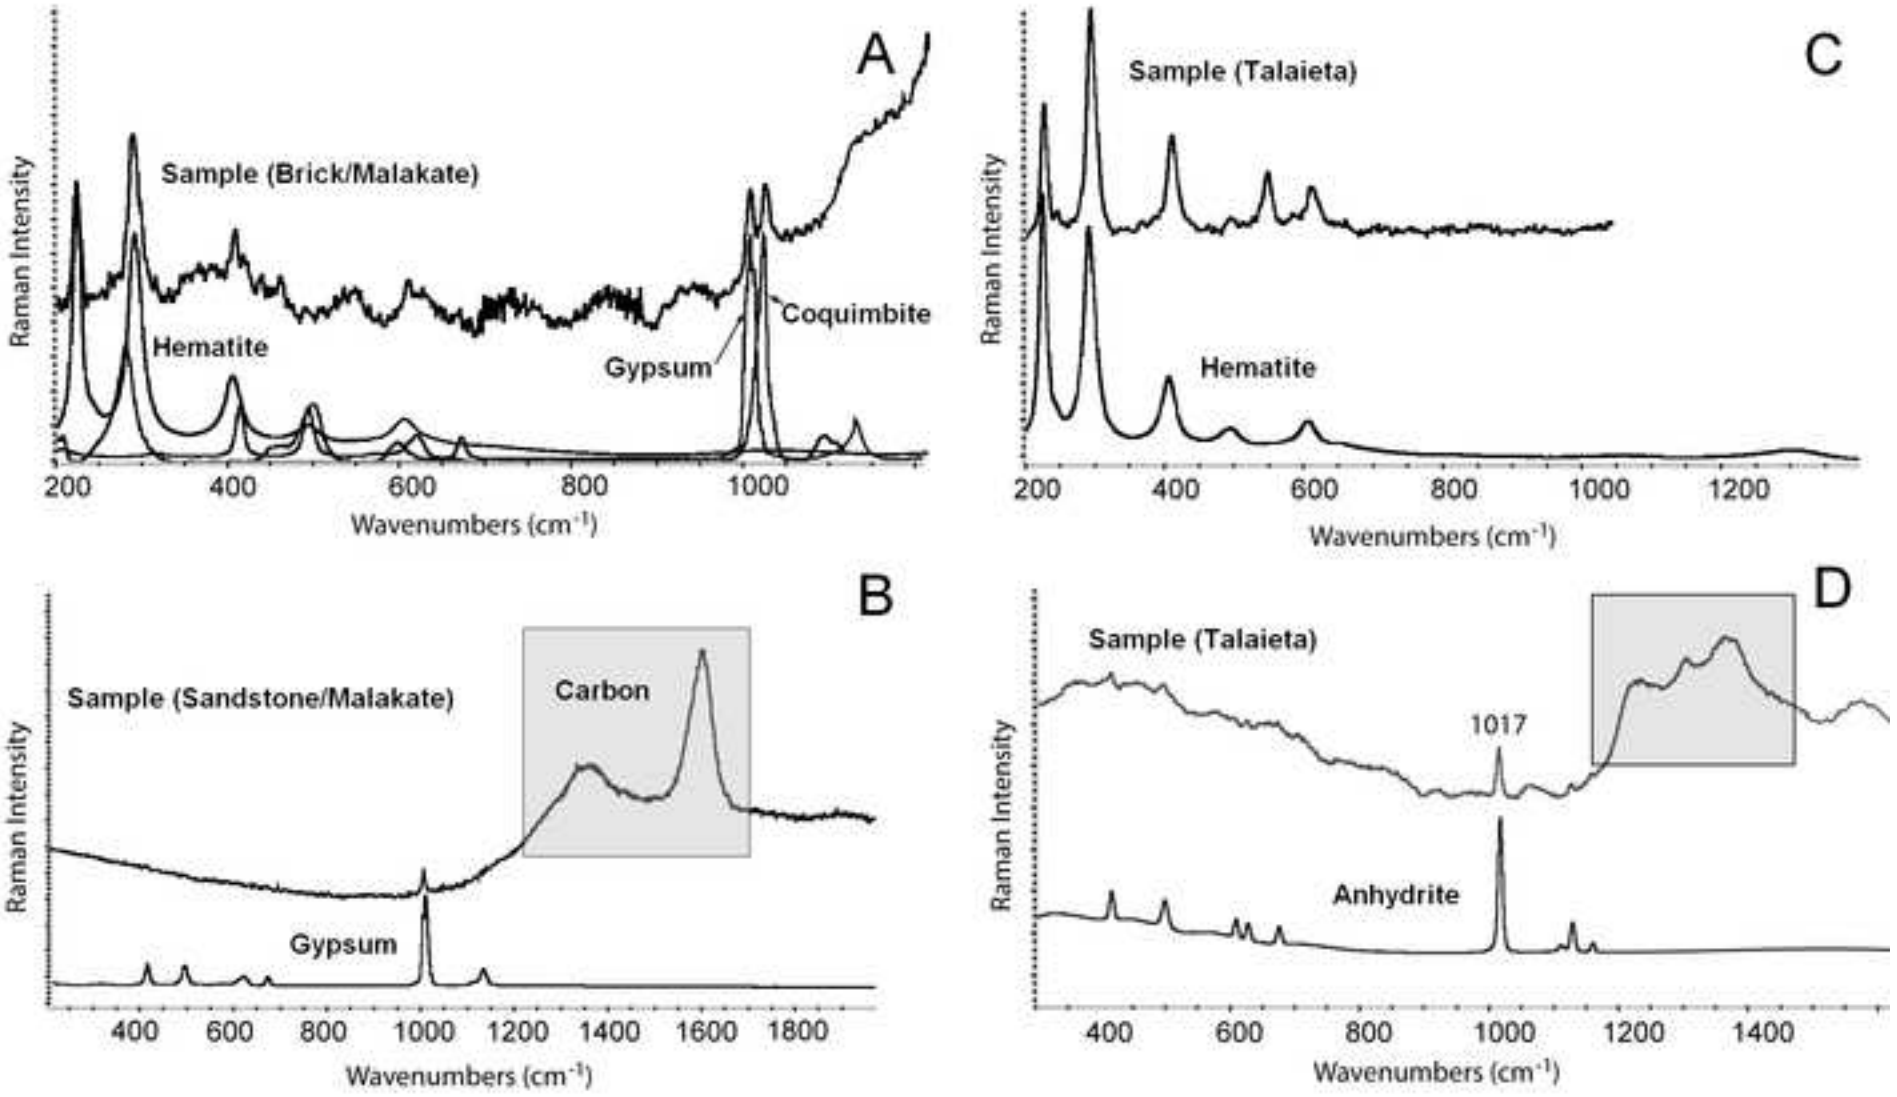
Click here to download Figure Figure 2.tif

According to this reaction, it is supposed to be normal to find (para)coquimbite together with gypsum and hematite, as they are the reactants of this degradation product (see the spectra in the Figure 2A).

Apart from the exogenous compounds ascribed to degradation processes and atmospheric depositions, some remains of graffiti painting were found. For instance, the presence of ultramarine blue pigment was confirmed by Raman spectroscopy (see Figure 2A).

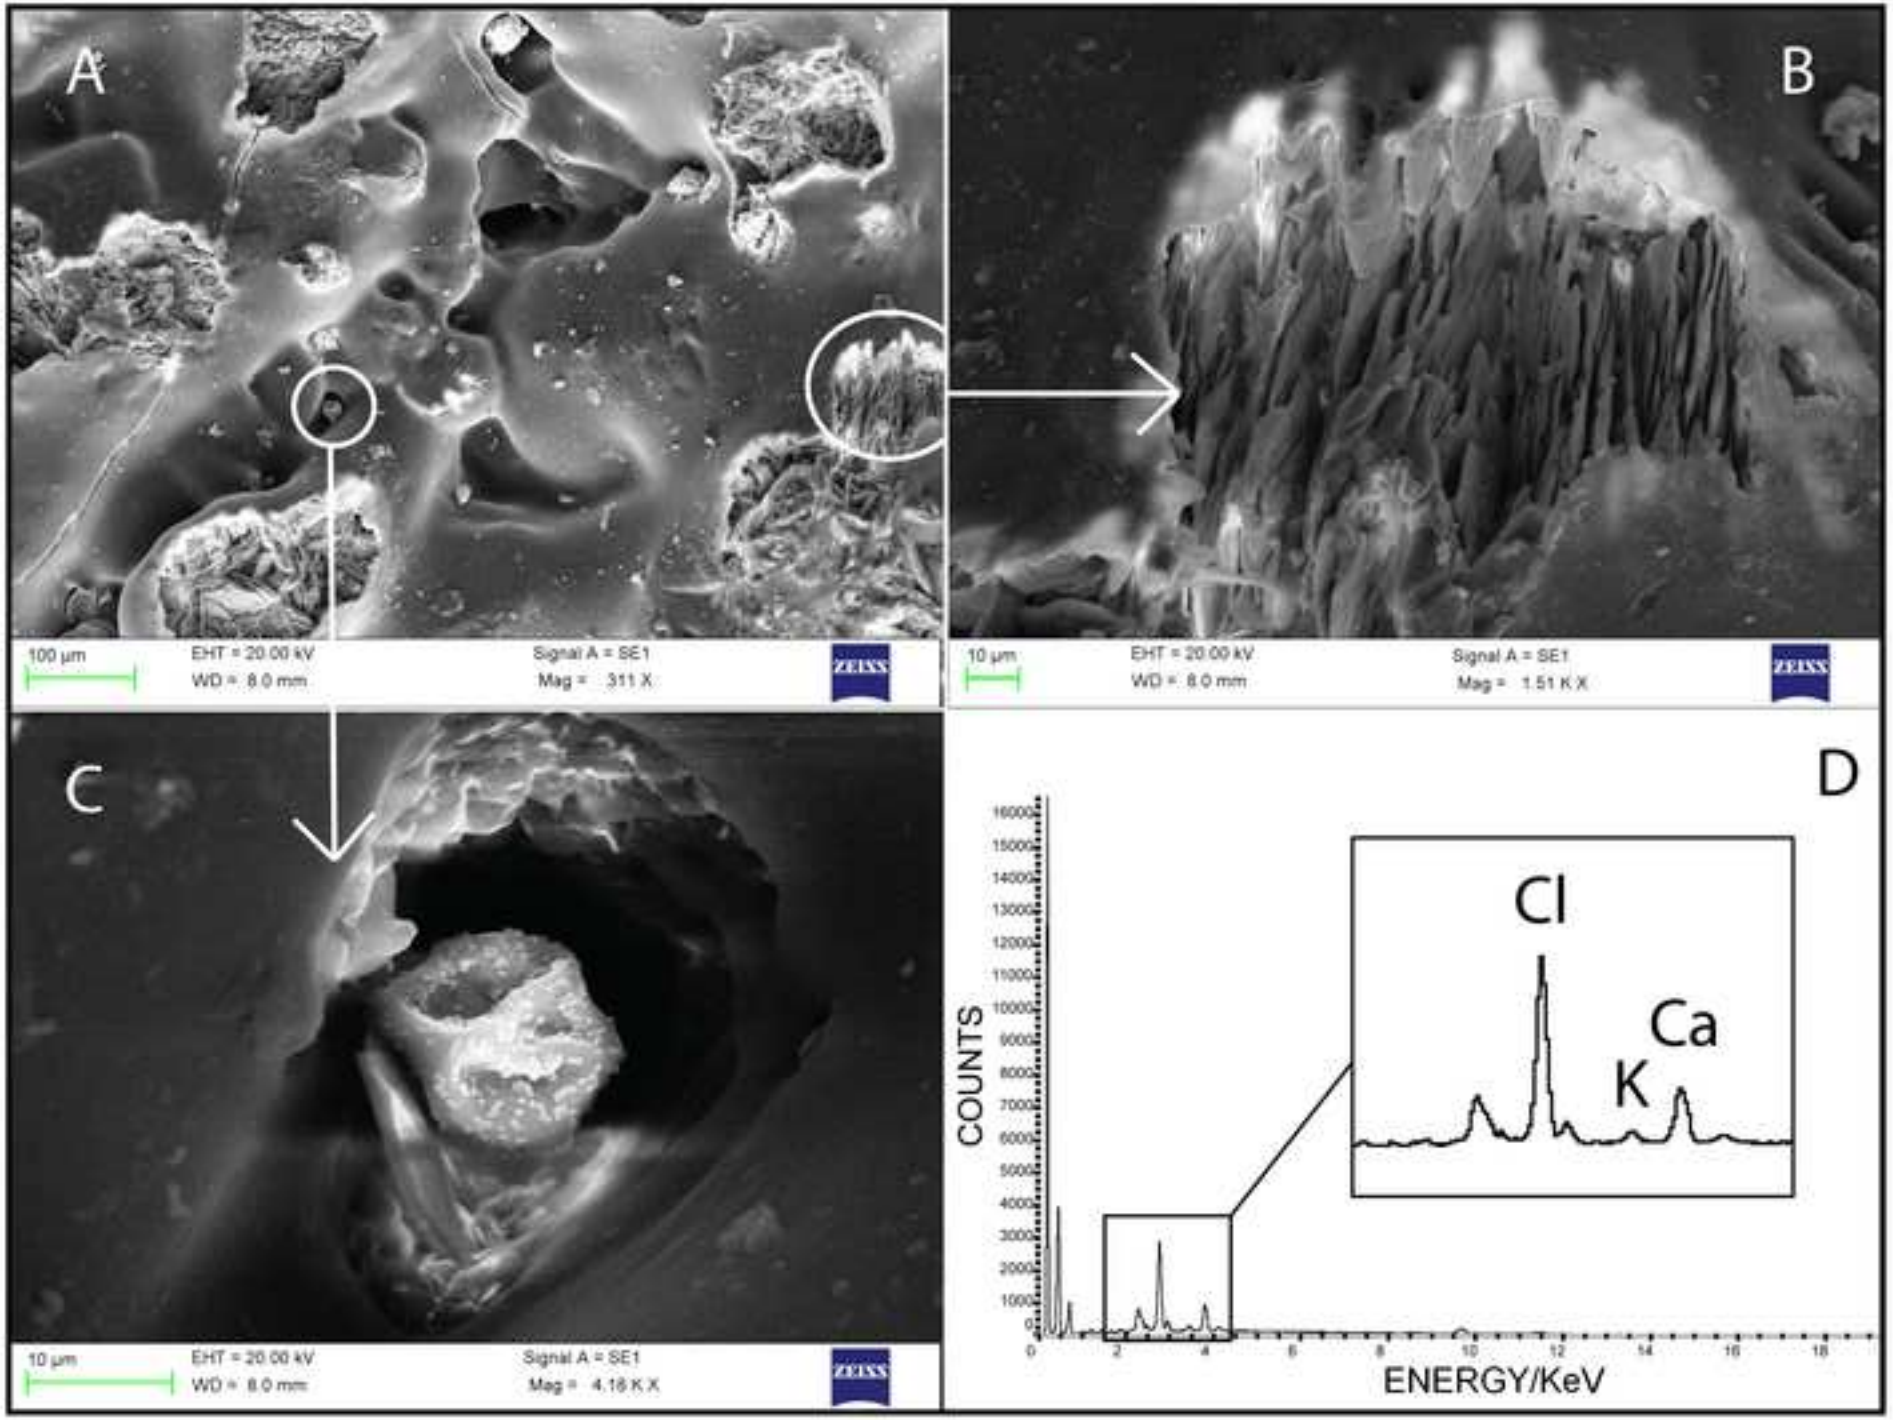
Click here to download Figure Figure 3.tif

In the black crust samples from Malacate building sandstone, a smooth and compact carbon layer with some pores from where the underlying gypsum crystals are observable can be appreciated (see Figure 3A and 3B). Furthermore, depositions of Al-silicates, quartz (α-SiO_2), calcite and those ascribed to sea aerosol containing Na, Mg, K and Cl were characterized on the surface. Concretely, in the Figure 3C a Cl particle inserted in the pores of the carbon layer of the black crust can be observed (see Figure 3C and 3D). These finding evidences that the particles coming from the marine aerosol can be deposited and trapped in the black crust matrix (Morillas et al. 2016a).

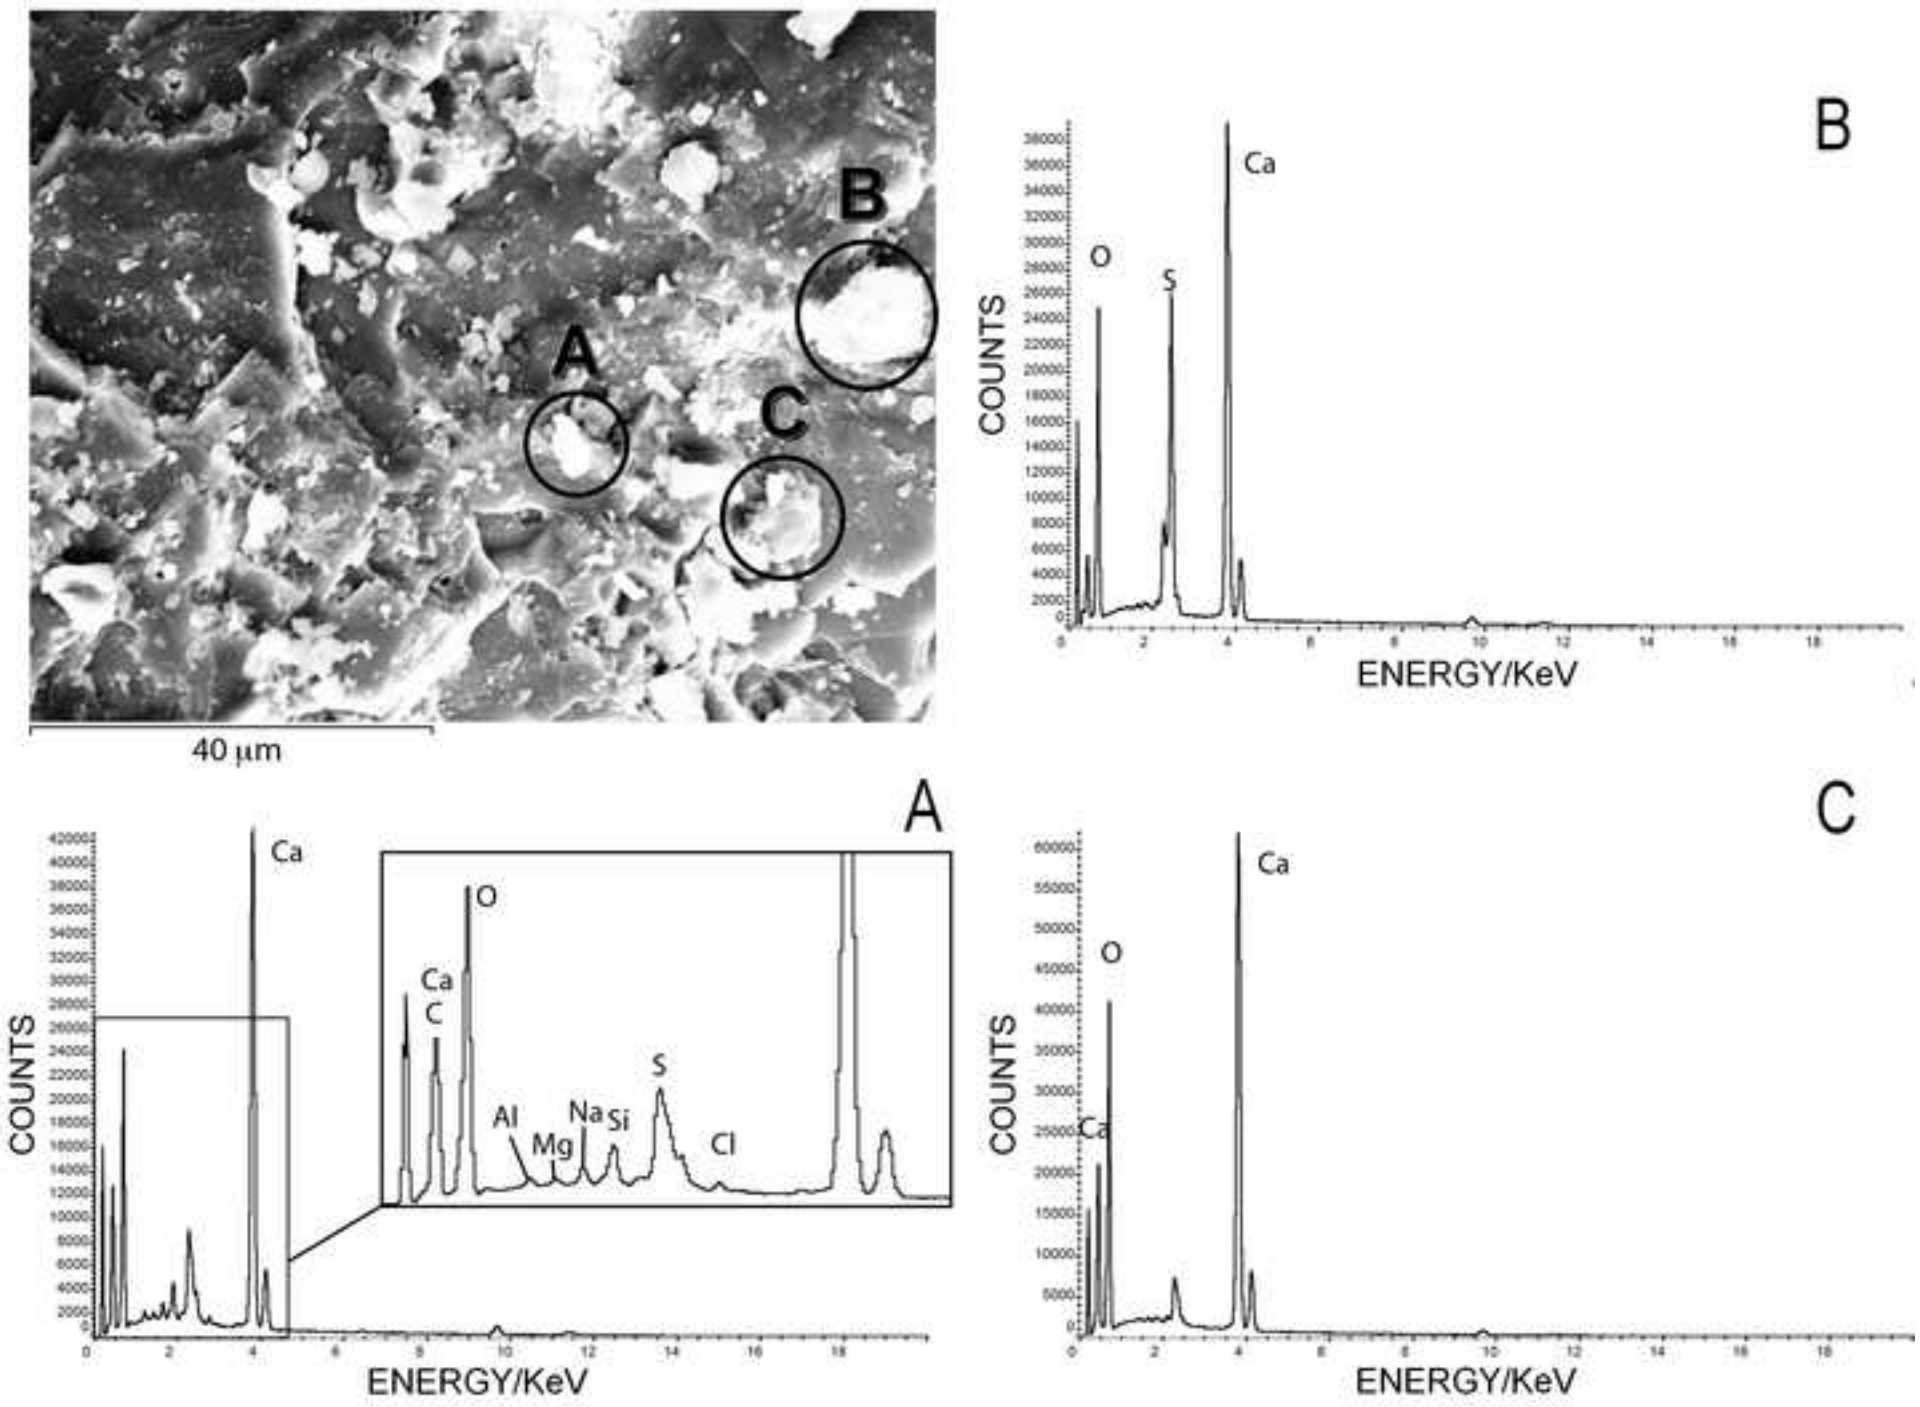
Click here to download Figure Figure 4.tif

With regard to the limestone's black crust, carbon was not present as a smooth and compact layer (see EDS carbon map in Figure S1 from Supplementary Material) like in the black crust from sandstone. In this case, the contribution of calcite depositions ascribed to the crustal particulate matter was observed over calcite crystals, which seemed to have been recrystallized during the black crust formation. In Figure 4, examples of particles deposited on the black crust can be observed. According to the semi-quantitative information included in Table 2 and EDS spectral evidences presented in Figure 4, not only individual particles of gypsum (see EDS Figure 4B and Table 2), and calcite (see Figure 4C and Table 2) were identified on the limestone's black crust, but also aggregate particles including aluminosilicates, sulfates and chlorine (see Figure 4A and Table 2)

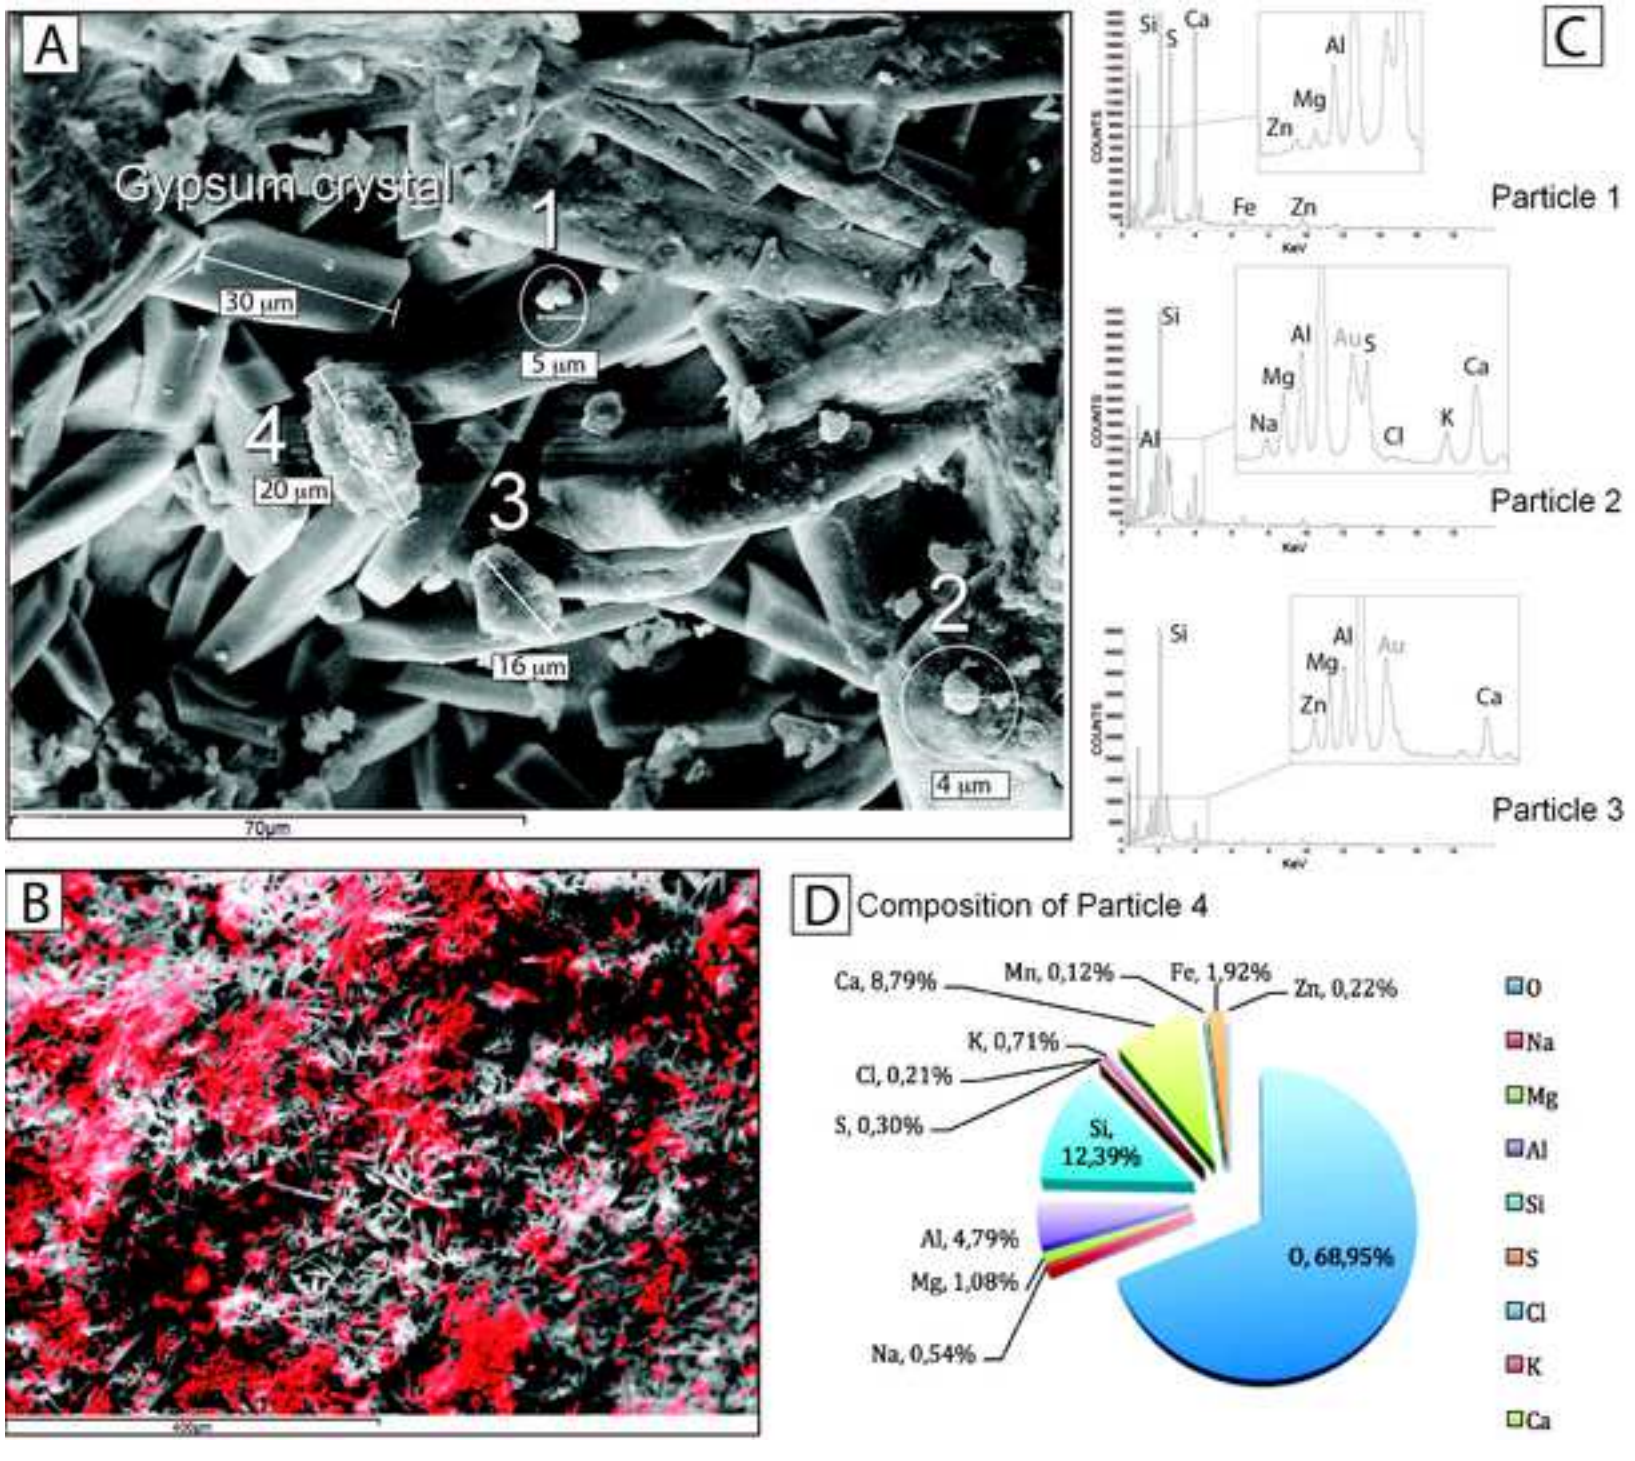
Click here to download Figure Figure 5.tif

The black crust in the cemetery gate was constituted by a matrix of gypsum crystals with depositions of carbon and random particles (see Figure 5B, where the carbon layer is highlighted in red). According to the literature, this is the most characteristic case of black crust (Moropoulou et al. 1998). The average size of the acicular gypsum crystals of the matrix (see Figure 5A) is circa 30 μm long and 5 μm wide.

The composition of particle 4 in Figure 5A is given in the pie chart (Figure 5D). It gives an idea of the nature of this kind of aggregates deposited on the surface. Apart from the elements mentioned before, here we can see the contribution of Na, Cl and Mg, ascribed to the chlorides coming from marine fog.

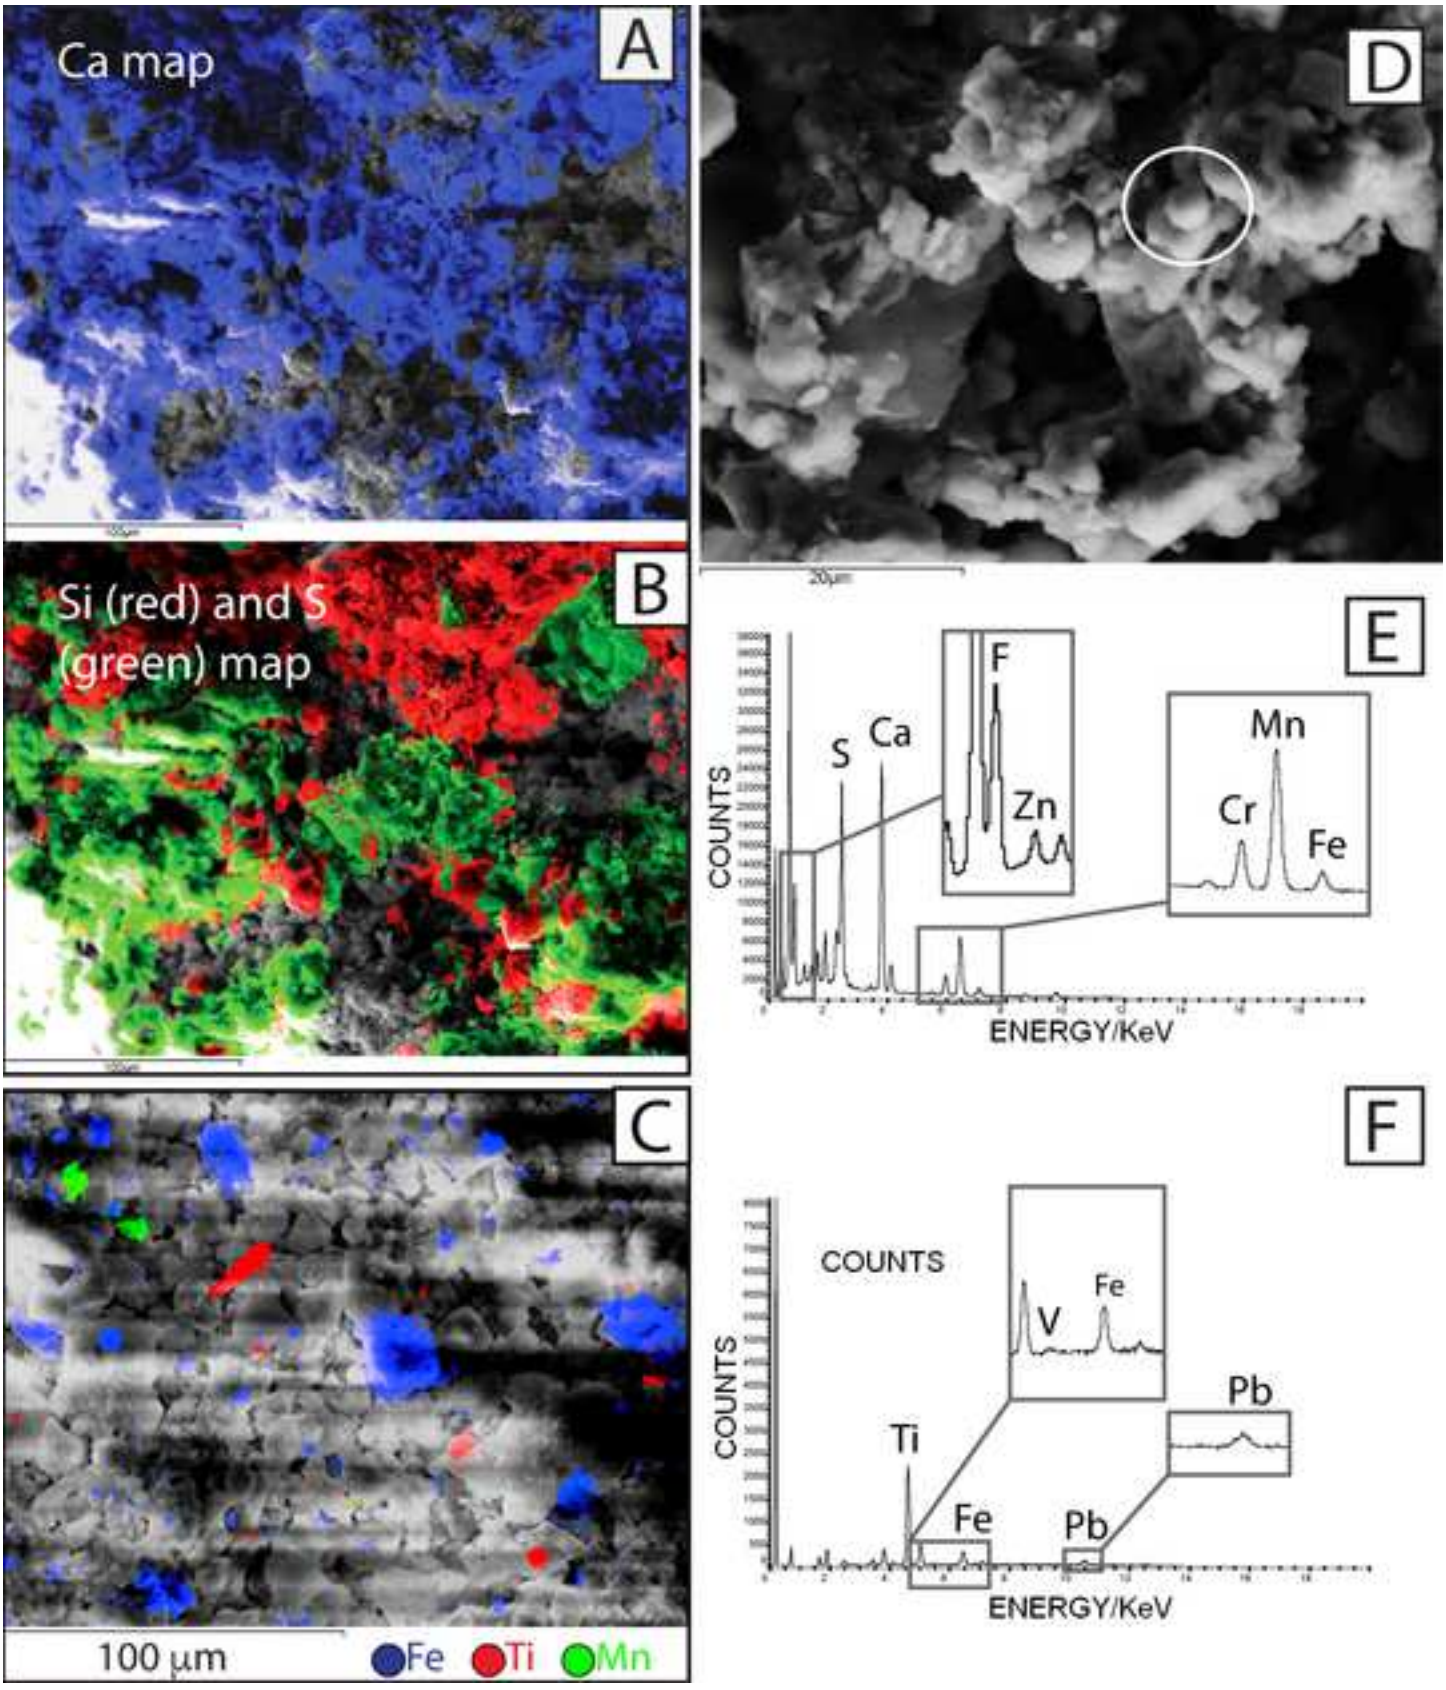
Click here to download Figure Figure 6.tif

EDS spectra indicate a high input of metallic airborne particulate matter. Al, Ca, Fe, K, Ti, Zn, Cu, Pb, Cr, Mn and V were identified. Among them, titanium particles were the most abundant, regularly accompanied by Fe and traces of Pb and V (see Figure 6F).

Apart from the Al-silicates encountered repeatedly among the EDS analysis, EDS spectra, acquired on the particle circled in Figure 6D of more heterogeneous nature and with a diameter of about 3 μm, showed gypsum as one of the main constituents of the particle, but also the presence of fluorine (around 22% in weight). The origin of the fluorine is not clear. Fluorides are naturally occurring components (in rocks, soils, etc.) and they can enter the atmosphere through volcanic emissions and the re-suspension of soil by the wind. Marine aerosols also release small amounts of gaseous hydrogen fluoride and fluoride salts into the air (Franzén 1990; Stefanis et al. 2005). Moreover, it may come from anthropogenic sources such as industry, incinerators, etc. Indeed, fluorine identified on the surface of a building located in Getxo, may come from a factory (where fluorine compounds are produced), as has been reported (Martínez-Arkarazo et al. 2007).

With regard to the metallic elements distribution, the predominant element was found to be iron as is depicted in Figure 6C (Fe particles are highlighted in blue). This spot was considered as representative of the sample as this behavior is extended along the surface. These maps contribute to know the way in which metallic particles are deposited. At this spot, Mn, Fe and Ti-rich particles are shown. Iron is clearly the most abundant element, being deposited in a wide range of different particle sizes, which range from 1 μm long to a diameter of 20-25 μm approximately. The EDS spectrum of the Fe particle particularly, revealed the contribution of other metals such as Zn and traces of Pb (see Figure 6F).

In addition to Fe, titanium particles with acicular shape of 20 μm long approximately can be observed (see Figure 6C). And finally, manganese is present in a minor extent with an average size of around 5 μm. The EDS spectrum of the Mn particle revealed that it is composed mainly of Mn, without any contribution of other metals, in contradiction to the cases of other aggregates.
