# Repair of Beam End Joints Using Steel Rods and Wood Prosthesis in Heritage Buildings: Implantation in the Structure of the Zabala Palace in Ordizia (Basque Country, Spain)

**Abstract:** This paper presents the methodology developed in the repair of three oak beam ends in a protected heritage building: the Zabala Palace in Ordizia (Basque Country, Spain). It describes the structural assessment, design, calculation and execution process, as well as the experimental tests carried out in the laboratory to verify and validate the structural capacity of the repair method. The intervention consisted of cutting and removing the beam ends degraded by fungi and replacing them with wooden prostheses. These elements were connected to the beams by means of threaded steel rods and epoxy resin. Calculations based on standards and the literature were verified by laboratory tests where aspects such as the fluidity, filling and pull-out resistance of four commercial epoxy resins were tested. Once the epoxy resin was selected, three samples of the reinforcement design were also flexure tested. The results of the different tests show capacities much higher than those resulting from the application

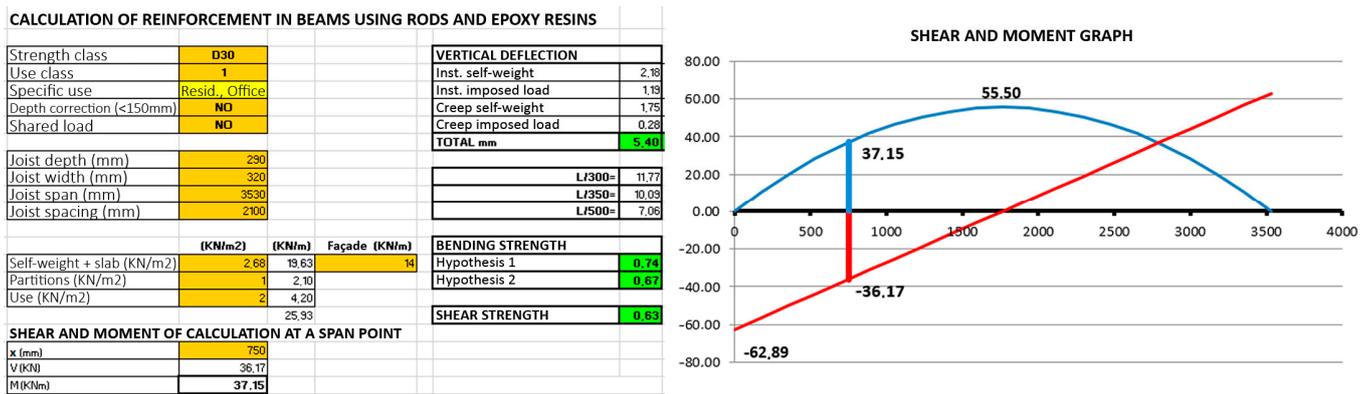
Figure 6. Spreadsheet. Input of basic data and resultant forces.

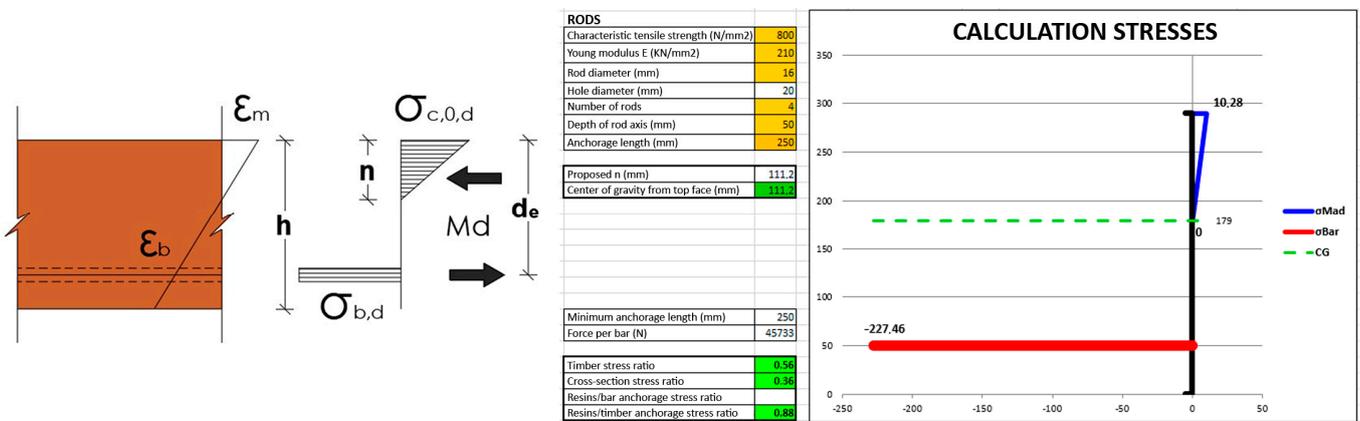
Figure 7. Spreadsheet. Calculation of rods and anchorage length.

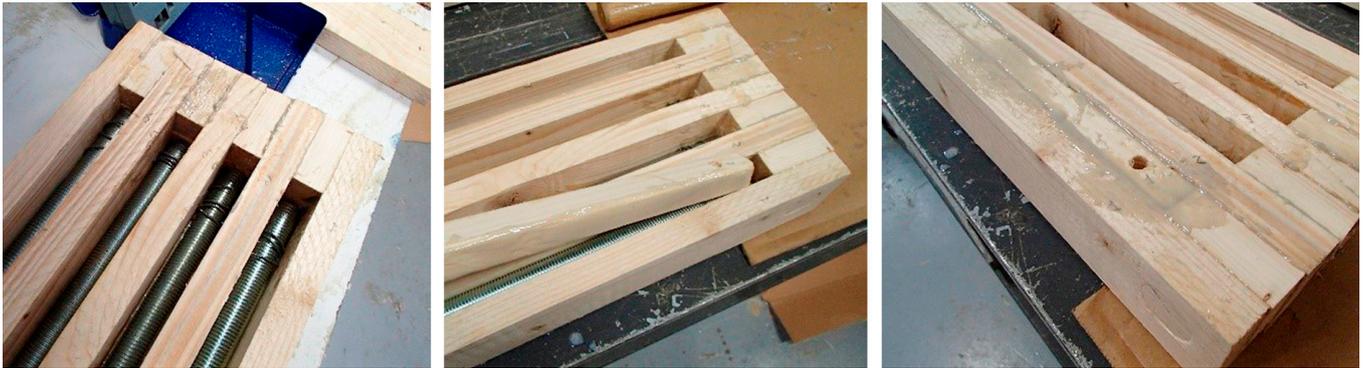
As mentioned above, the first phase of the experimental verification studied the suitability of four different resins for injection, fluidity and filling. The test specimen manufactured for this purpose consisted of a timber block with four grooves into which the rods were inserted. These rods were separated from the wood surface by wire spacers and sealed with a wooden strip glued with epoxy resin (Figure 8).

Figure 8. Sample preparation for testing. Fluidity and filling test of resins.

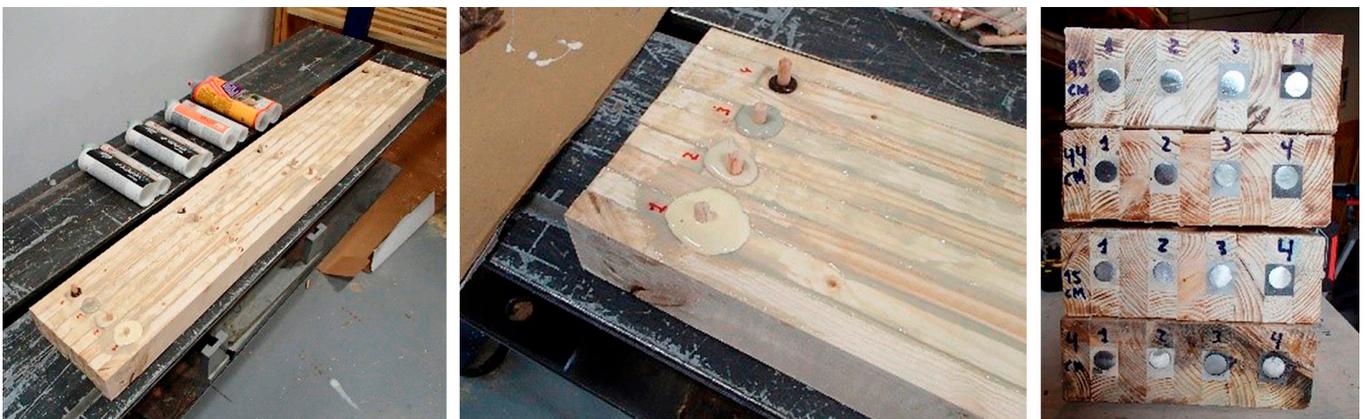
To assess the fluidity of the resin, holes were drilled along the wooden caps at distances of 50 cm, 75 cm and 100 cm from the injection point (Figure 9, left). As the resin overflowed each of the holes, they were sealed with a wooden dowel (Figure 9, center) and the injection continued. The results indicated that all four resins were suitable for injection through holes separated 100 cm apart, which was a distance significantly longer than required for the intervention. It is noteworthy to mention that one of the resins was found to be excessively fluid and was subsequently discarded, as it would partially run out through the holes if injected from below. After the fluidity tests were completed, the test sample was sectioned into four parts to verify that the space between the rod and the wood surface was adequately filled (Figure 9, right).

Figure 9. Fluidity and filling test of resins.

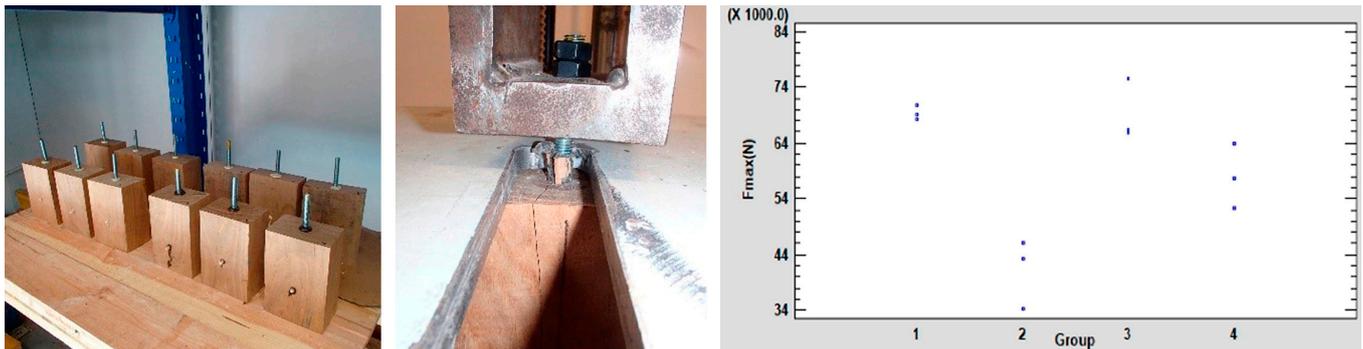
In the second phase, the pull-out tests revealed substantial differences between the four resins (Table 2), even between the two from the same supplier. Epoxy resin 1 showed a fairly constant pull-out resistance with values between 68 and 71 kN. Epoxy resin 3 also showed high pull-out resistance, although with slightly more dispersed values (66–76 kN). Epoxy resins 2 and 4 showed a lower pull-out resistance, also with a considerable variance between 34 kN and 46 kN and 52 kN and 64 kN, respectively (Figure 10). All samples showed a predominant timber failure around the bonding line.

**Figure 10.** Samples, test and results of extraction of rods glued with 4 types of resins (1–4).

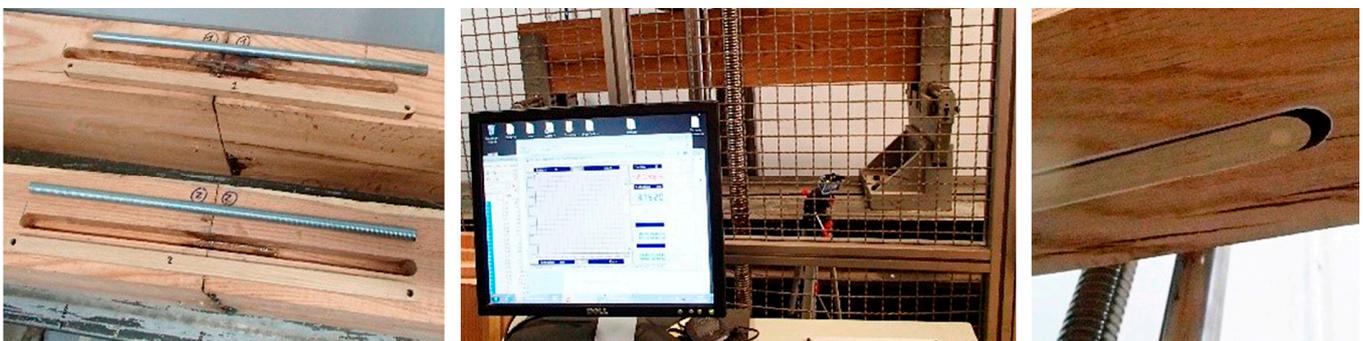
After the two initial phases of tests, it was decided to use epoxy resin number 3, because it showed a high pull-out resistance and one of the best fluidity and filling capabilities. After the choice of the resin, the third phase of the experimental verification was carried out on timber elements with beam-size dimensions. Three samples were manufactured and flexural tested (Figure 11). These test beams had the height and other characteristics of the original ones, but only one single rod in the central axis could be inserted since it was not possible to obtain historical oak elements with the same width as the beams in the project. Likewise, a test configuration with a span shorter than the original beams was designed to reproduce, in a controlled manner, the same stress that the rods would have in the real situation. Thus, the bending capacity provided by each rod to the prosthesis was obtained (Figure 12).

**Figure 11.** Samples and flexural test.

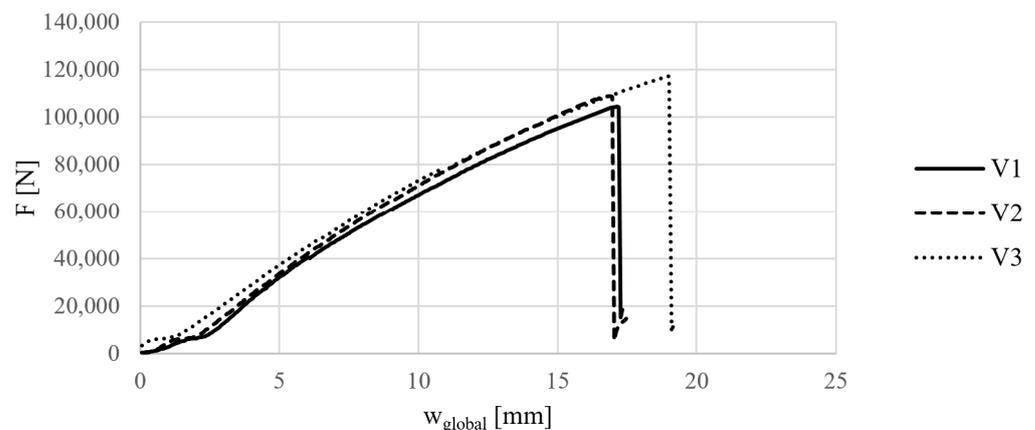
**Figure 12.** Load–displacement curves of the flexural tests.

The three tested samples exhibited predominant timber failure around the bonding line, consistent with the failure mode observed in the pull-out tests and predicted by the
