Marine aerosol weathering of Mediterranean Calcarene stone: durability of ethyl silicate, nano Ca(OH)₂, nano SiO₂ and nanostructured consolidating products

Abstract

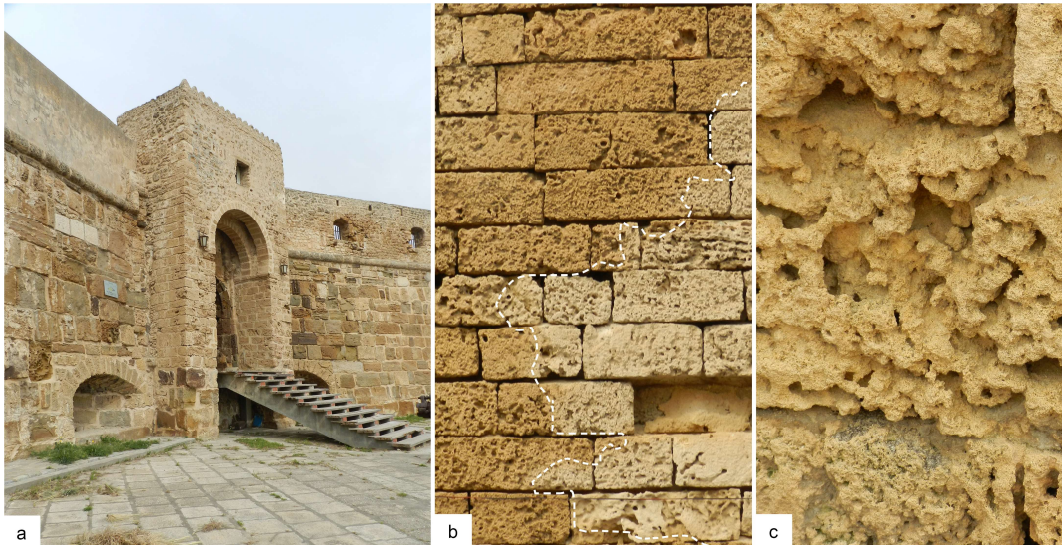
Figure 1. a) Spanish Fort of Bizerta (view from the port); b) Wall of the Fort with honeycomb weathering and moisture problems; c) Honeycomb weathering and loss of material on decayed stone ashlar

The elements that influence degradation of materials used in architectural heritage buildings and archaeological stone artifacts can be divided in extrinsic factors, i.e. those related with the surrounding environment such as atmospheric, constructive or anthropic agents, and intrinsic factors, i.e. those that depend upon the material characteristics, such as chemical composition, mineralogy and physical properties. These factors do not act isolated, they interact with each other enhancing or accelerating weathering patterns and being precursors of further alterations. Regarding the extrinsic factors, honeycomb weathering can take place under different environments but it is a very common decay pattern of stones exposed to marine aerosol or sea-spray action in coastal areas. The particles of seawater present in the atmosphere are mainly originated by the breaking of gas bubbles when the waves collapse (Monahan, 1986). Their principal chemical components are the same as those present in average marine water, being sodium, magnesium, calcium, potassium and strontium the main cations, and chloride, sulfate, bromide and bicarbonate the most important anions (Mottershead et al., 2003). Although the term “honeycomb” has been used for a long time (since the 19th century), the

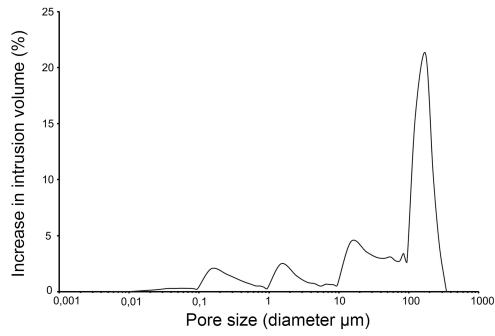
Blank specimen		
Total connected porosity (%)	46.87	
Pore size distribution (%)	< 0.01 μm	0.00
	0.01 - 0.1 μm	2.21
	0.1 - 1 μm	7.92
	1-10 μm	8.38
	10 - 100 μm	28.67
	>100 μm	52.82

Figure 2. Pore size distribution curve obtained by mercury intrusion porosimetry and total connected porosity (%) and pore size distribution (%) of non-treated and non-aged calcarenite samples

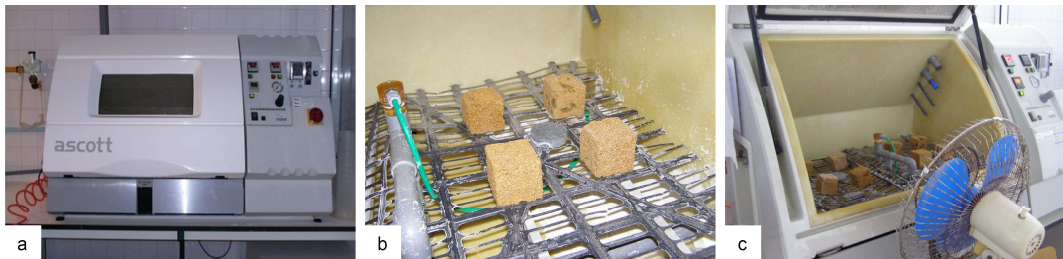
Figure 3. Marine aerosol accelerated ageing test. a) Marine aerosol ageing chamber; b) Drying process without ventilation (6h); c) Drying process with ventilation (6h)

Marine aerosol ageing test was carried out to evaluate the effect of a sea-spray atmosphere and checking the stability of the applied consolidation treatments. It has been also assessed if the applied products entailed a durability increase of the stone subjected to this type of weathering. The ageing test was carried out in one of the blank specimens (B2-1) and in one sample treated with each consolidating product and environmental conditions (B2-5, B2-7 and B2-9 under dry environment and B2-11, B2-13, B2-17 and B2-15 under humid environment). The ageing was carried out in one specimen per each type of product because the previously treated specimens were used to perform destructive analyses in order to study the consolidation effectiveness of the products after their application (Zornoza-Indart et al., 2016) (Table 1). To include the wind factor in the process of honeycomb weathering, the standard test UNE-EN 14147 (2004) was followed with adaptations introducing, as a modification, the use of fan ventilation in the drying process of the cycles due to the impossibility of placing an air generator inside the chamber. The ageing test was carried out using a marine aerosol ageing chamber (Ascott S120T) of the Faculty of Sciences and Technology of NOVA University of Lisbon (Portugal) (Fig. 3a). Samples were submitted to 28 cycles consisting of 12 hours of saline fog exposition with a 1:9 solution of sodium chloride (NaCl) in distilled water (35°C), 6 hours of drying without ventilation (25°C) (Fig. 3b) and 6 hours of drying with ventilation (25°C) (Fig. 3c). At the end of the cycles the samples were submerged in deionized water to remove the absorbed salts. The volume of water in the tank was three times the total volume of the

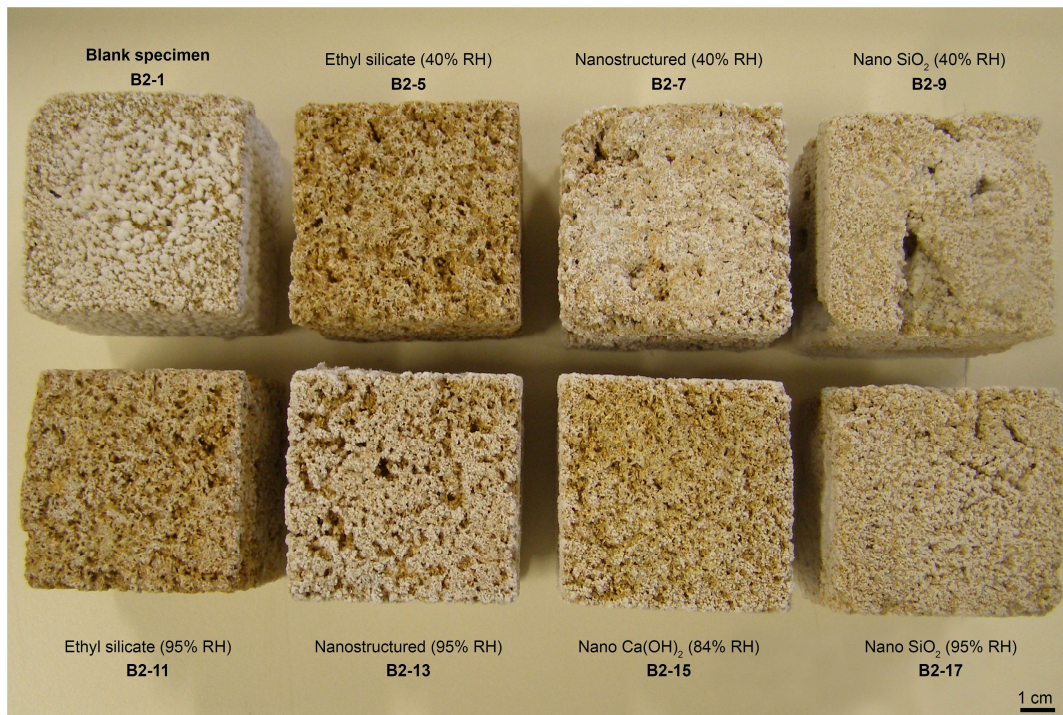
Figure 4. Calcarenite stone cubic specimens after treatment with different consolidation products exposed to different relative humidities (RH) (dry (40% RH) and very humid (84-95% RH) environments) after marine aerosol ageing test and before cleaning with water.

The saline efflorescence visually observed in the blank specimen is greater, especially in the central parts (Fig. 4 and 5). The specimens treated with ethyl silicate almost do not show any efflorescence on the surface, since only thin whitish veils are observed. The reduction of the observed efflorescence's, retained salt and weight, can be given by the generation of a superficial microporous coat (Mosquera et al., 2008) with the occlusion of the pores, modifying the hydric behavior and reducing the penetration of marine aerosol, avoiding salt crystallization due to the smaller size of the pores in the hydrophobic coating layer. So, the crystallization is only possible in the originally coarse surfaces and sections with larger pores where the gel has penetrated but which have not been filled by it.

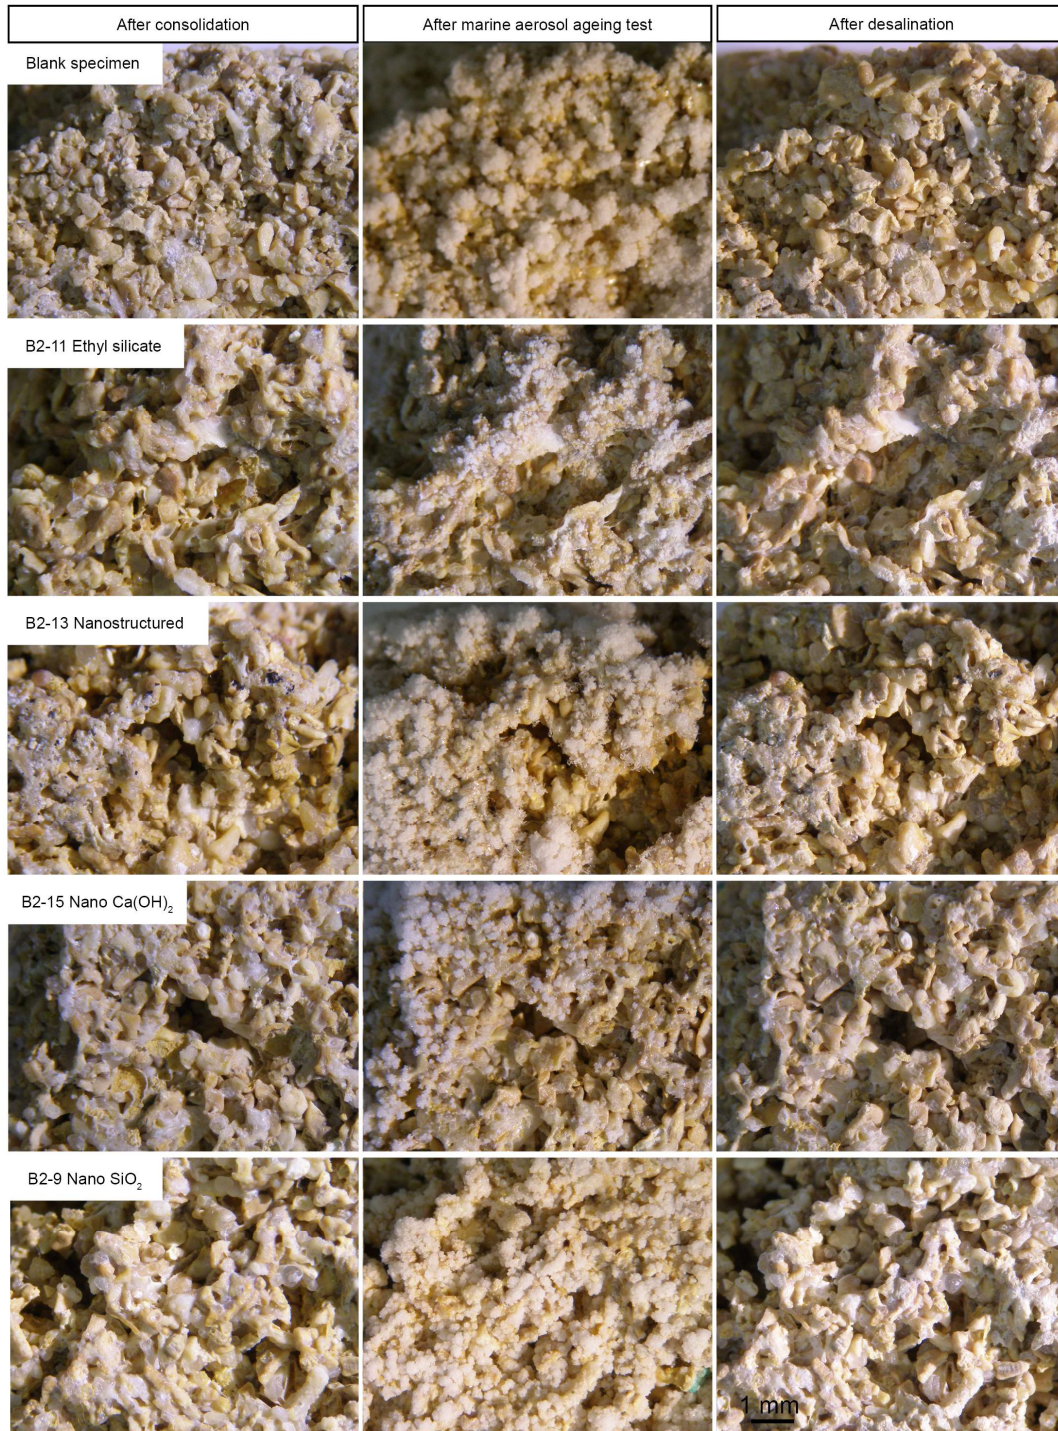
Figure 5. Surface detail images of the treated stones specimens (upper left corner) after one month from the consolidating product application, after marine aerosol ageing test and after being cleaned with water. The pictures were taken with an Olympus binocular loupe (SZ51) and a Olympus camera (C5060WZ, 5.1 megapixels, 5.7-22.9 mm)

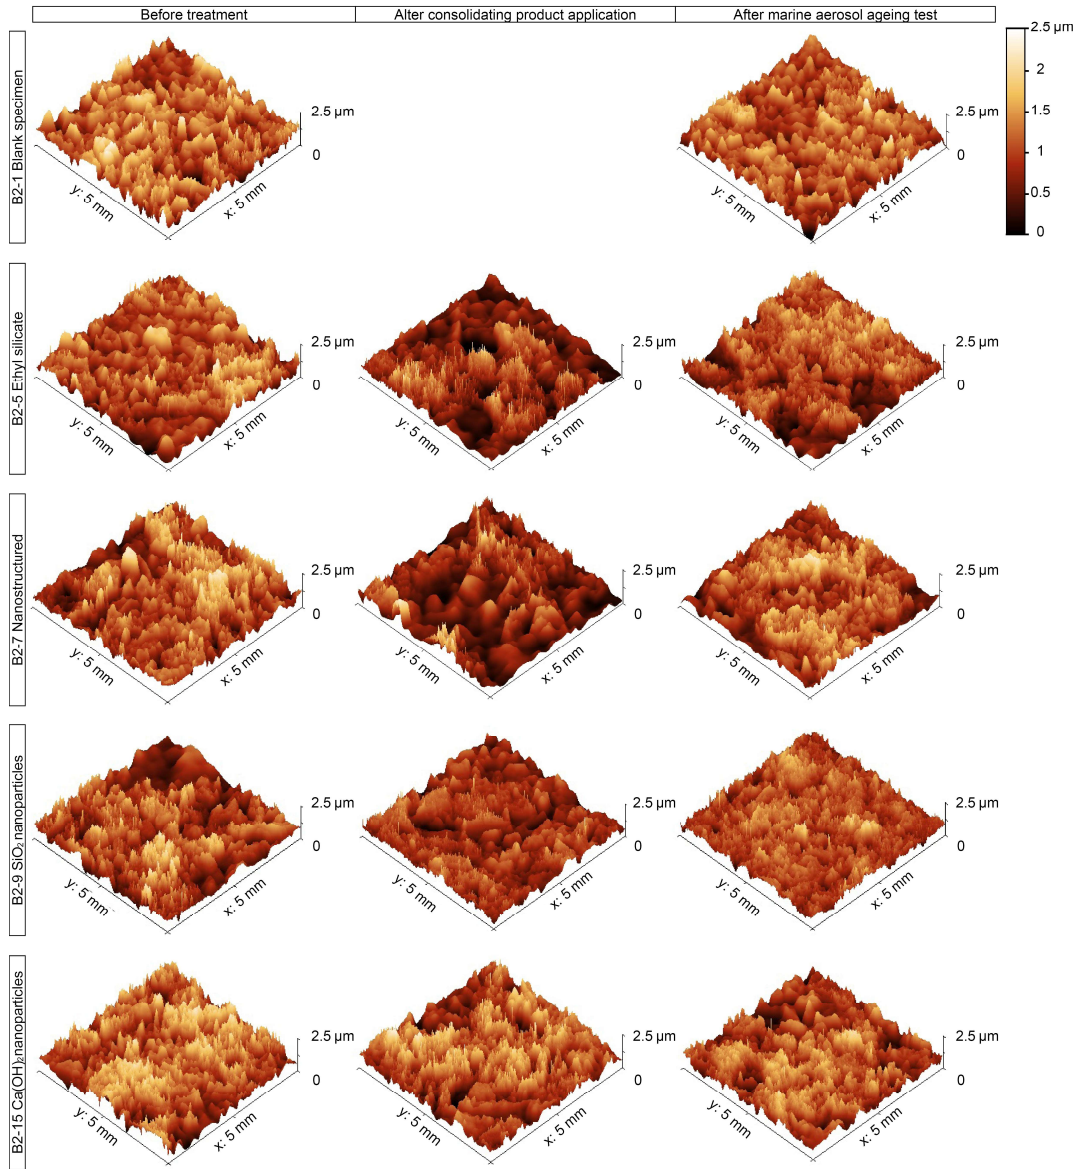
Figure 6. Surface roughness 3D height maps obtained under optical surface roughness (OSR) on the top surface of specimens before, after consolidating product application and after marine aerosol ageing test.

The optical surface roughness parameters, after one month of the consolidating product application and then after the marine aerosol ageing test, are shown in Table 6. Fig. 6 compiles the surface roughness 3D height maps of the specimens. In the blank specimen, both Ra and Rz values increase due to the surface damage produced by salt crystallization. However, the increase of Ra value is slightly higher than Rz, creating a coarser surface instead of producing deeper cavities. In all the treated specimens, surface roughness values are lower except for the ethyl silicate in very humid environment. This could be due to the fragmentation observed in the superficial coat produced by the consolidating product after its application (Zornoza-Indart et al., 2016). Consequently a greater damage of the treated surface takes place.

The nanostructured product is the least stable, since after the ageing test it loses all the previously gained effectivity, especially in the dry environment (Fig. 6). The ethyl silicate product provides a low stability, since a great increase of surface roughness values is also produced, when compared to the values just after consolidation, especially under humid conditions. However, these values decrease on the samples treated with Ca(OH)₂ and SiO₂ nanoparticles in dry environment, while these are almost the same in very humid environment.

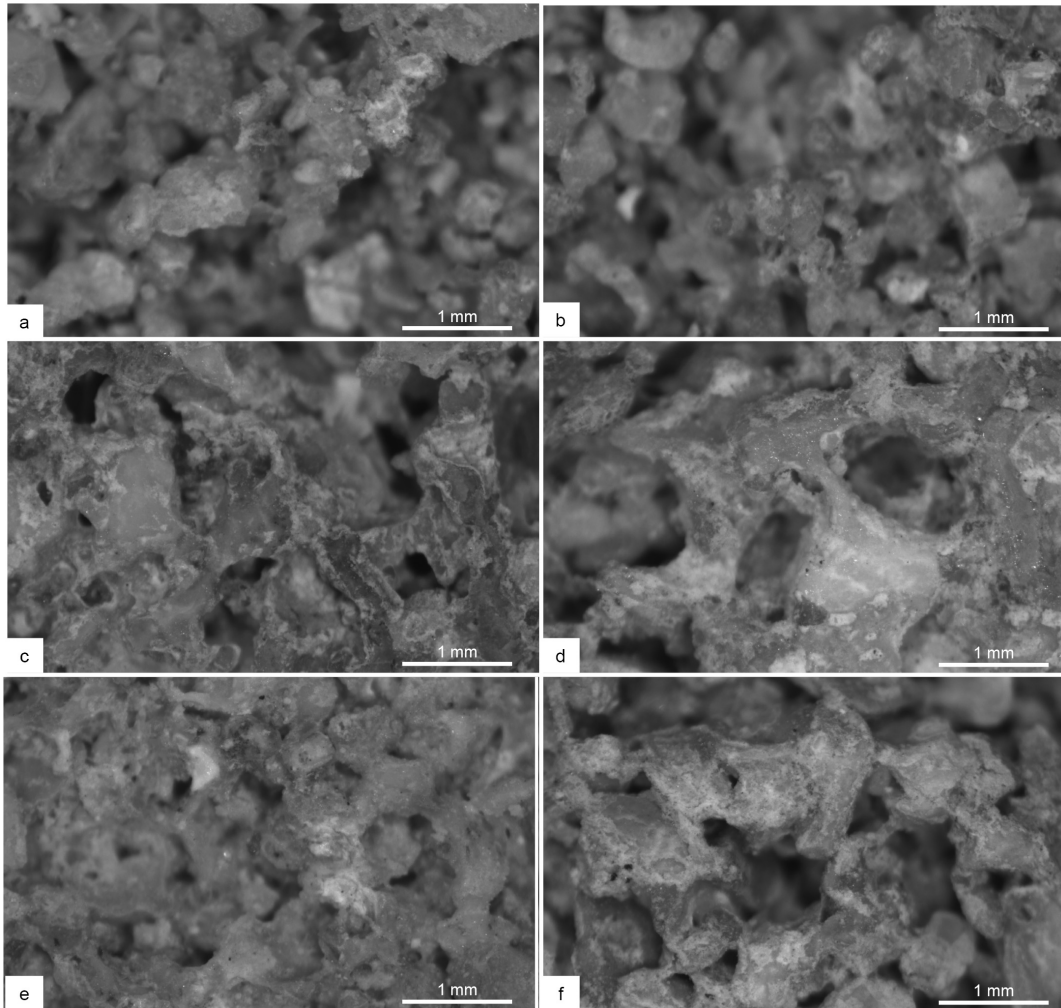
Figure 7. OSR micro-detail images of the treated stone specimens after the marine aerosol ageing test. a) and b) Surface of blank specimen; c) Surface of sample treated with ethyl silicate; d) Surface of sample treated with the nanostructured product; e) Surface of sample treated with nano SiO_2 ; f) Surface of sample treated with nano Ca(OH)_2

obtained on the blank and treated stone specimens. A white opaque layer can be observed on the samples treated with the ethyl silicate and nanostructured products (Fig. 7c and 7d).

The greatest roughness reductions are obtained in the specimens treated with SiO₂ in dry environment. Micro-detail images of these specimens after the ageing test show a reduction of surface porosity where a surface layer coating the substrate grains is observed (Fig. 7e). In the very humid environment, the values are very similar to those obtained before the treatment. In the, even though just after consolidation

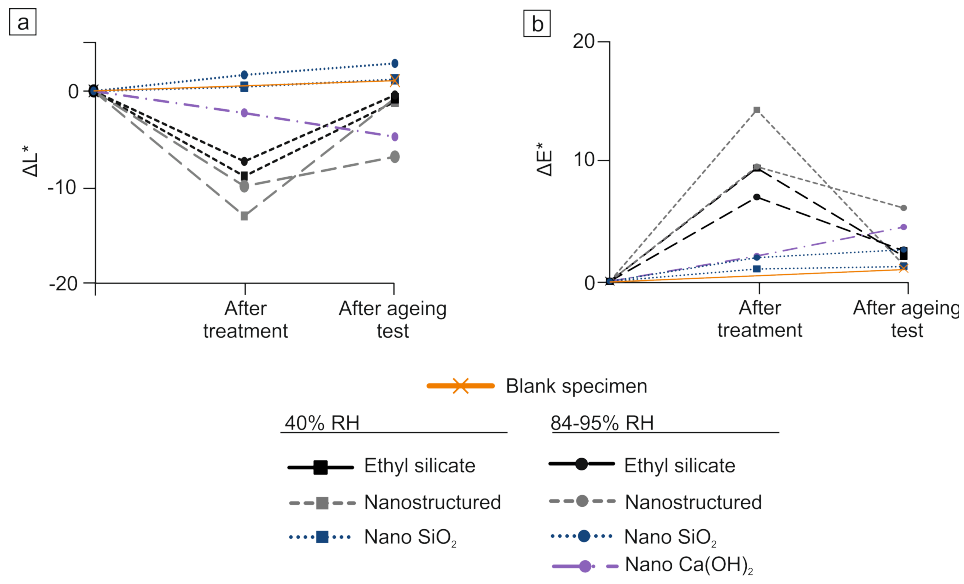
Figure 8. Comparison of luminosity (ΔL^*) and total color (ΔE^*) variations promoted on the stone specimens after one month from the application of different consolidating products and then after the marine aerosol ageing test

The results of chromatic parameters determination on the stone treated surfaces are shown in Table 7 and Fig.8.. In the case of blank specimens, although a slight increase in luminosity and brightness values is observed after the ageing tests, no visually perceptible color changes occur because total color difference (ΔE^*) is lower than 5 (CNR-ICR, 1996) or lower than 3 according to other authors (Benavente et al., 2003; Delgado & Grossi, 2007). The specimens treated with the ethyl silicate and nanostructured products display a reduced ΔE^* and luminosity values, showing a lower stability compared to the other products. In the specimens treated with nanoparticles, ΔE^* keeps constant or slightly increased after the ageing test (Fig. 8a and 8b).

The specimens treated with SiO₂ nanoparticles show lower chromatic variations and greater stability. Lower variations are observed in the case of dry environment, closer values to the blanks, like the results obtained just after consolidation. Luminosity and ΔE^* values increase slightly after the ageing test, in contrast to the other products, although being visually unnoticeable (Fig. 8a and 8b).
